## Kenwood TS-2000 receiver crackling noise problem

### Ceramic filter failure – how to change the filters

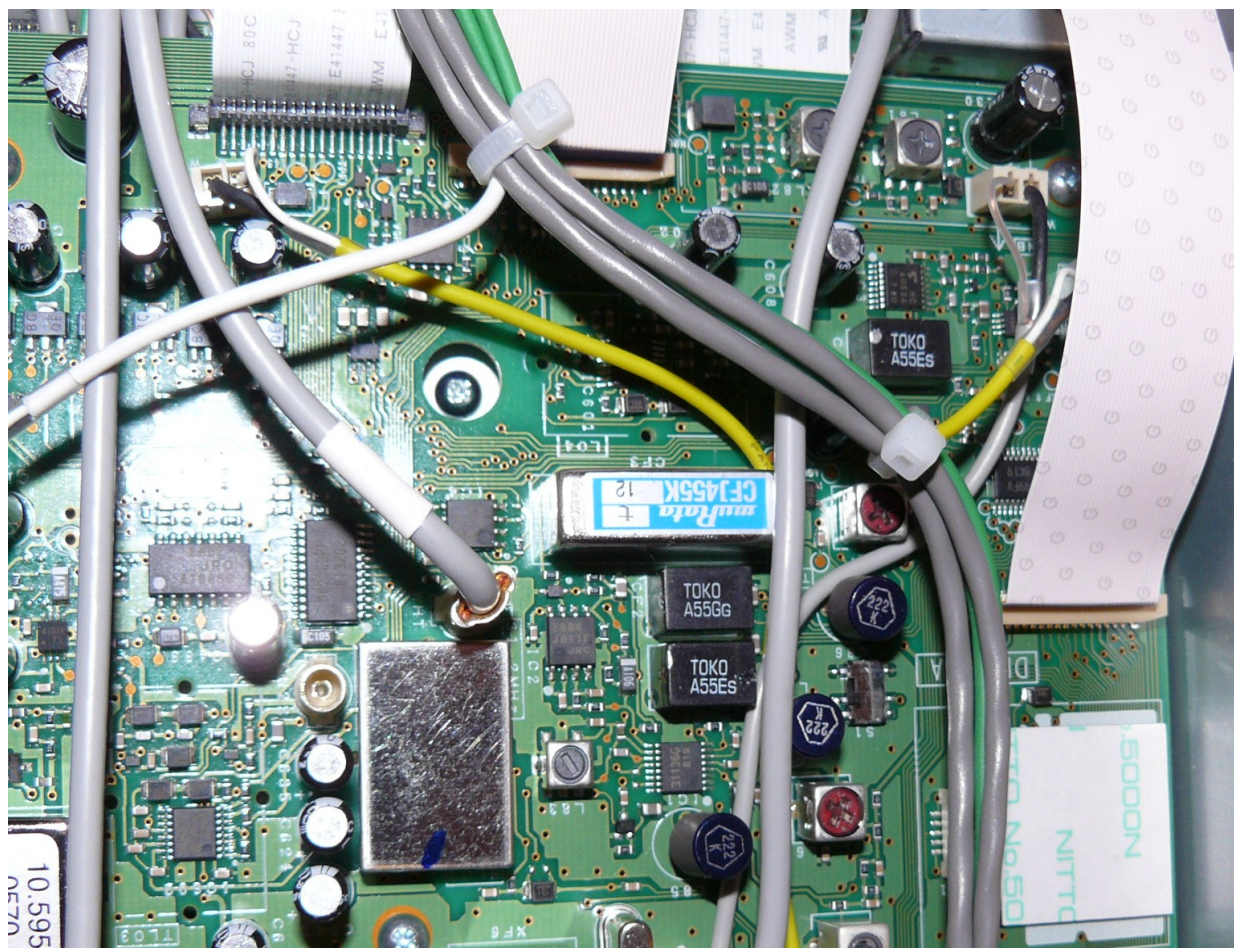
The problem is the failure of the small black ceramic filters (CF1, CF2 and CF4) on the MAIN receiver. But both MAIN and SUB receiver can have this failure. These filters are the TOKO ALFYM455E (15kHz wide) and the ALFYM455G (9kHz wide). I found equivalent filters LTM455EW (15kHz wide) and LTM455GW (9kHz wide). These have exact same electrical data, so it is safe to use them without any re-tuning of the radio. On the SUB receiver, there is 2 ceramic filters on the E (EU) version (FM-W and FM-N), the K (USA) version has only one filter (FM-W).

The MAIN receiver filters are located on the TX/RX board in the bottom (underside) of the radio. The board are marked right next to the filters, CF1, CF2, CF3 (Murata CFJ455K 12) and CF4. The Murata 2.7kHz ceramic filter (CF3) is a different construction and does not need to be replaced.

I decided to replace all filters with YIC LTM455EW and LTM455GW because the original TOKO filters have develop this problem, so I did not want to put in the same filter. These YIC filters is available at eBay for £1.20 (G.B.P) / each. Also, ECS Inc. and others make these LTM455 filters.

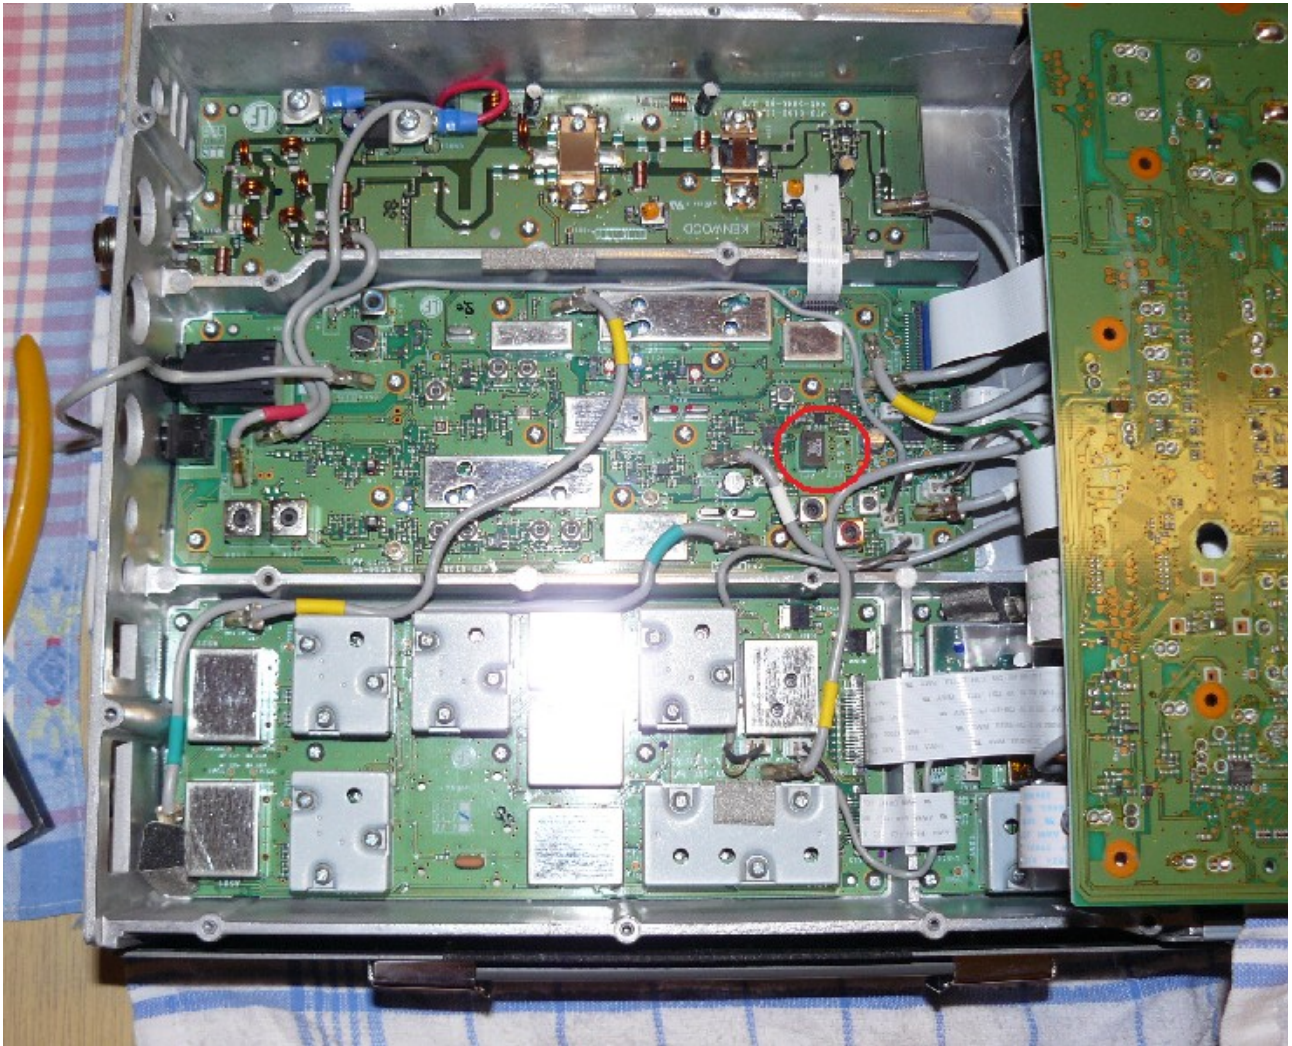
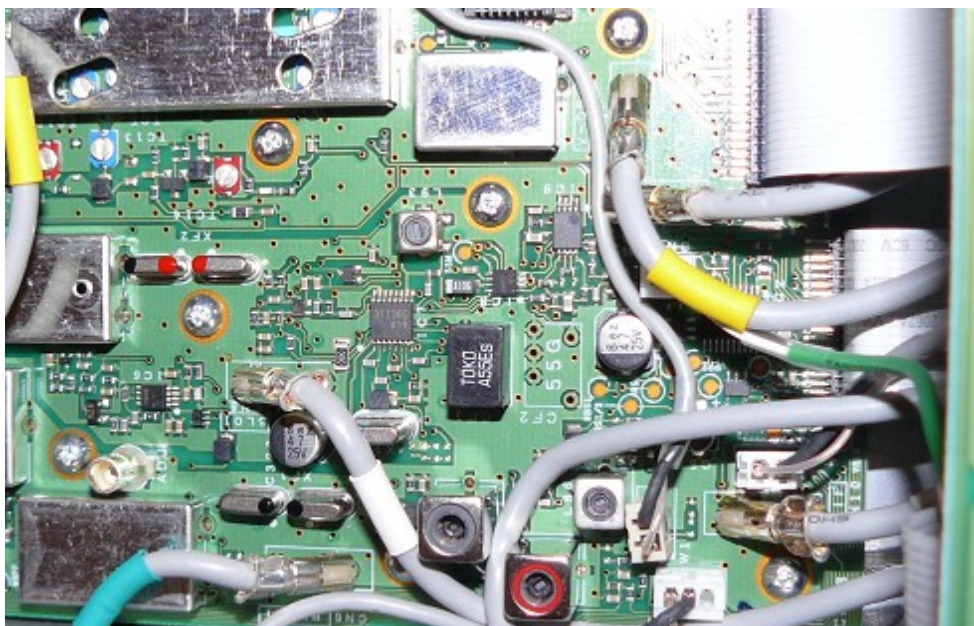
Note this K (USA) version has only the FM-W filter. Replace it with a LTM455EW (15kHz).

You may want to change the SUB receiver ceramic filter(s) as well. Remove the metal shield plate. Locate the Filter on the SUB receiver TX/RX board. This is quite a lot of work as you must remove several cables, then lift out the board and solder out the old filter. Then solder in the new filter(s).

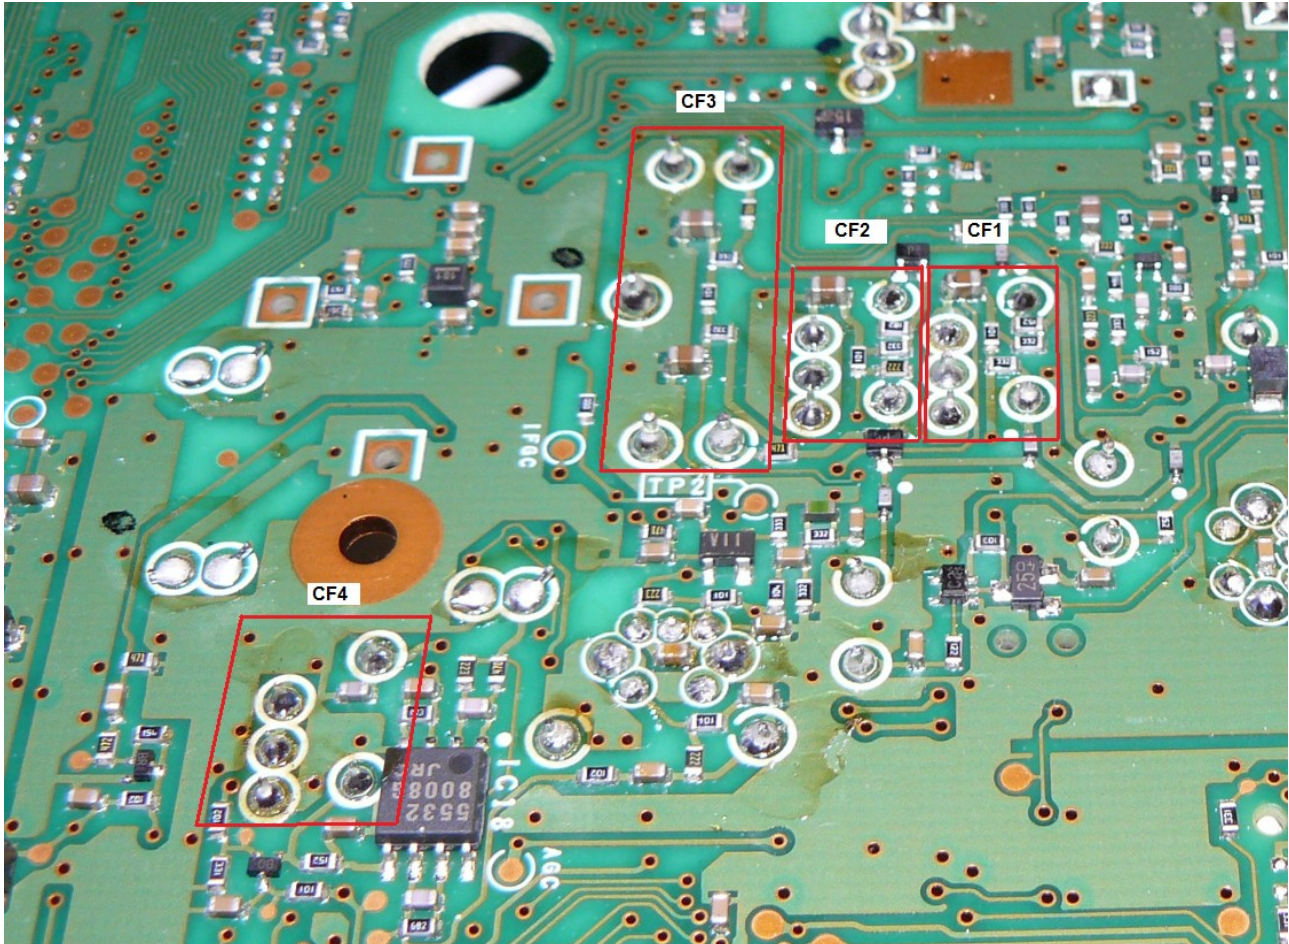
The rear side of the Main TX/RX board do show signs of bad soldering:

The SMD components is of course soldered using a machine, but filters and other large component/parts seems to have been soldered by hand at a later time. There are also some small tin-blobs lying on the board here and there, and on my Radio there was some kind of white powdery substance that was “splashed” out on one corner of the board.
