SERVICE BULLETIN

TS-660

#856

SUBJECT: TS-660 Microprocessor Latchup

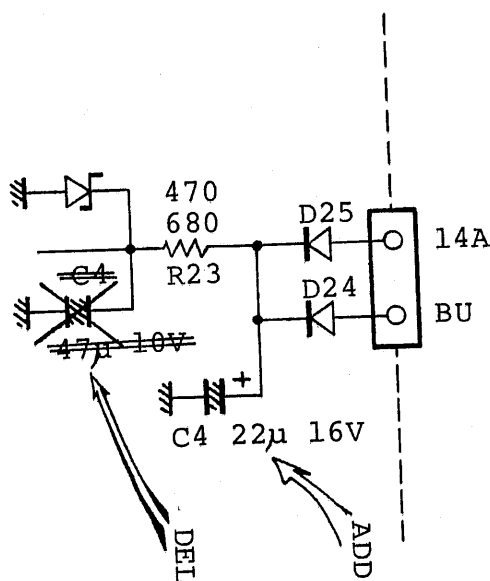
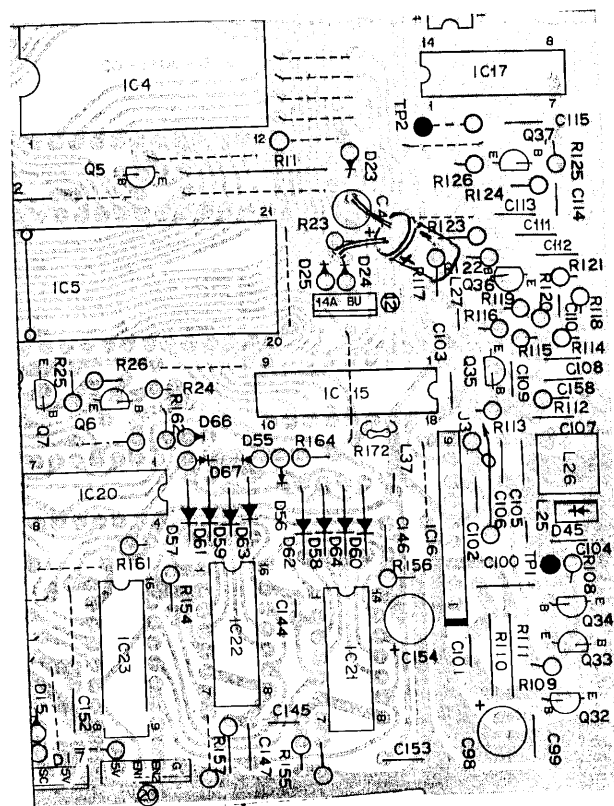
Microprocessor latchup may occur if the power switch is cycled several times in quick succession, if the supply is turned off while the power switch remains on, or if the power supply is turned on with the transceiver already on. Symptom will be no display, erroneous display, or locked display. Change two components on the Control unit to prevent further trouble.

On the Control unit X53-1220-00:

1. Replace R23 680 Ω with a 470 Ω resistor (RD14CB2E471J).
2. Remove and delete C4 47 μ F
3. Add a 22 μ F 16V electrolytic (CE04W1C220M) on the foil side of the board between D24, R23 (positive) and ground (negative).
