SIGNAL ONE

TROUBLE GUIDE

**R. Sullivan
WOYVA/4**

Revision 10
December 2001

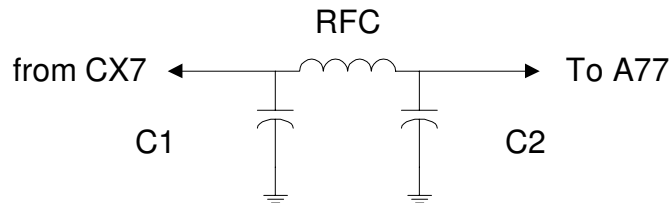
PROBLEM Erratic Alpha 77 operation when being driven with the Signal/One. (For example, A77 cannot be tuned properly on one or more bands)

CAUSE RF is getting into the A77 via the control relay cable to the Signal/One.

SOLUTION Check to see if this is the problem by disconnecting the relay control cable and shorting the relay jack on the rear of the A77. If the problem no longer exists stray RF is the problem. Build the following circuit in a small minibox and insert it between the A77 and Signal/One relay control line.

C1, C2 are .001 1kv disc ceramic
RFC in the range of 10-50 microhys and
able to handle 100 ma.

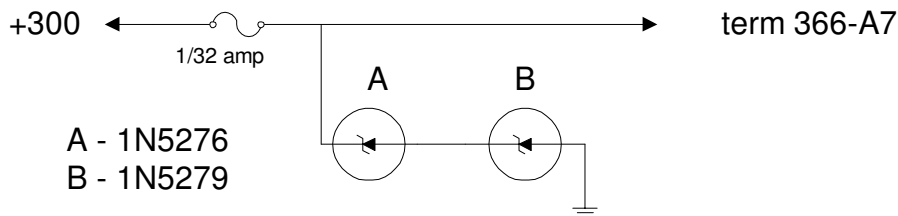
2. Protection for counter board against inadvertent high voltage:

If the +300 volts rises to a high value, the zeners will conduct and force the fuse to blow. (For example if the final develops a plate to screen short, +1500 volts will be placed on the +300 line which will wipe out nearly every semiconductor and tube on A7! If you don't believe it, ask W7IV)

Install the following circuit between the 300 volt supply and the 300 volt terminal on the counter board, A7 (terminal 366):
