# Circuit Improvements for the TS-430S

by Richard L. Measures, AG6K

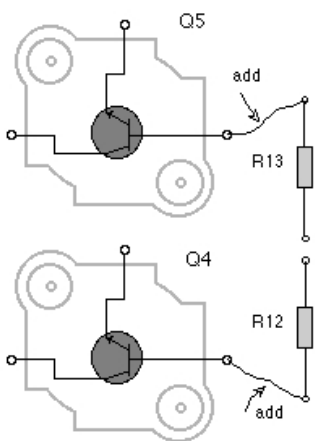
**Problem:** Intermittent ALC during transmit and/or intermittent reduction or loss of power output. The power output can sometimes be restored to normal by turning up the microphone gain or by dropping the radio a few inches. Signal reports of intermittent transmit audio distortion are normal.

**Note:** If the radio continues to be operated after displaying these symptoms, the eventual result is often catastrophic failure of Q2, Q3 [RF driver-transistors], and Q7 [bias-transistor] on the 100W Final Unit.

**Why:** This problem is caused by repeated thermal expansion and contraction of the cheap, phenolic printed circuit board [PCB] which eventually breaks the two, plated-through the circuit board connections between the output of the 10W driver stage and the input [base] connections to the 100W RF final transistors, Q4 and Q5. When the break occurs, the RF from the drivers does not reach the input [bases] of the final transistors, so there is no load on the driver output transformer, T2. Without a load on its secondary, the peak RF voltage across the primary of T2 runs wild and breaks down the collectors of the driver transistors. When the driver transistors fail and short,, they destroy the bias transistor, Q7, as well. Changing these components is an unpleasant and uncheap job. Worse than that, the same components will most likely fail again unless the real problem on the PCB is taken care of. **Fix:** On the component side of the 100W Final Unit circuit board, install a jumper wire between the (outer) end of R12 that is nearest to the base of Q4 and the base lead of Q4. Install a jumper wire between the (outer) end of R13 that is nearest to the base of Q5 and the base lead of Q5. These two jumper wires make sure that the driver RF arrives at the final amplifier transistors, whether or not the plated-trough connections are are doing their job.

Another method of fixing the problem is to solder Z-wires in the plated through holes. [a Z-wire is a wire that is passed through the board and whose ends are bent in opposite directions so that it will stay in place during soldering]
