AKG

SERVICE

D 112 E

2220 Z000

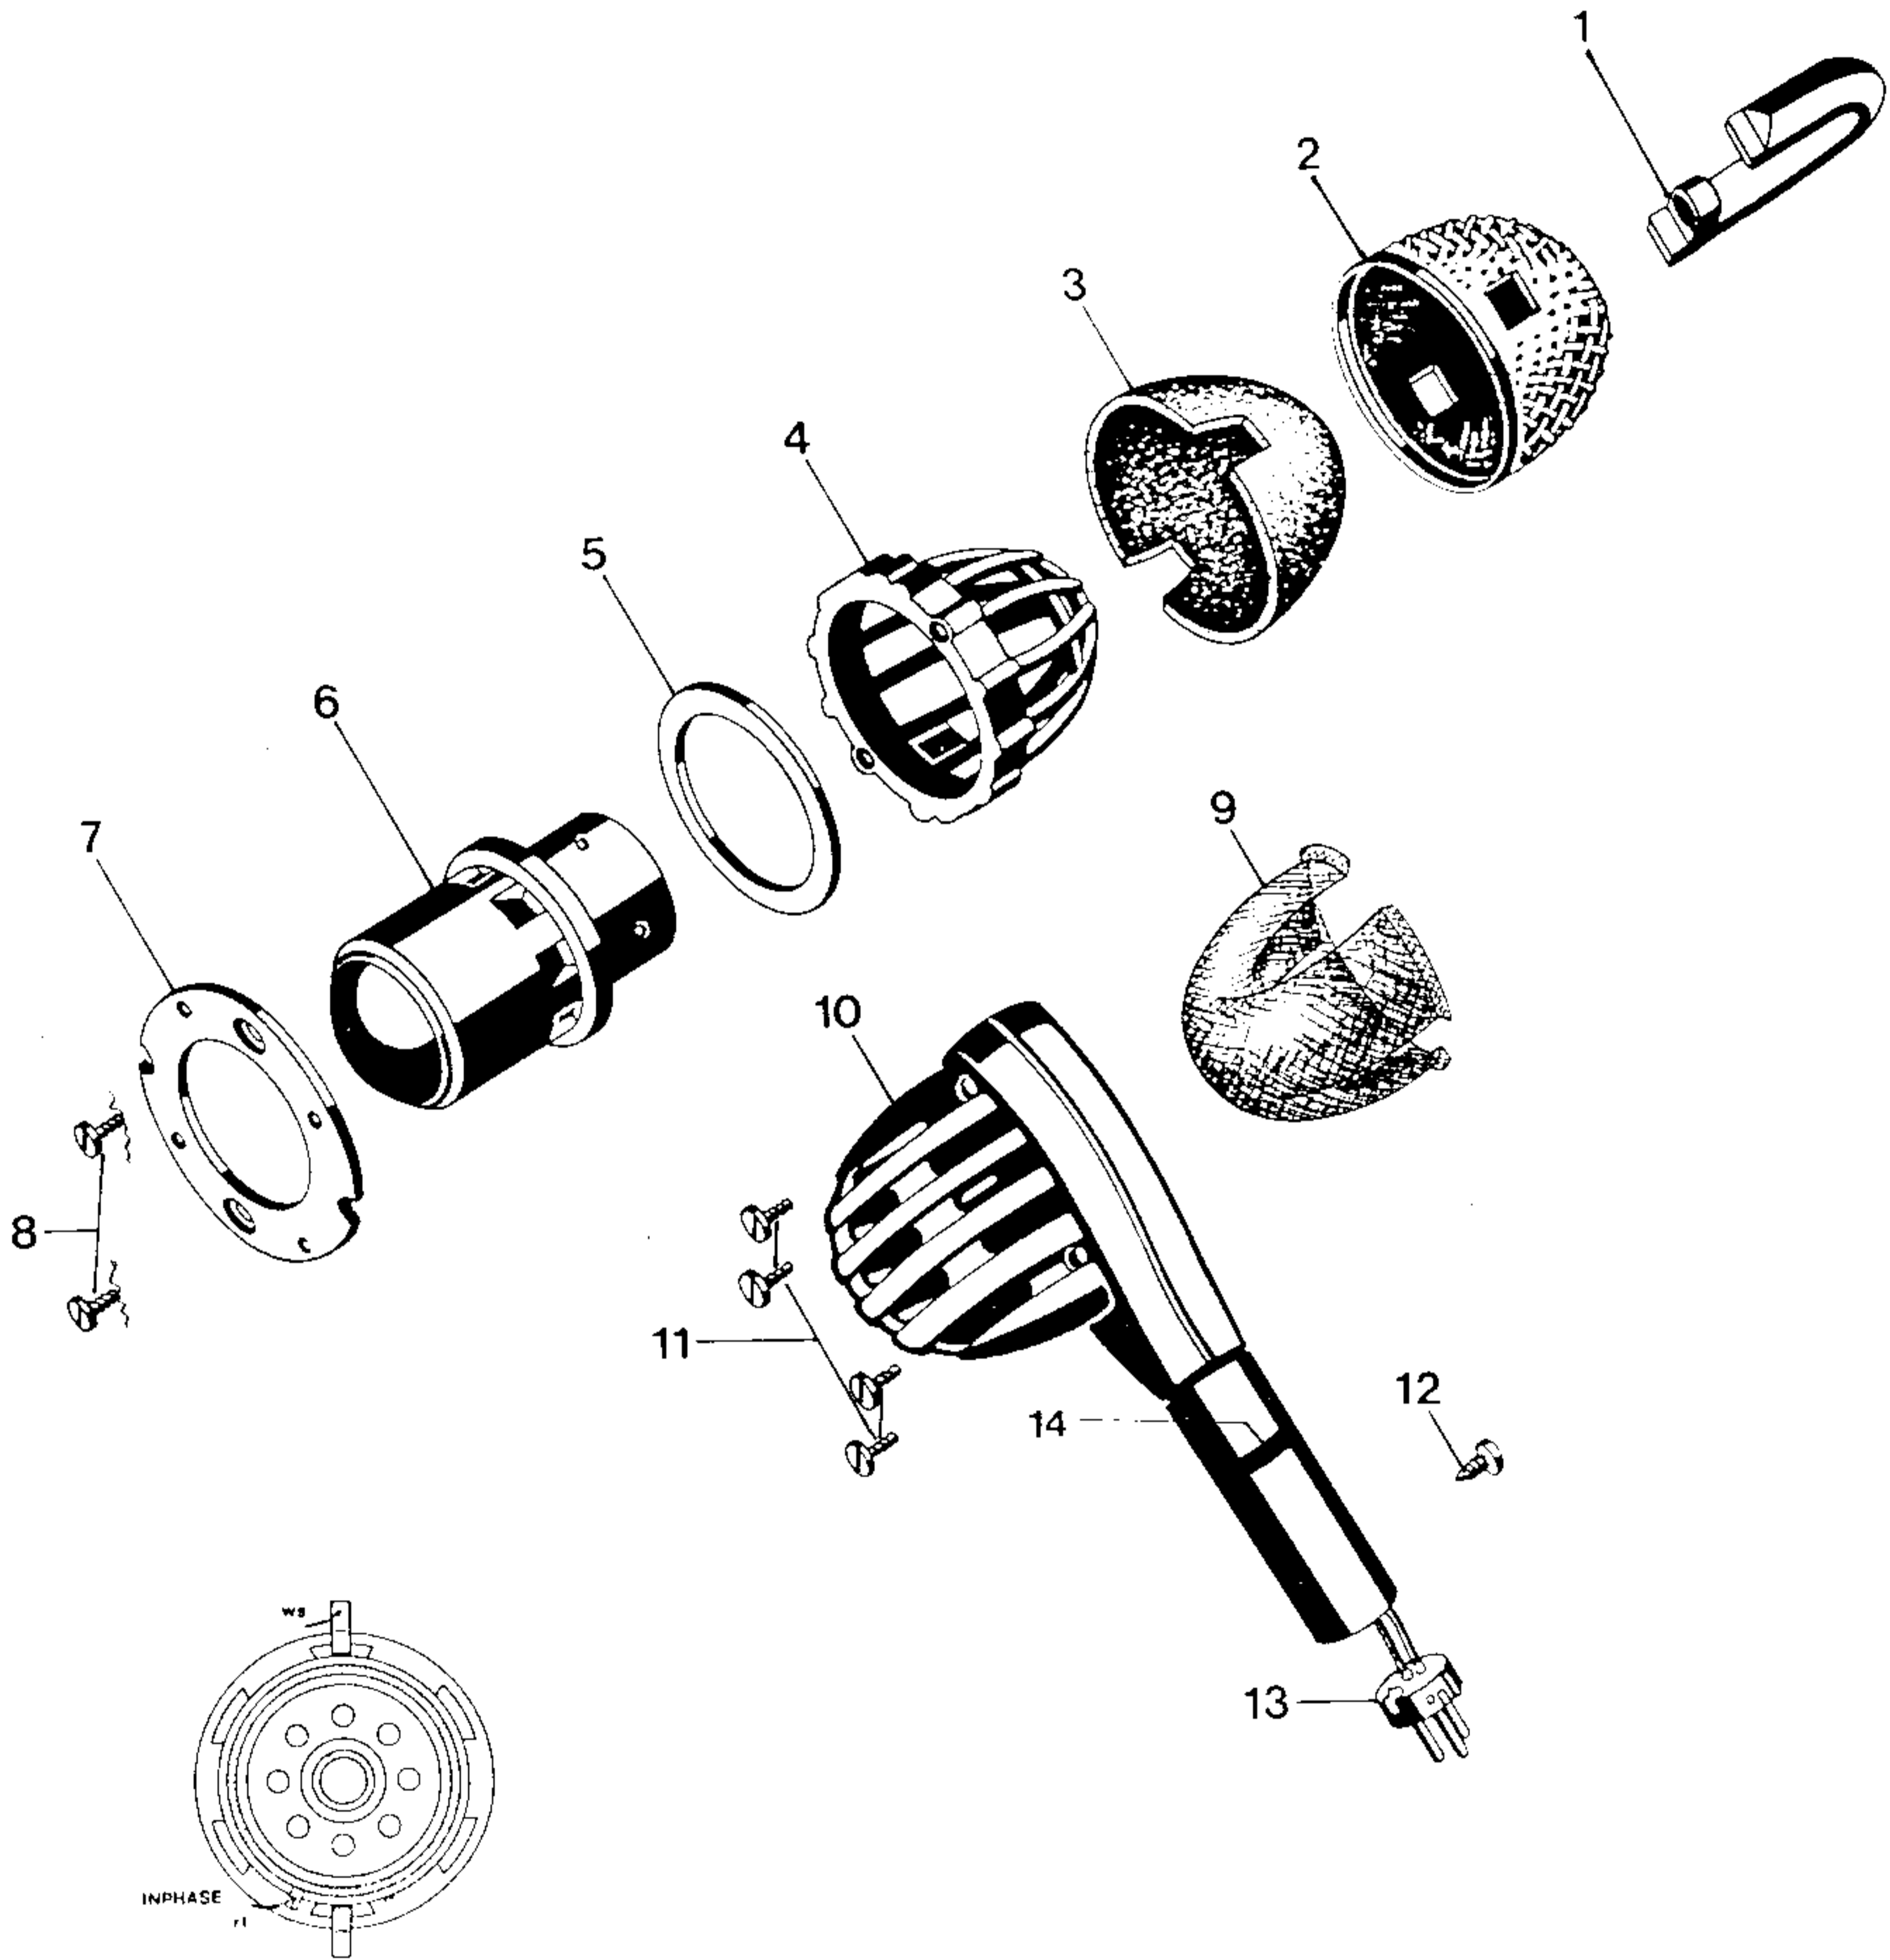
Beim Wiederausammenbau eines zerlegten D 112 muß der Steckereinsatz 13 entfernt und die Litzen straffgezogen werden. Erst dann kann das Gehäuse zusammengebaut werden. Im Anschluß daran ist der Stecker wieder anzulöten. Diese Vorgangsweise ist unbedingt einzuhalten, da sonst die Litzen zwischen Hauptkörper 10 und Ring 7 eingequetscht werden können. Mikrofone die mit Fehlerangaben wie "kracht", "Geräusche", oder "Brumm" retourniert werden, haben höchstwahrscheinlich eingeklemmte Litzen. Prüfen Sie in diesem Fall das Mikrofon bitte mit angelegter Phantomspeisung. Damit können Feinschlüsse zum Gehäuse festgestellt werden.

When assembling a dismantled D 112, the plug insert 13 has to be removed. The litz wires have to be tightened. Then the microphone can be put together. Only after that the plug can be remounted. This procedure prevents crushing of litz wires between housing 10 and ring 7. Microphones returned with errors like "hum", "noisy", "crackling sound" will most likely have the litz wires damaged. In that case please test performance of microphone with attached phantom powering. This will reveal any shortcircuit to the housing.

Neuerdings wird der Bügel 1 mit selbstschneidenden Schrauben (8) befestigt. Zum alten Bügel 2220M0301 mit Gewindeeinsätzen gehören die Schrauben 0084D3020, zur neuen Bügelversion 2220Z0901 die Schrauben 0099N3004. Ebenso wurden die Schrauben 11 auf selbstschneidende Versionen umgestellt. Teil 0099N3000 war eine Zwischenlösung. Gleichzeitig wurde auch der Ring 7 von 2220Z1101 auf 2220Z1201 geändert.

Recently ring 1 is fixed with selftapping screws. Screws 0084D3020 belong to the former ring version 2220M0301 with metal thread inserts, while for the new ring 2220Z0901 screws 0099N3004 are necessary. Also screws 11 have been changed to selftapping versions (0099N3000 was an intermediate variation). At the same time the ring 7 was modified (2220Z1201 instead of 2220Z1101).
