Drake TR-7 - Full Output Power on 10m

My TR-7 (rather old unit; s-nr.: 1933) had only about 35W output on 10m, the other bands provided full output, i.e. more than 100W. A complete new alignment didn't improve the situation. Here are my proposals to improve the situation:

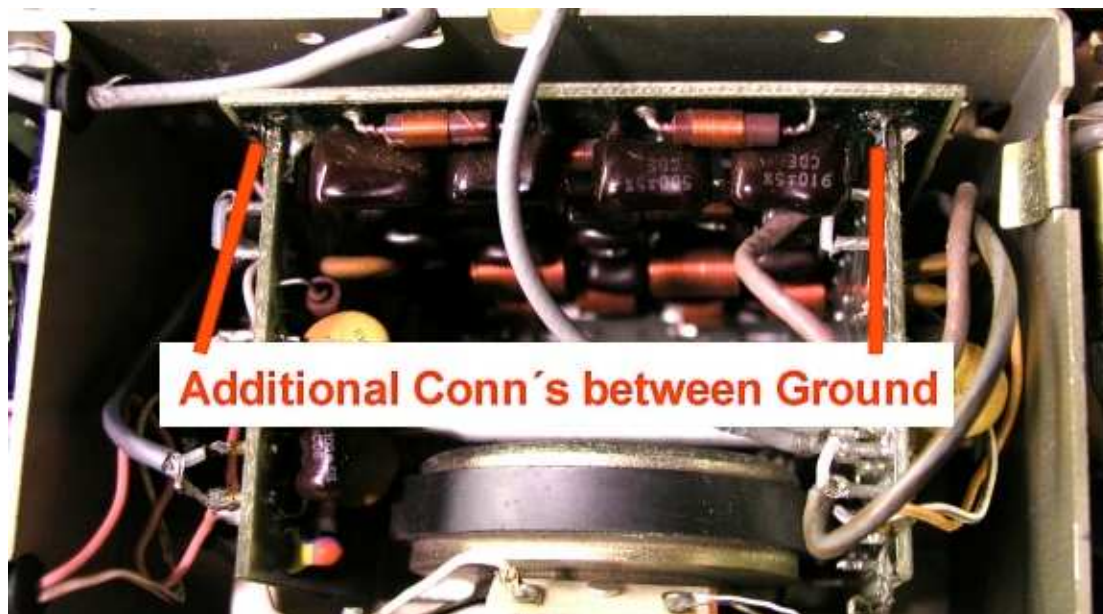
The HP- and LP-modules have rather few connections in the groundplane – especially the connections between the pcb's could be improved. There are only few pins in the ground-path, so i added additional copperstrips to improve the groundplane – see **pictures 4, 5 and 6**.

Picture 4: Additional groundconnections in the highpassmodule

A lot of work, but the result was not very effective: The output rose only by some watts.

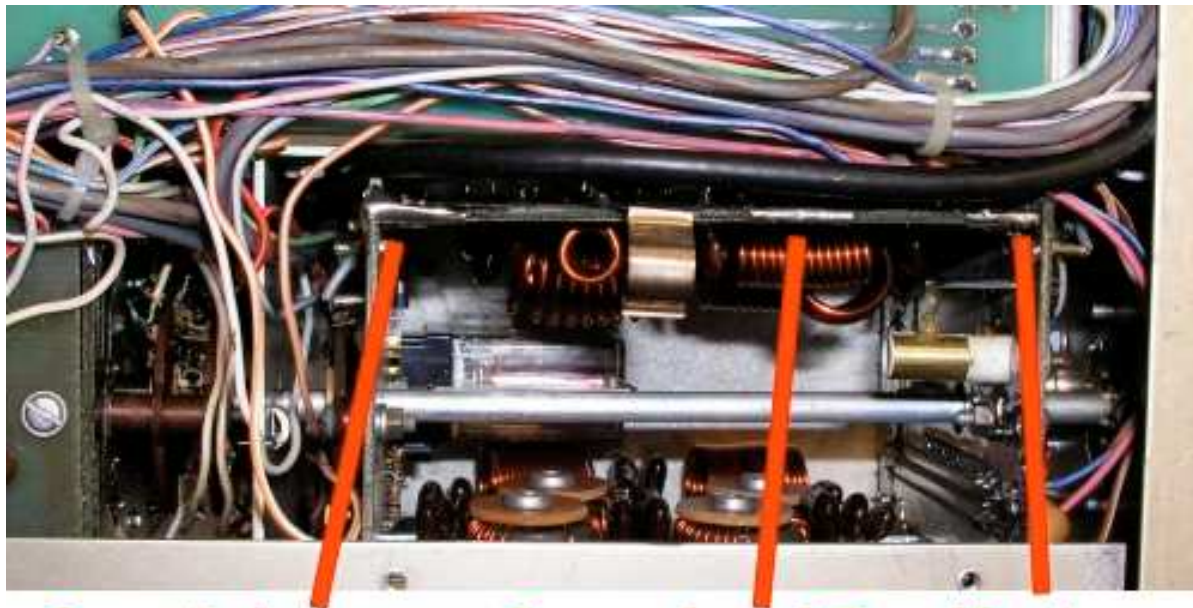
Conn's between Ground and Top-/Bottom

Picture 5: Additional groundconnections in the lowpassmodule

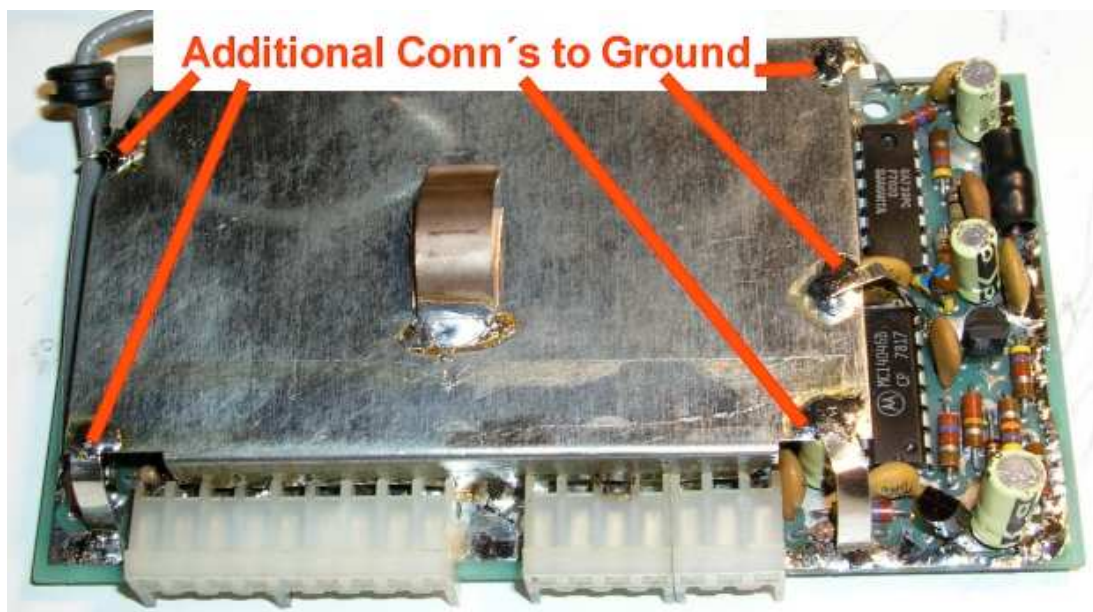
Picture 11: Shielding used as additional ground-layer

I resoldered all critical groundconnections of all components on the pcb's including the connectors. This required sometimes the unsoldering of other parts who hindered the access to the soldering points. Also additional copperstrips have been used for connections between top- and bottomlayer of the pcb's where necessary. Some examples are shown in the **pictures 8 to 11**.
