Harry Leeming G3LLL's In the Shop

Pot Cores and Kippered (Smoked) Rigs!

In this month's *In The Shop* column, Harry Leeming G3LLL discusses dodgy pot cores, safety problems, tobacco damage, awkward relays and switching faults.

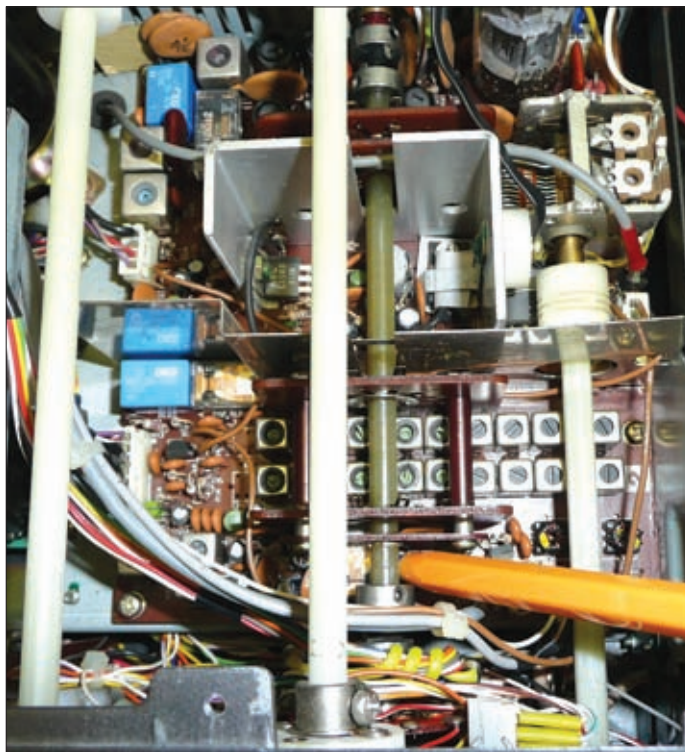
The main culprits are the five relays on the r.f. board, shown in **Fig. 2**. You can see two original relays with transparent covers, and two blue Omron ones that have been used as replacements. (The 'extra' blue one is a reflection in a screening cover!).

The yellow-bodied pen points at the fifth relay, which is located underneath the band switch spindle. (Just to make replacement or cleaning difficult!).

across these five relays and as the original items were not air tight any pollution in the atmosphere soon has an effect. Strangely, the rig doesn't just become intermittent, instead the receive gain, and sometimes also the transmit drive, fall off as the contact resistance increases with age. The best cure, of course, is to replace the relays, but as these are becoming difficult to get hold of I have recently resorted to cleaning the originals.

Fig. 2: The r.f. board from the FT-102. Note that there's a reflection of the lower blue relay on the metal screening wall. Once you've removed the relay covers you will need some switch cleaner that does not contain a lubricant.

Once you have removed the relay covers you'll need some switch cleaner that **does not** contain a lubricant, such as 'Aero Klene 50' from Maplin. (Don't use anything that leaves a residue, or which damages plastic). You'll also need a set of sparking plug feeler gauges with the '4 thousandth' of an inch blade cut down as per **Fig. 4**. With care you will find that you can pass the feeler gauge between the contacts, apply the switch cleaner, and then work it back and forth cleaning the contacts.

If you look at **Fig. 2** you'll see that the band change switch incorporates three separate switches coupled together with spindle couplers. One coupler is at the front near the yellow pen, and the other coupler is near to the power amplifier (p.a.) valves at the rear. The spring loaded indexing ball is on the front section, and it is this section that determines as to what band is indicated by the display, and as to

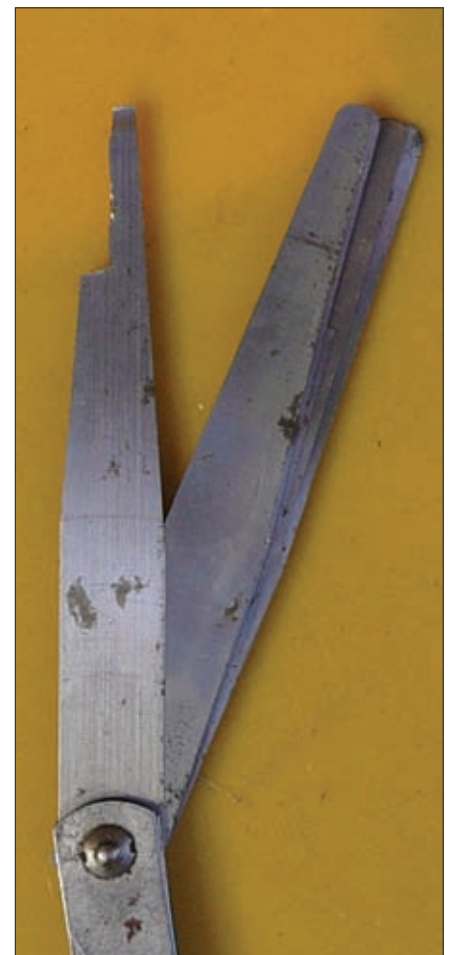
Fig. 4: Feeler gauges can make an ideal relay contact cleaning tool.
