The Marconi communication test set 2955 series has a common fault – the 10MHz oscillator is prone to failure. Shows as a breaking up of the display and general lockup. It is not a good idea to use your unit if it is showing this symptom as it can corrupt the eeprom, see below – here is one way to fix it.

Marconi 2955
replacement TXCO
courtesy VK6JBN

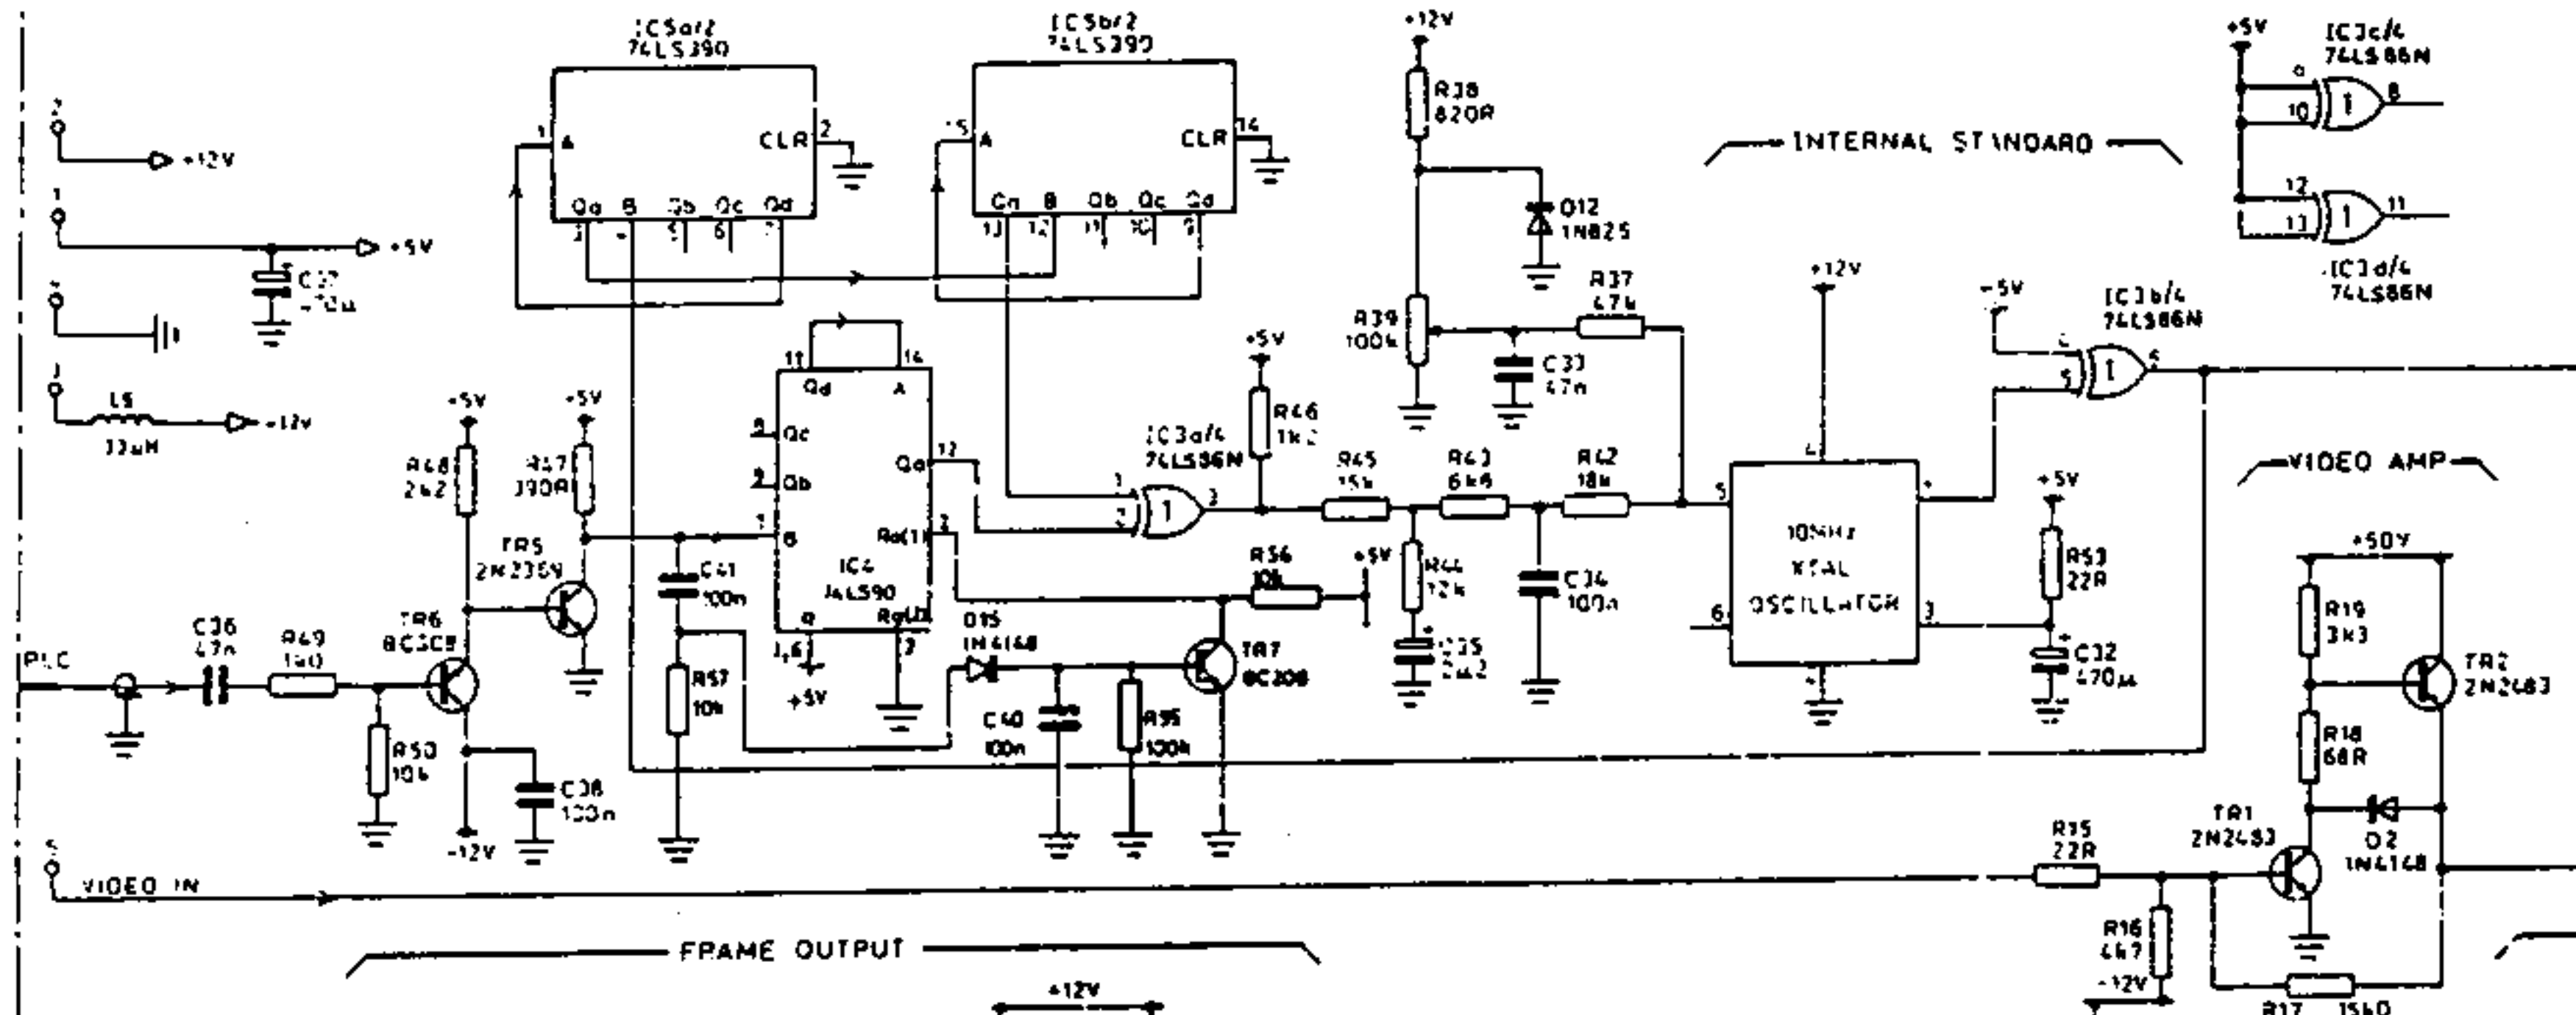
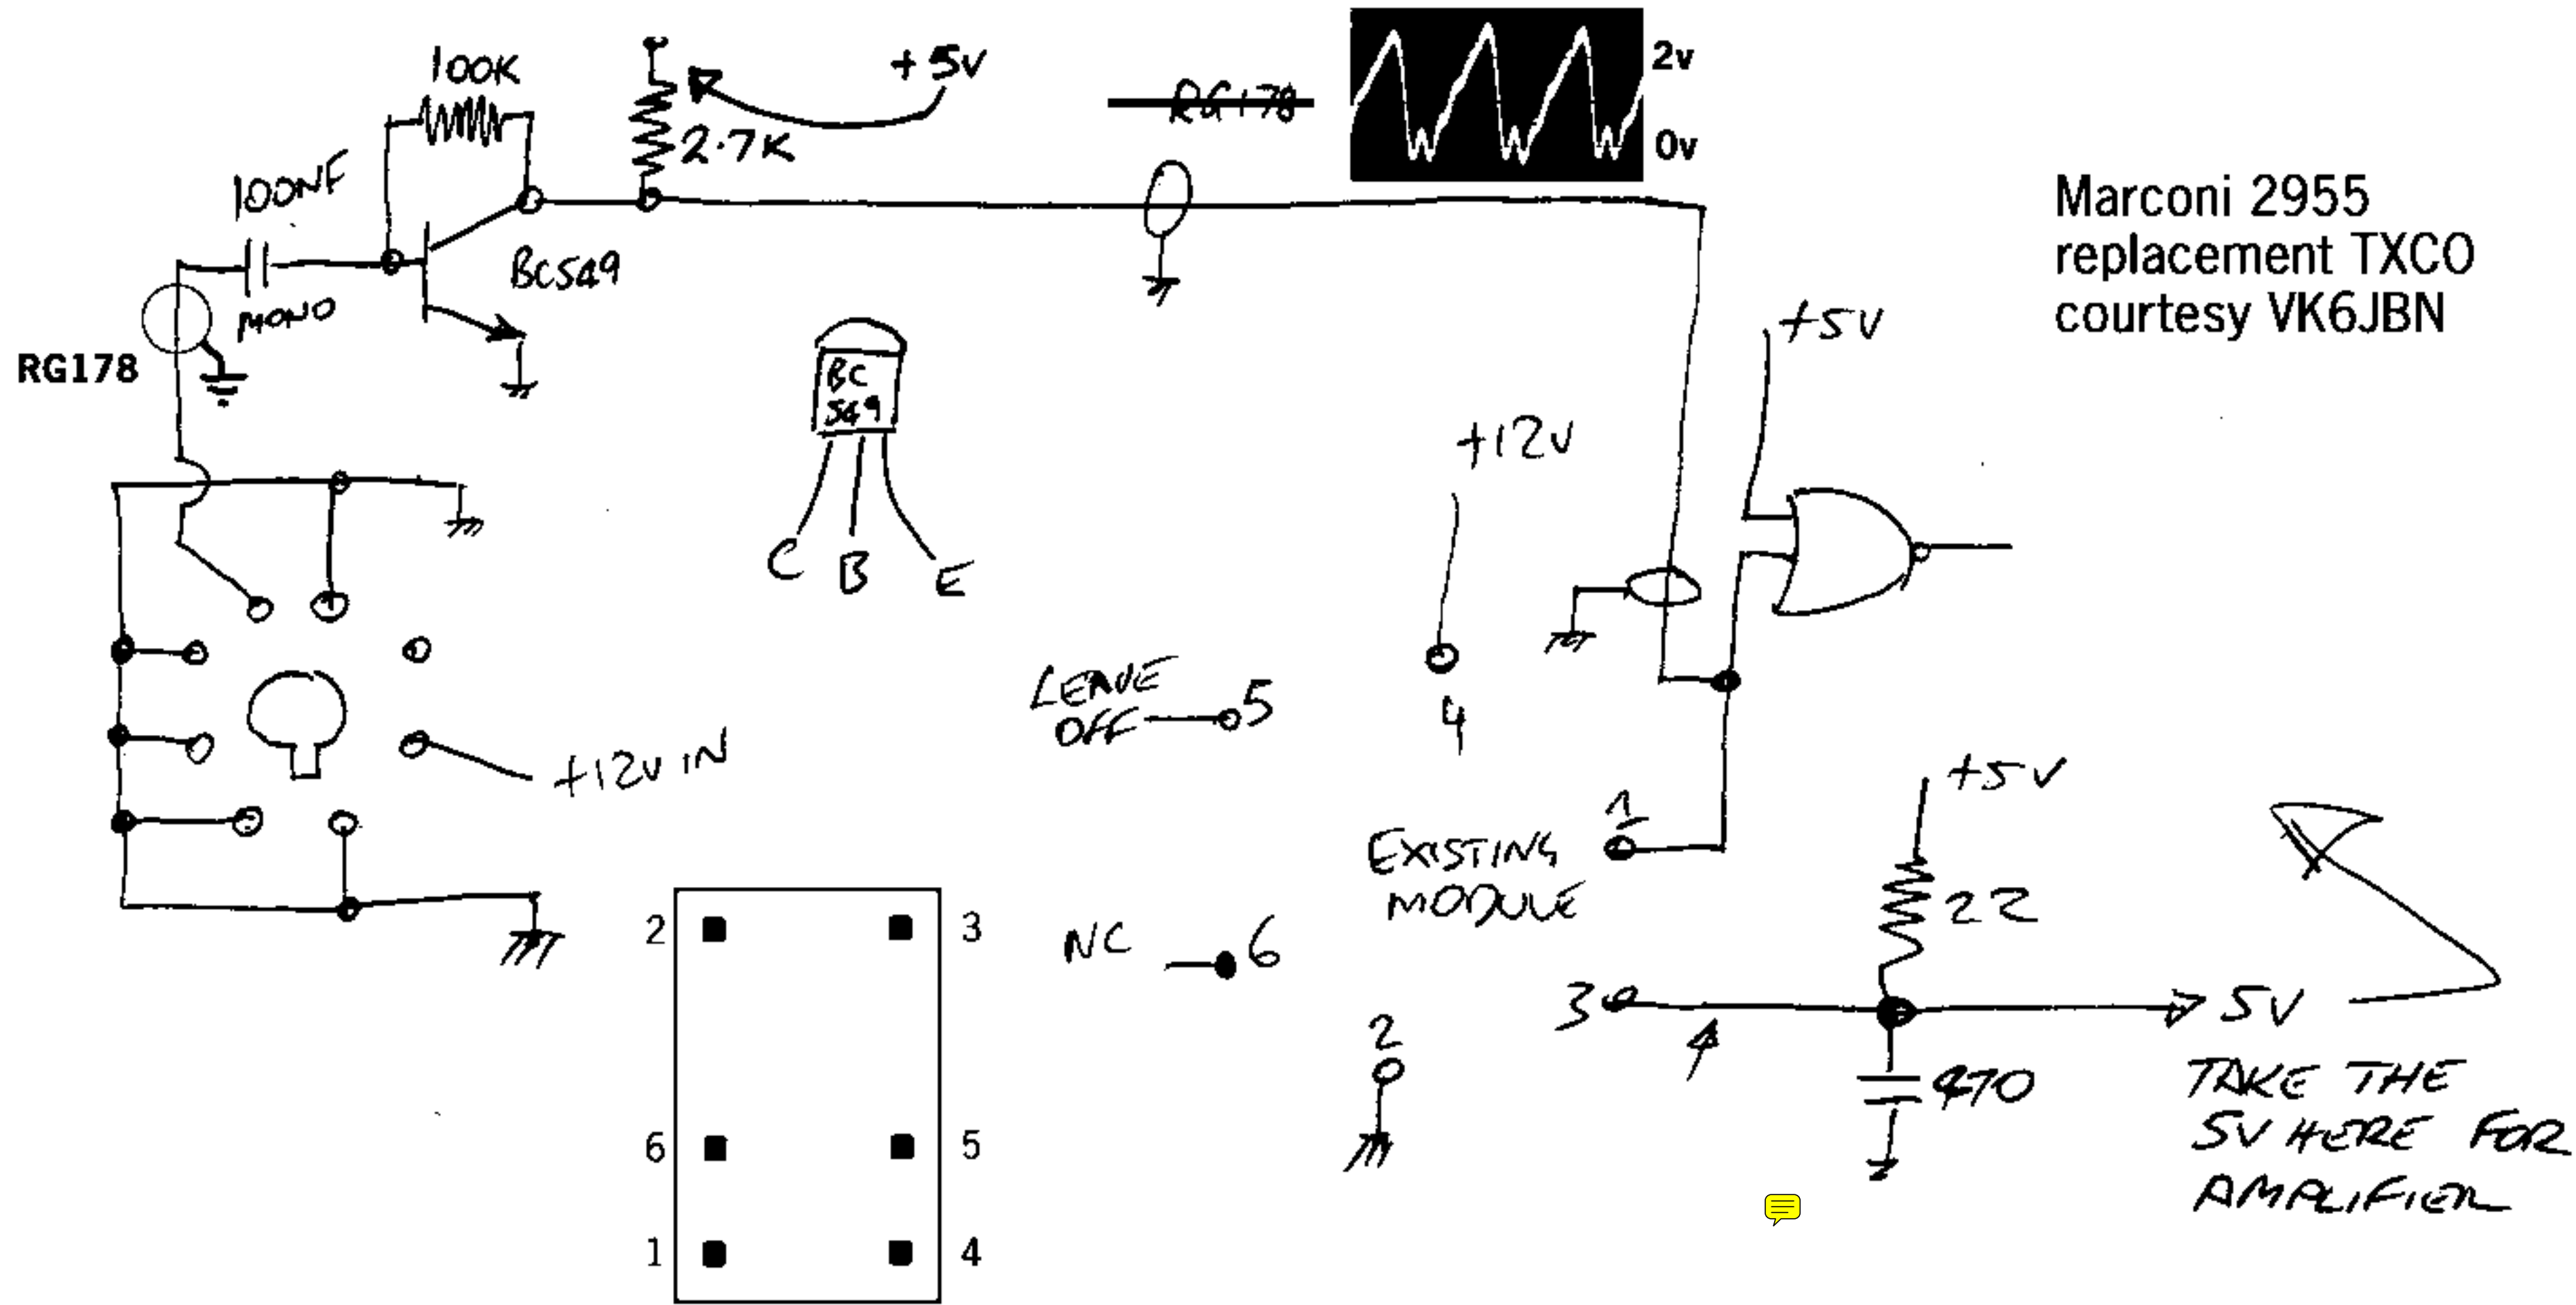
The fault you mention sounds like the 10mhz ref oscillator on the crt board is intermittent. This is an extremely common fault.

It's a small grey box located towards the rear of the long crt pcb. There is a blue multiturn pot directly above it. That sets the frequency. It will lock the unit up if it fails during warmup or operation. It supplies all the timing signals for the 2955 including the display. Best way to fix it is remove and install a new 10mhz reference oscillator. The original oscillator is not easily sourced and they are getting too old. I fitted a 10mhz Vectron oven which fits nicely onto the side of the case directly behind the crt pcb. There is 12v on the crt board as the original oven uses 5v. You will require a transistor, a couple of resistors and a cap to "pullup" the level of the oscillator signal to 2v p-p which the Marconi needs to work. If the level is low then the unit won't start on power up. You won't obviously need to do that if you source an oven with a high level output. I suppose another way is to find a good hp oscillator on ebay.

Also don't use the unit too often as the intermittent timing signals will screw the cal data in the eeprom and you will need a new board. Symptoms of that is unusual readings in the sinad, frequency etc when no signals are applied. Also levels out will be unusual too! This happened to another set I fixed up and I ended up buying a second hand controller board to fix it. *[email to VK2BAK]*

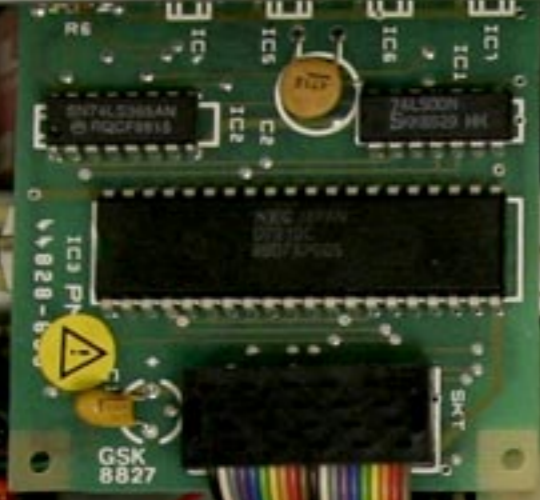
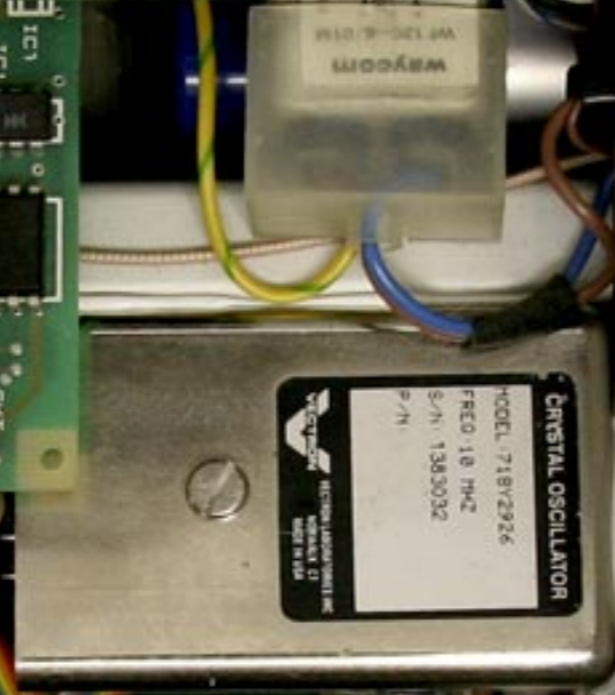
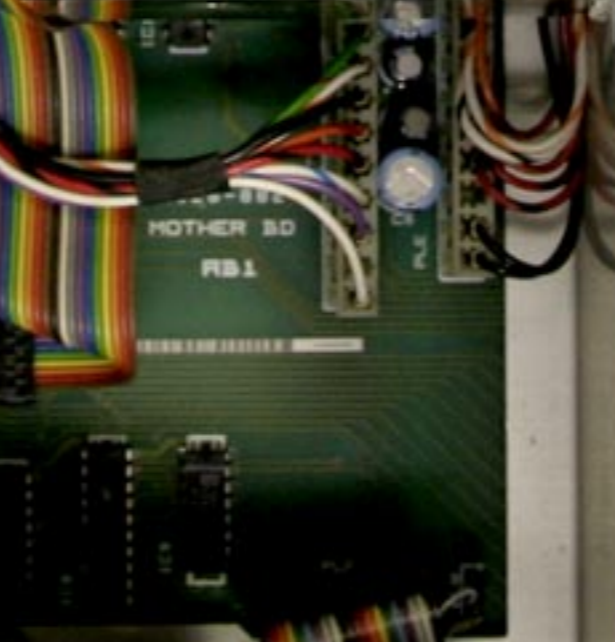
USE SCREW ON XTRAL OVERVIEW

in sync with GPS fx standard

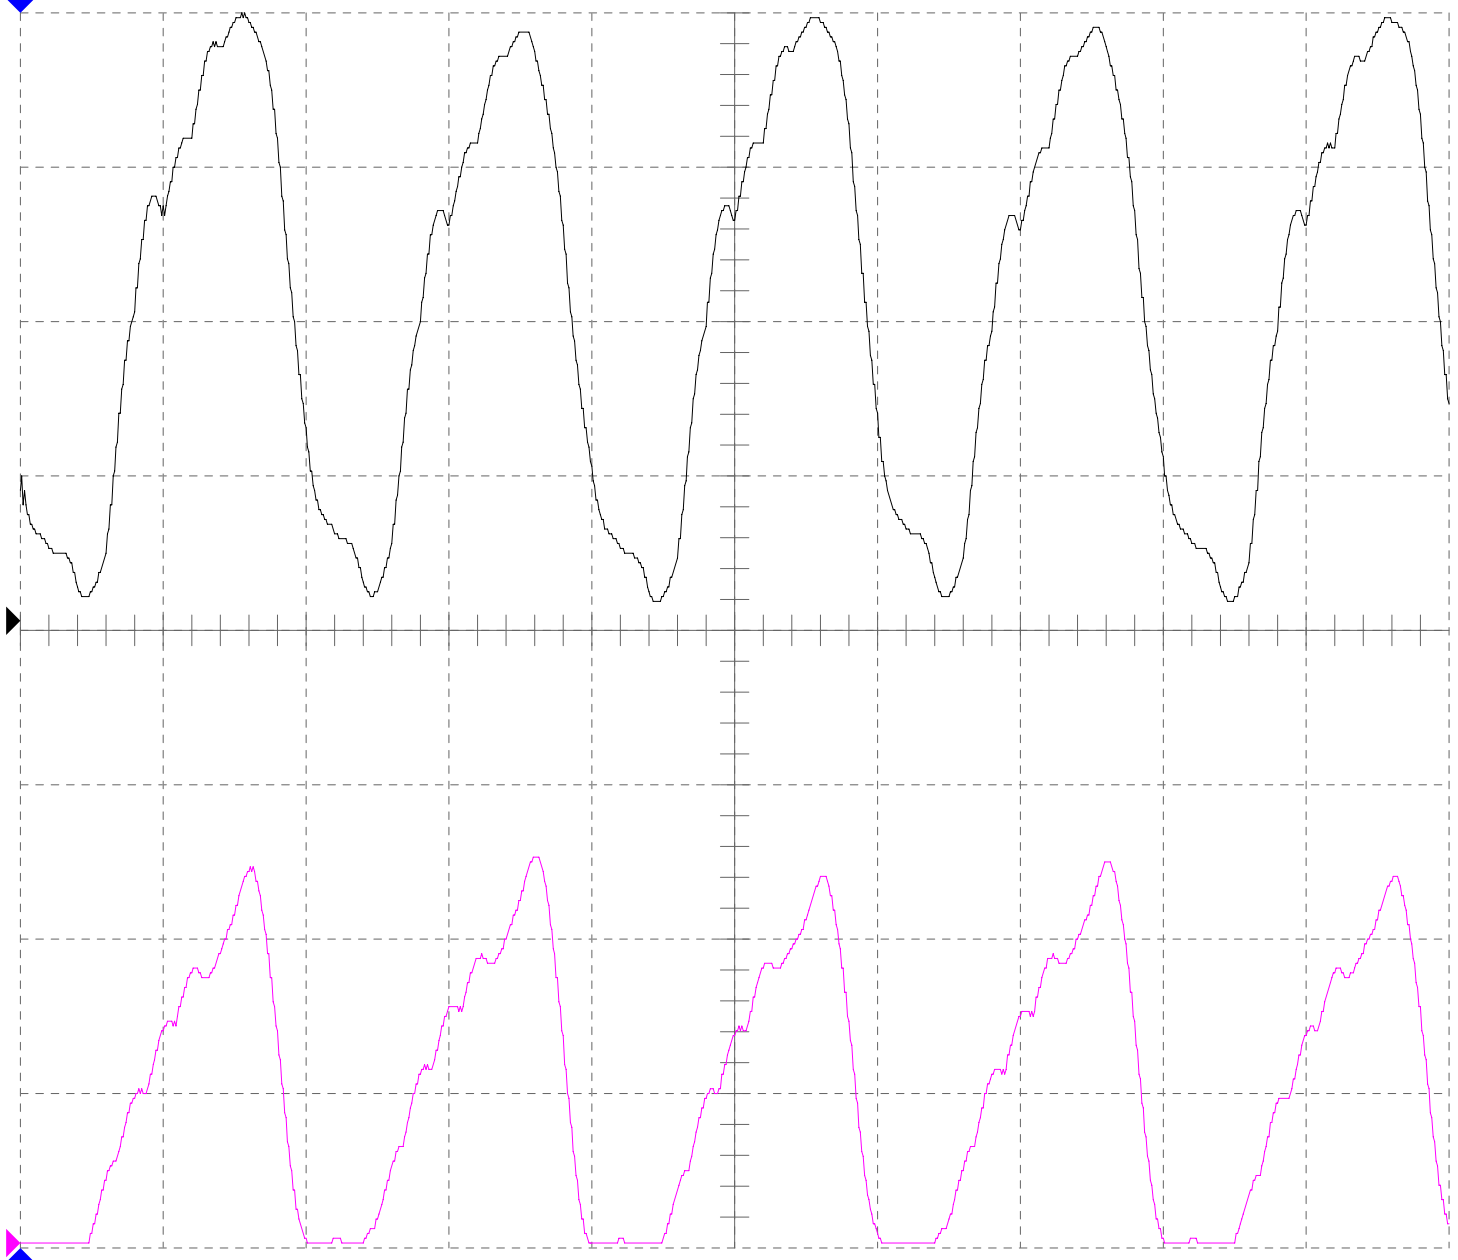
TEST REPORT

SAMPLING RATE = 100MS/s

TIME DIV = 50 ns/div

CH1 VOLT DIV = 1V/div

CH2 VOLT DIV = 1V/div

After the modification the 2955 would often fail to start, especially when cold - it would display a scrambled screen. The transistor was replaced by a 74HC4046 used as a buffer amplifier. (Pinched from elsewhere - For more information about the 4046, see Neil Heckt, "A PIC-Based Digital Frequency Display," QST, May 1997, pp 36-38.)

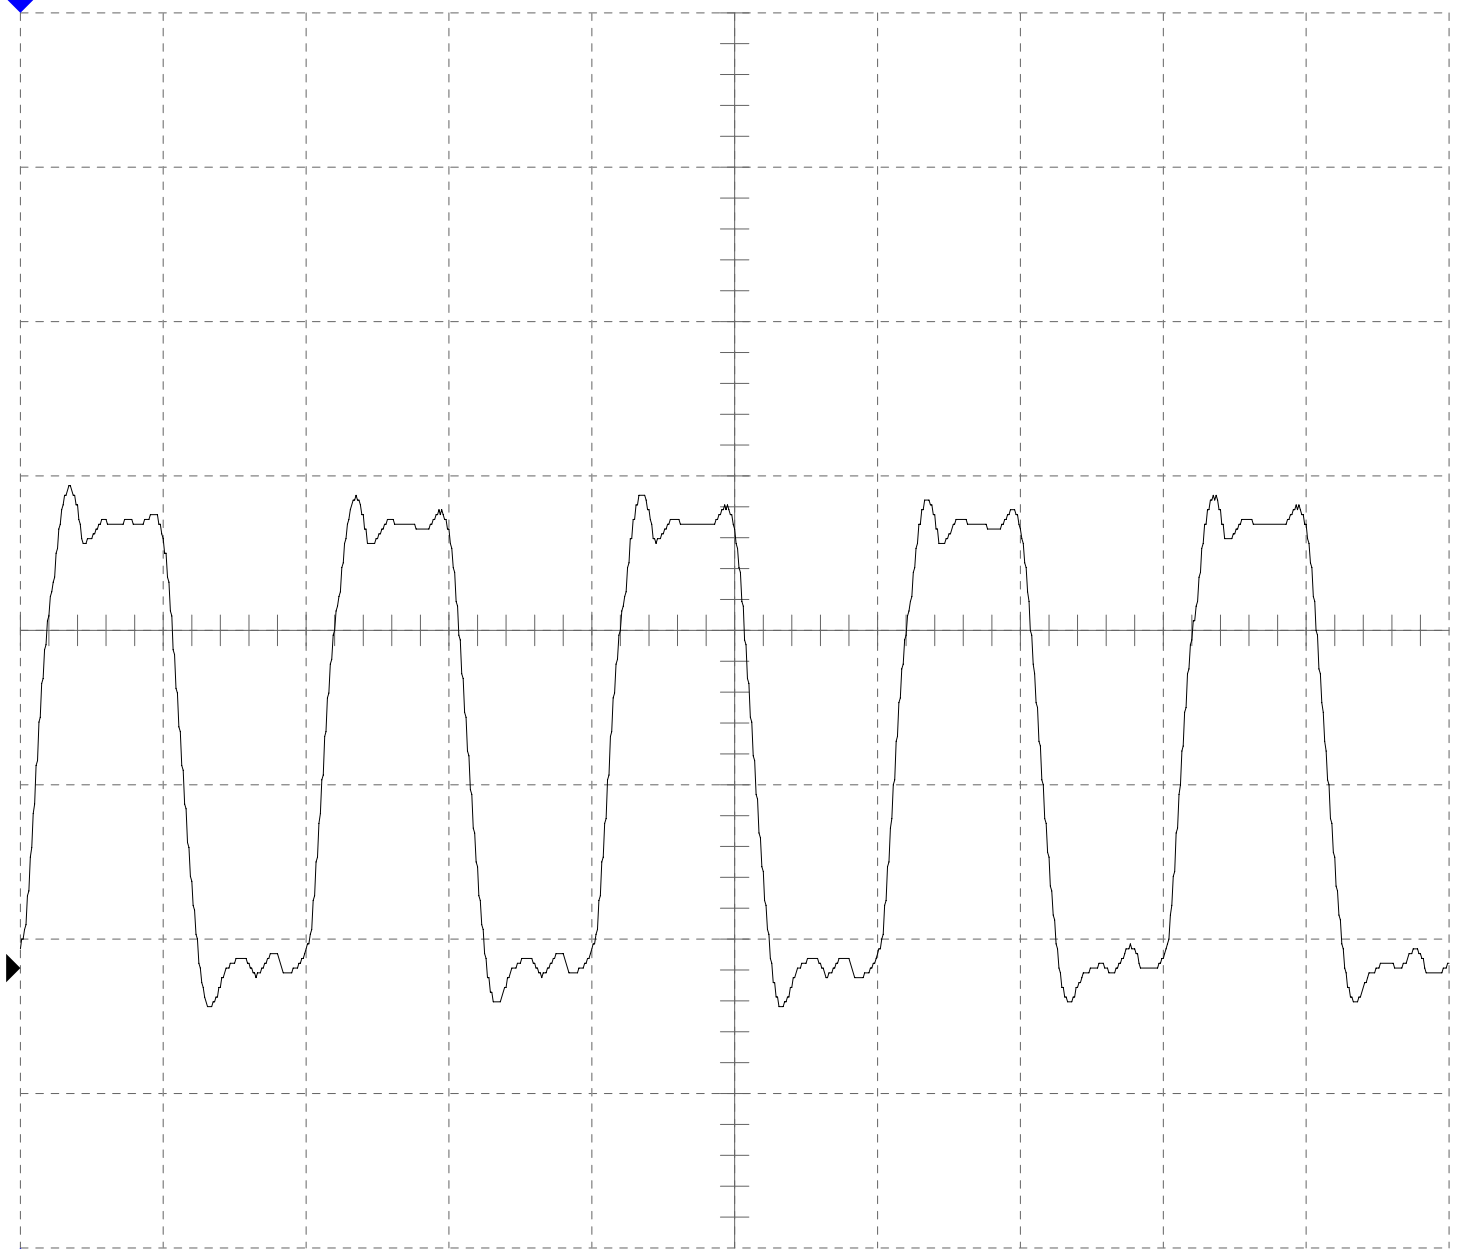
TEST REPORT

As of May 2007 it is behaving itself very well. New waveforms follow:

SAMPLING RATE = 100MS/s

TIME DIV = 50 ns/div

CH1 VOLT DIV = 2V/div

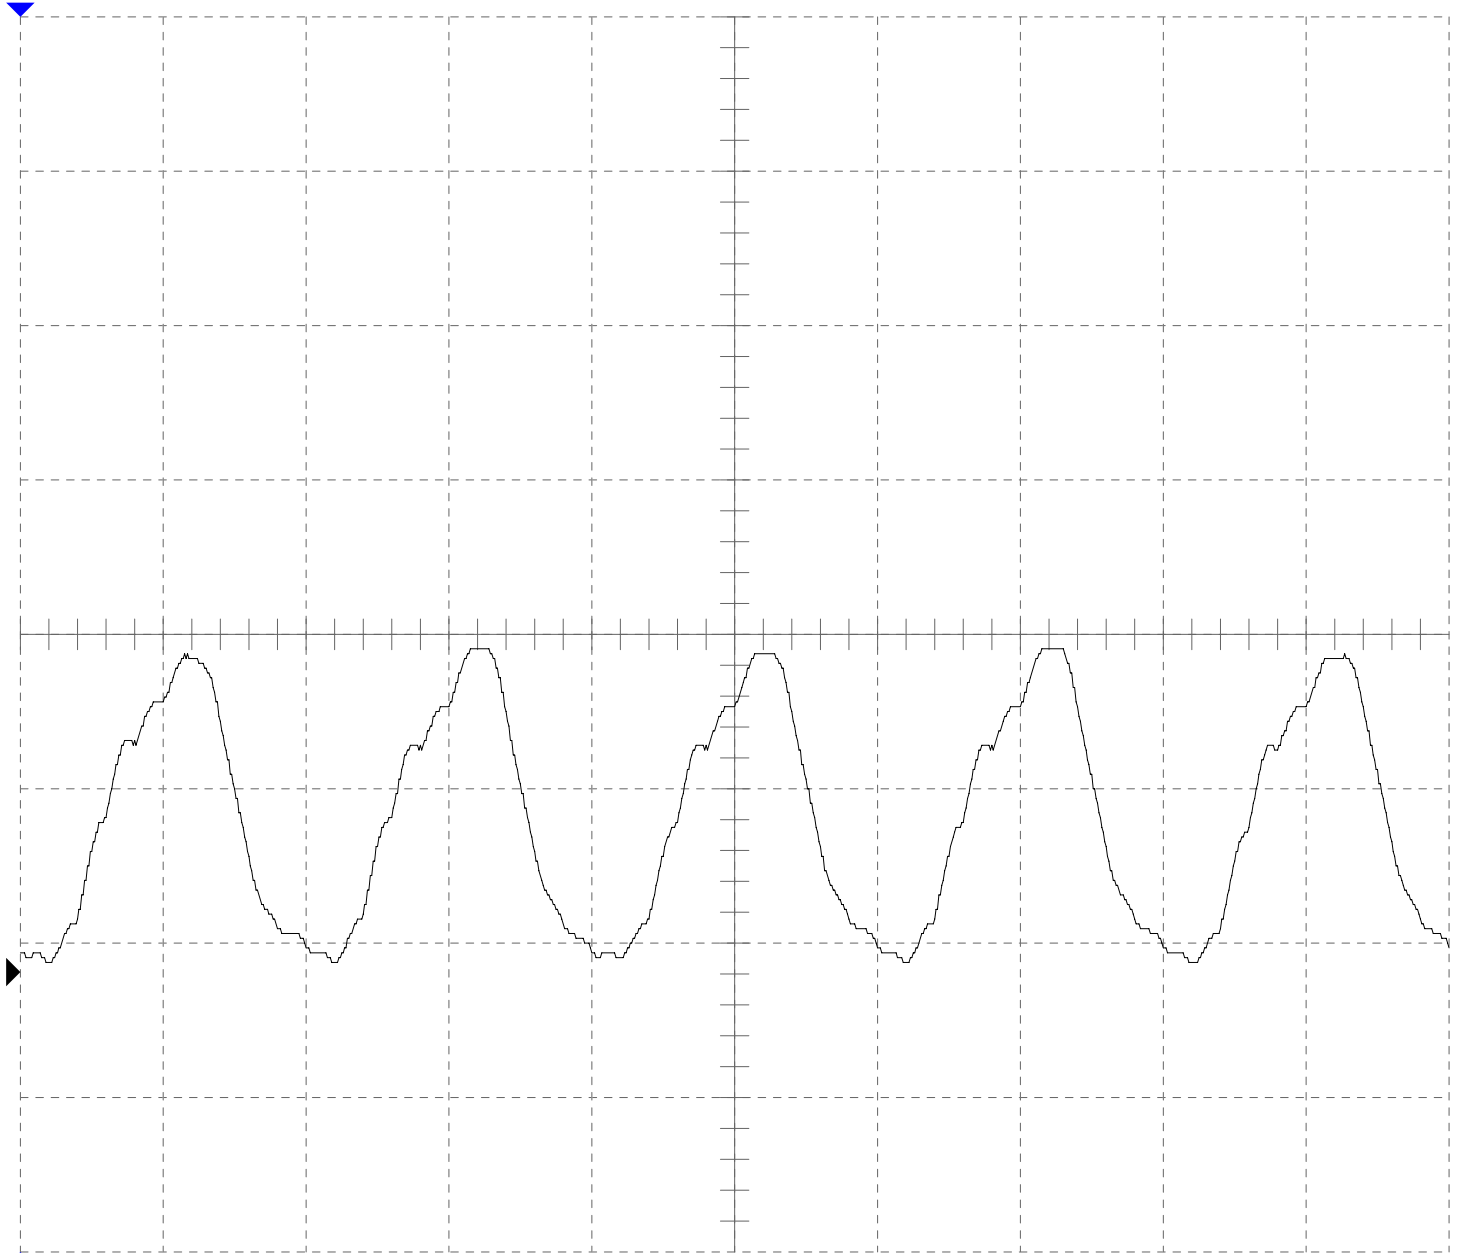
TEST REPORT

SAMPLING RATE = 100MS/s

TIME DIV = 50 ns/div

CH1 VOLT DIV = 2V/div
