## Kenwood TS-2000 receiver crackling noise problem

### Ceramic filter failure – how to change the filters

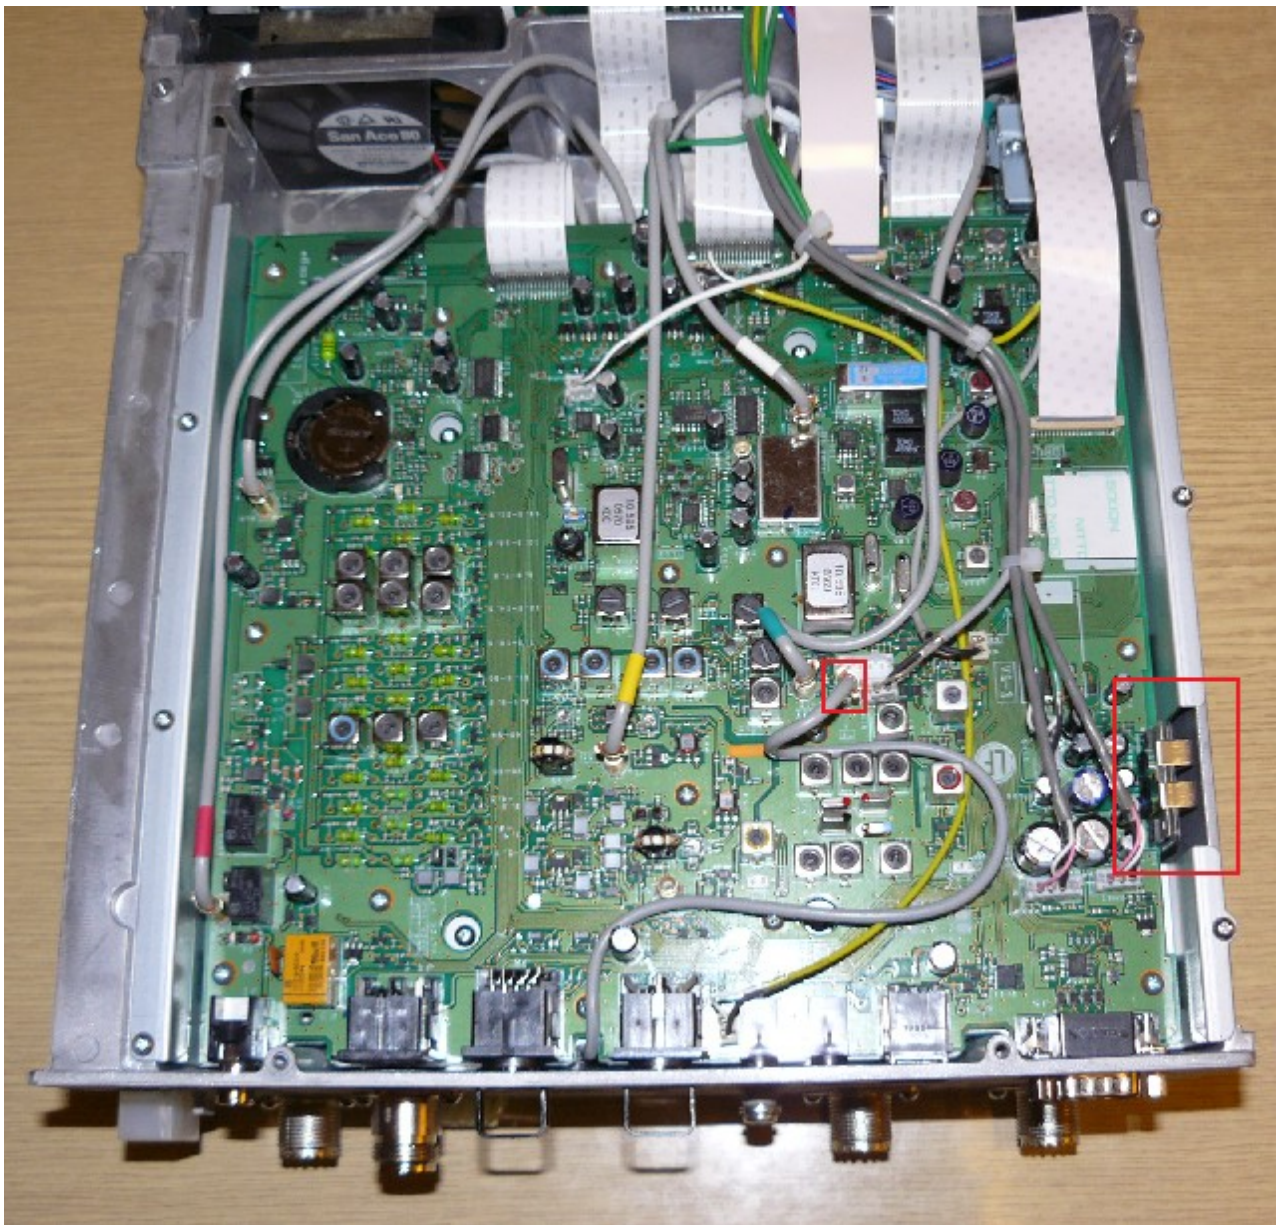
The procedure: Remove the bottom cover. Remove the small steel spring plate that holds the transistors at the side of the radio. Remove only one cable (mini coax) at the rear of the radio.

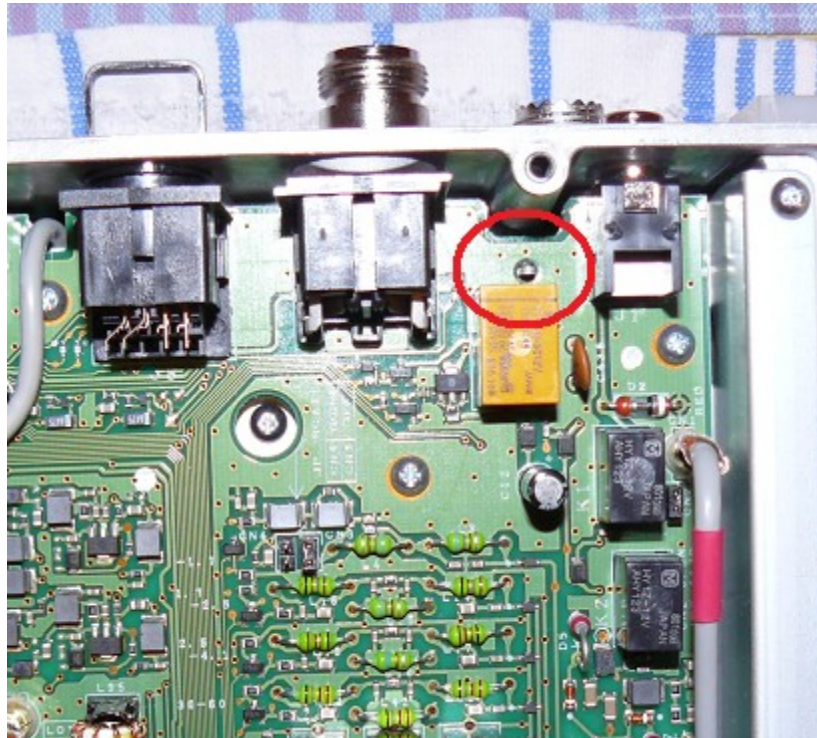
Just lift the board up a bit and move the board a bit towards the front to make all the rear connectors come clear of the aluminum chassis rear end, be aware of the location pin that sticks up in a hole in the board at the rear end. You must lift the board to enable this pin to come clear of the board.

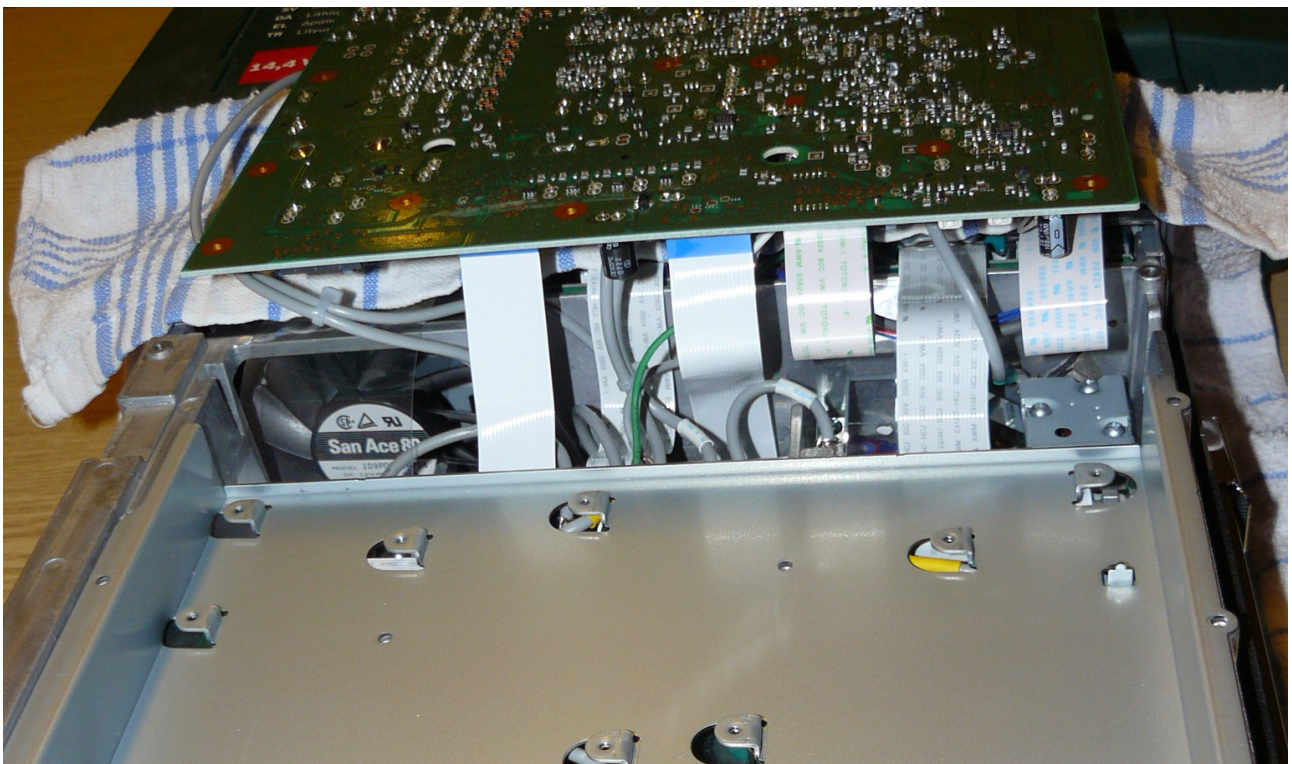
Then flip the board around and lay it with the bottom up on the support to allow soldering on the rear side of the board.
