AKG

SERVICE

D 112 E

2220 Z000

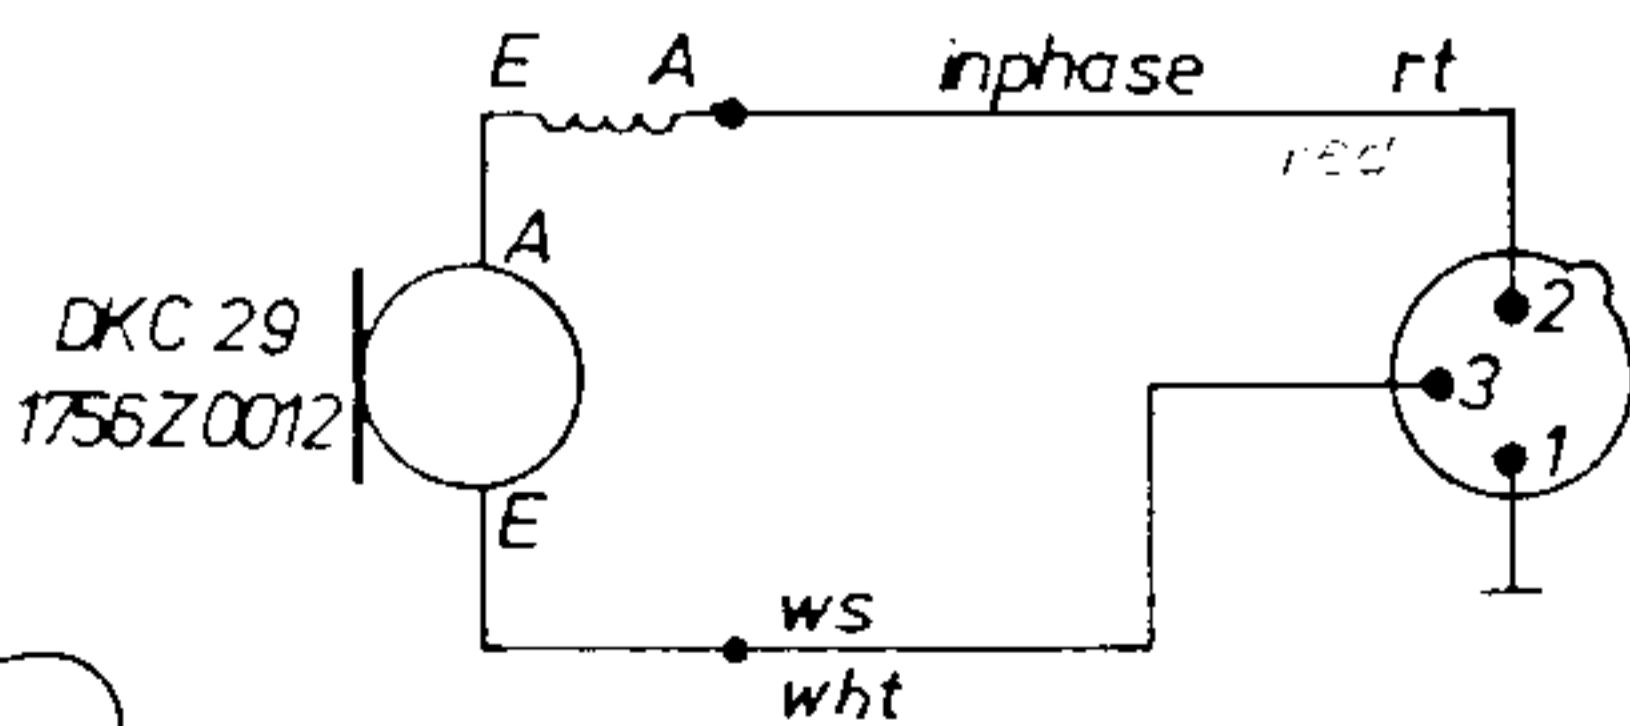
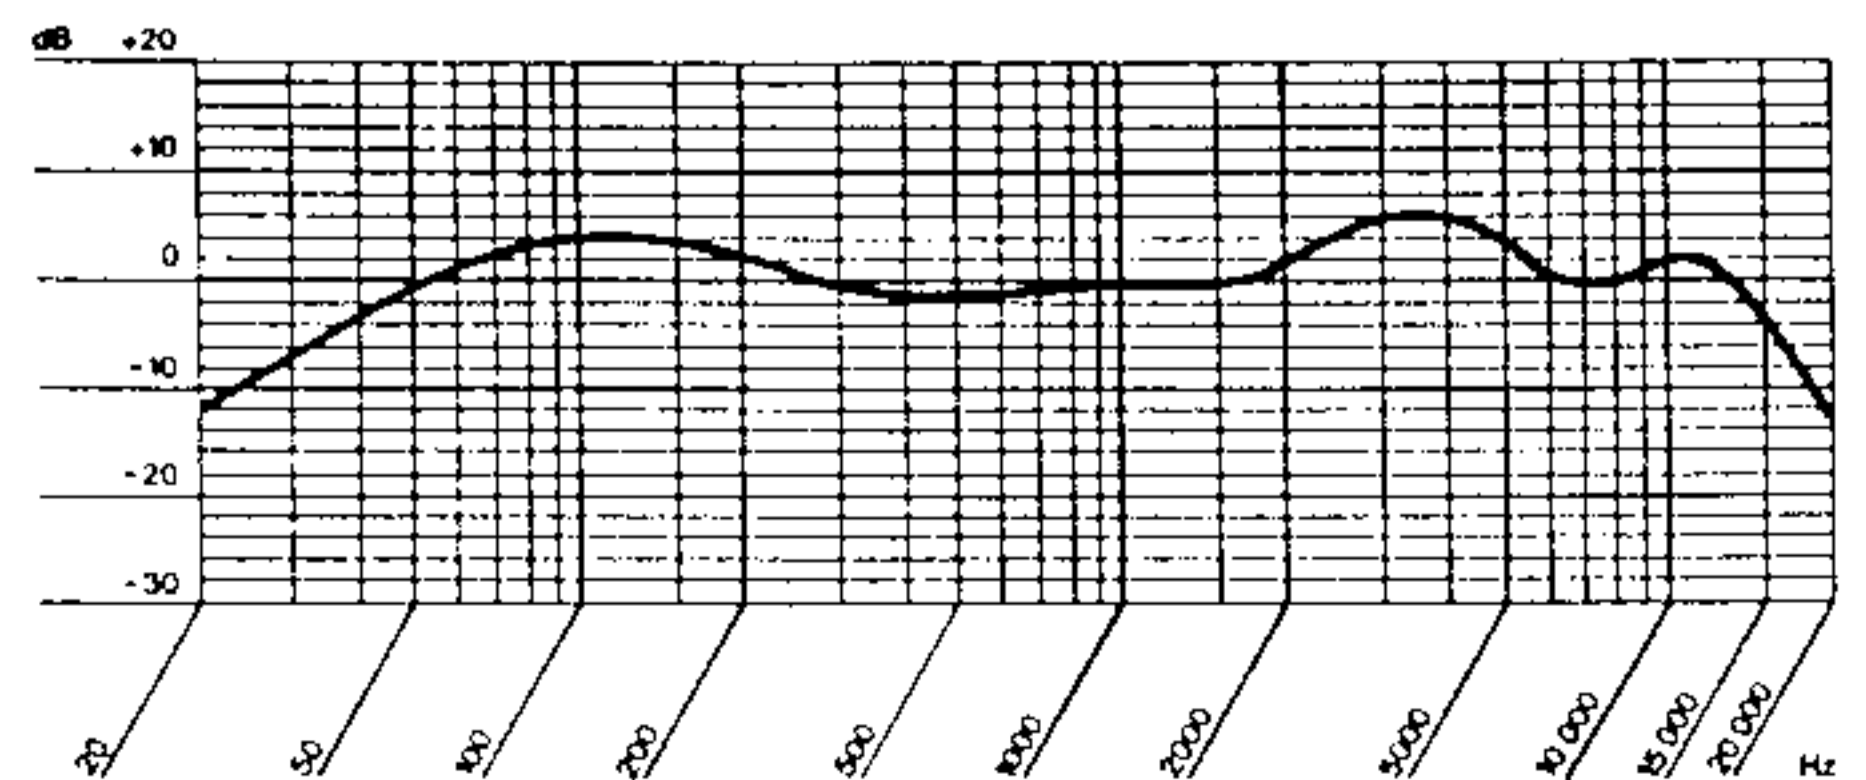
Beim Wiederausammenbau eines zerlegten D 112 muß der Steckereinsatz 13 entfernt und die Litzen straffgezogen werden. Erst dann kann das Gehäuse zusammengebaut werden. Im Anschluß daran ist der Stecker wieder anzulöten. Diese Vorgangsweise ist unbedingt einzuhalten, da sonst die Litzen zwischen Hauptkörper 10 und Ring 7 eingequetscht werden können. Mikrofone die mit Fehlerangaben wie "kracht", "Geräusche", oder "Brumm" retourniert werden, haben höchstwahrscheinlich eingeklemmte Litzen. Prüfen Sie in diesem Fall das Mikrofon bitte mit angelegter Phantomspeisung. Damit können Feinschlüsse zum Gehäuse festgestellt werden.

When assembling a dismantled D 112, the plug insert 13 has to be removed. The litz wires have to be tightened. Then the microphone can be put together. Only after that the plug can be remounted. This procedure prevents crushing of litz wires between housing 10 and ring 7. Microphones returned with errors like "hum", "noisy", "crackling sound" will most likely have the litz wires damaged. In that case please test performance of microphone with attached phantom powering. This will reveal any shortcircuit to the housing.

Neuerdings wird der Bügel 1 mit selbstschneidenden Schrauben (8) befestigt. Zum alten Bügel 2220M0301 mit Gewindeeinsätzen gehören die Schrauben 0084D3020, zur neuen Bügelversion 2220Z0901 die Schrauben 0099N3004. Ebenso wurden die Schrauben 11 auf selbstschneidende Versionen umgestellt. Teil 0099N3000 war eine Zwischenlösung. Gleichzeitig wurde auch der Ring 7 von 2220Z1101 auf 2220Z1201 geändert.
