Technical Bulletin

ICOM

IC-R71/R71AJ

GENERAL COVERAGE RECEIVER
GJ36783

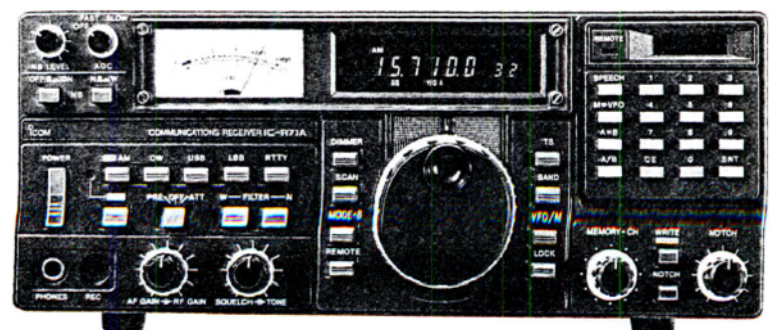
Replace the following trimmer caps:

C78	10pf	with an Icom # 4610000110 12pf unit VCO cap (white)
C88	10pf	with an Icom # 4610000110 12pf unit VCO cap (white)
C97	6pf	with an Icom # 4610000100 6pf unit VCO cap (red)
CI07	6pf	with an Icom # 4610000100 6pf unit VCO cap (red)

We recommend that you remove the excessive sealing wax from around replacement trimmer caps to prevent future contamination. We also recommend that you check the REG unit circuit board for cracked or cold solder joints. The circuit is adjacent to the PL unit.

The replacement trimmer caps are long-life ceramics. A partial realignment is required after these trimmers are replaced. See Service Manual for procedure.
