Report of an
Unidentified Aerial Phenomenon and its Safety Implications
at O'Hare International Airport on November 7, 2006
Case 18

Richard F. Haines, Ph.D. Senior Editor
Chief Scientist

March 9, 2007

National Aviation Reporting Center on Anomalous Phenomena¹

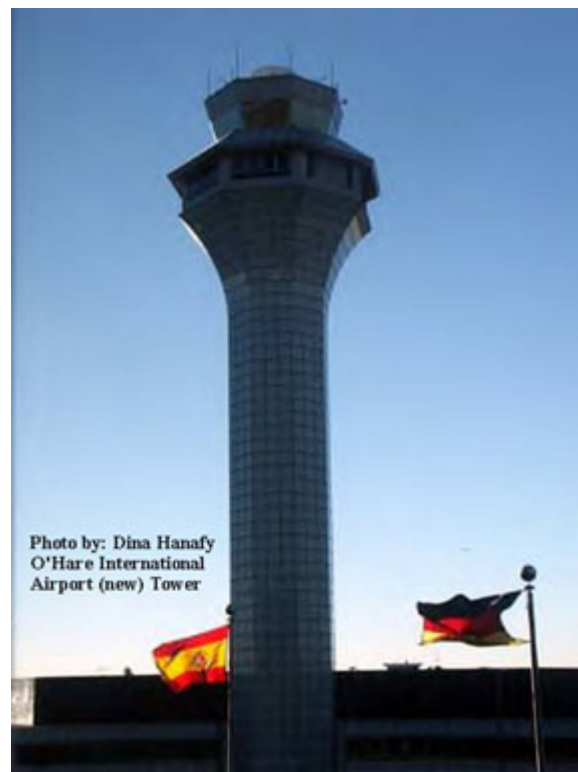
Figure 7. New O'Hare Airport Control Tower

The new control tower at O'Hare International Airport, completed in 1995, is 253 feet tall (905 feet MSL). It is shown in Figure 7. The ATC work area is at the level of the transparent outward sloping windows.

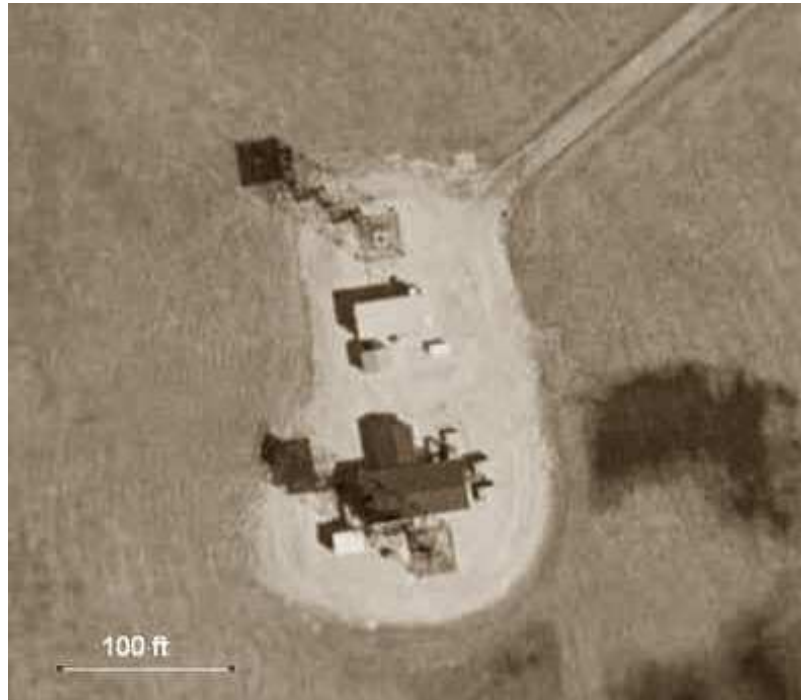
Fig. 15 Aerial View of ASR-9, ORD #1, Chicago O'Hare, Dupage County, Ill.

The main FAA surveillance radar serving Chicago O'Hare is designated in the FAA NAS Architecture (ref.12) as CHICAGO SRR (ORD) and is located in Dupage County, Illinois. Most of O'Hare Airport is located in Cook County. However satellite photos (Fig. 15) show what appears to be an ASR-9 radar antenna tower on the west side of the airfield, 600m over the county border inside Dupage County, consistent with the statement of a case witness and with the FAA supplied information.

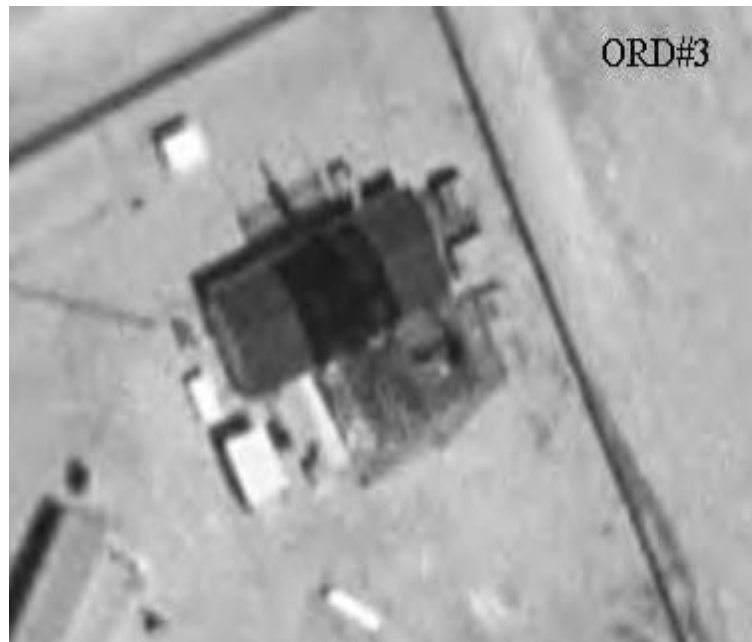
Figure 16. Aerial View of ASR-9, ORD #3, Oak Forest, Cook County, Ill.

These coordinates locate the antenna shown in Fig. 16 near Oak Forest, Cook County, a couple of miles from Tinley Park and about 11 miles south of Chicago Midway Airport, confirming the identification of this site as the one designated in the FAA National Airspace System Architecture as CHICAGO-OAK FOREST (ORD #3) SRR [QXM].⁶³

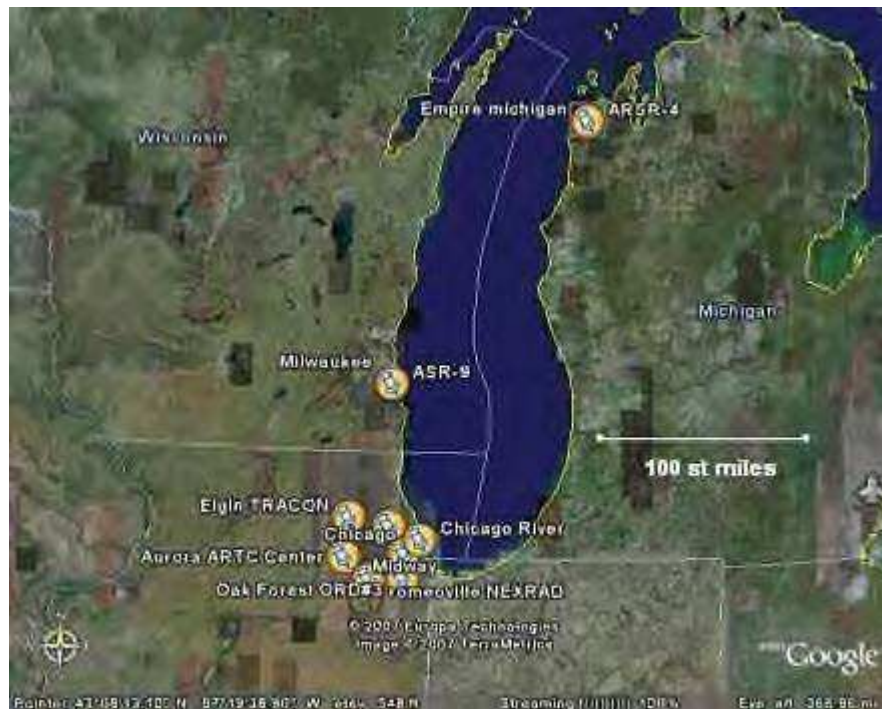
Figure 18. Radar Locations Around Lake Michigan Showing the ARSR-4 at Empire, Michigan, and ASR-9 at Milwaukee. The maximum range of the latter falls a few miles short of the area of the incident at Chicago O'Hare.

Nearest ARSR-4 site is at Empire, north Lake Michigan [QJA]. Fig. 18 shows the position of this long-range radar in relation to the Chicago area. The exact antenna location remains uncertain.

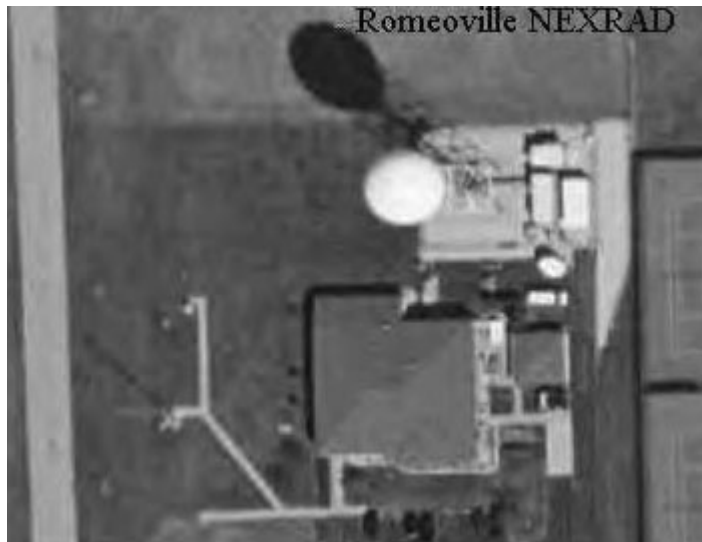
Figure 19. Aerial View of NEXRAD WSR-88D Weather Radar at Romeoville, Ill.

The nearest NEXRAD WSR-88D radar is at Romeoville, Illinois (Fig. 19).

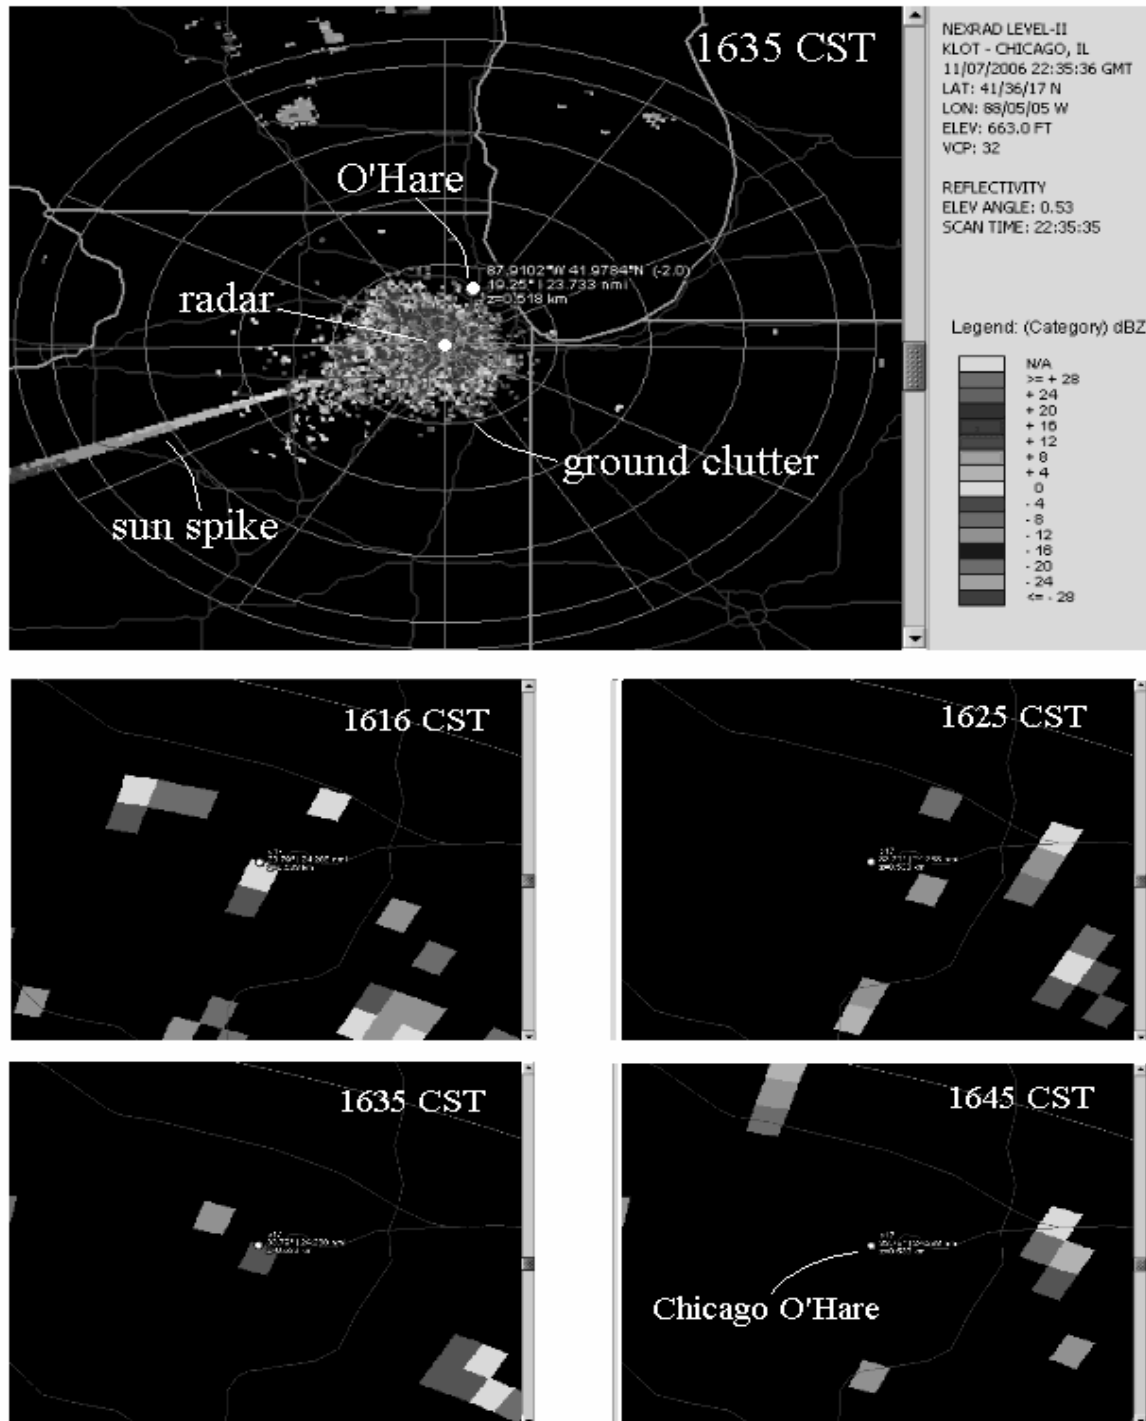
Figure 22. NEXRAD Base Reflectivity Radar Images Bracketing the Observation Period.

At least four WSR-88D antennas give overlapping coverage of the Chicago O'Hare region. The nearest at Romeoville, Ill., is about 27 miles from Chicago O'Hare. Figure 22 shows radar data from this site for 1635 CST (top) and four enlargements for the O'Hare area for the times indicated. The author acknowledges the help of James C. Smith in supplying detail images of the Romeoville NEXRAD weather product for four VCP 32 Clear Air Mode antenna scans bracketing the observation period.

Fig. 24 shows the VCP 32 elevation coverage pattern of the radar. Complete volume coverage up to 4.3 degrees is accomplished in a number of scans of the ~1 degree beam at distinct elevations. The diagram shows that the full VCP 32 scan algorithm gives coverage at the range of the sighting location (27 nmi) up to an altitude of more than 15,000 ft. However for times around the sighting period only the lowest scan (0.53 deg) showed any data in the area of Chicago O'Hare, as shown in the images of the product from this scan in Fig. 22.

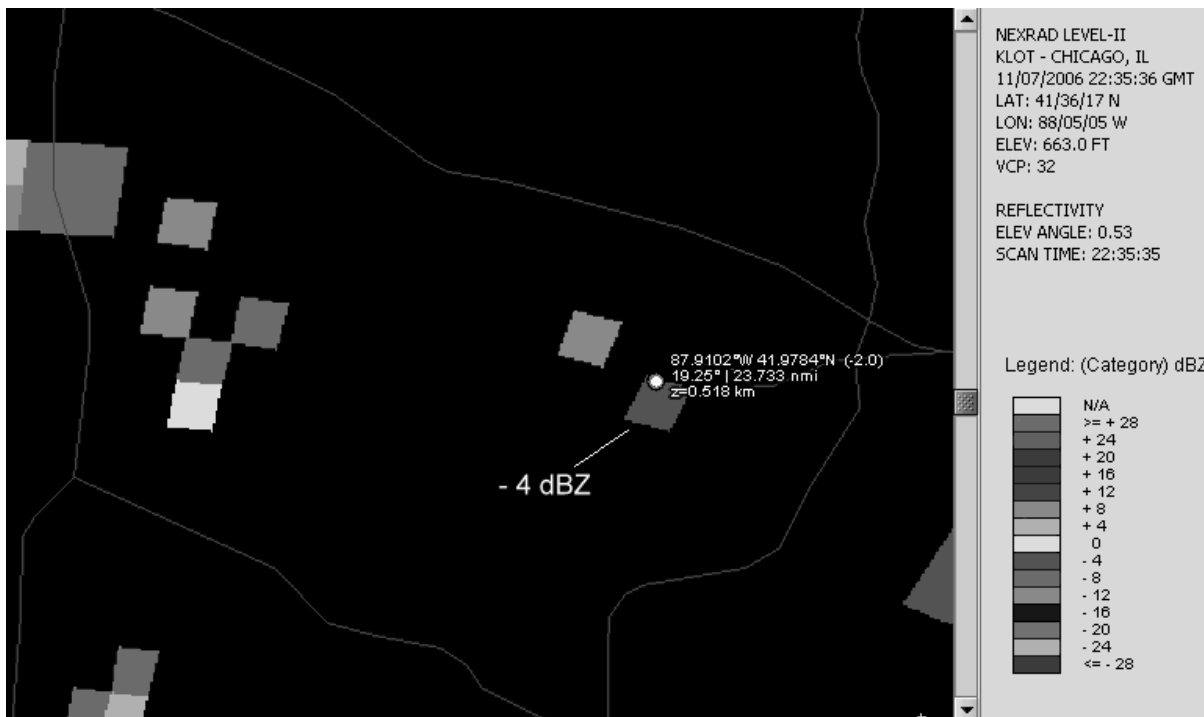
Figure 23. NEXRAD 0.5 degree Base Reflectivity Radar Image for 1635 CST Showing Echo Detail Over O'Hare Airport.

The 1635 scan has been enlarged in Figure 23.

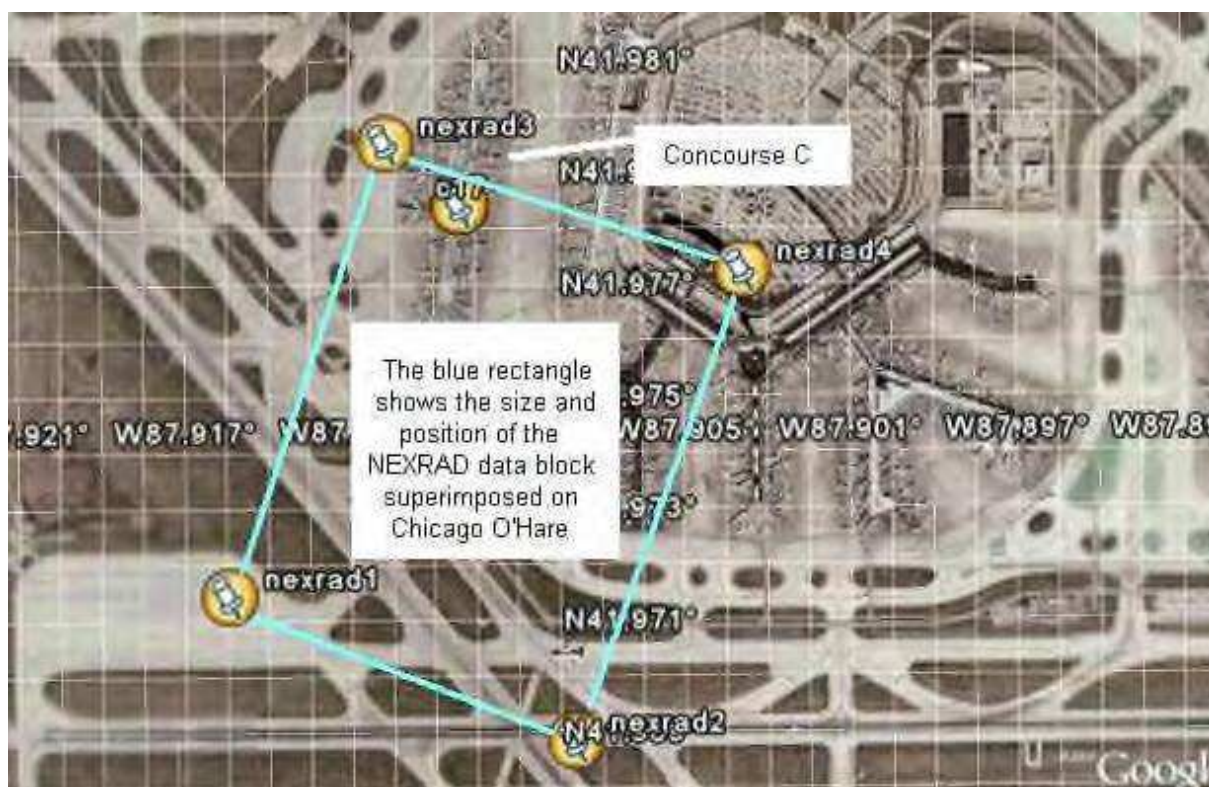
Figure 25. Footprint of the NEXRAD Radar Resolution Cell
Superimposed on the Sighting Location
(adapted from image supplied by James Smith)

The images show that Romeoville WSR-88D did detect some echo, at the average signal reflectivity level less than light precipitation, in the resolution cell corresponding to the sighting location above Gate C17 and at an altitude not inconsistent with the visual reports, at 1616 CST, and again at 1635 CST. The latter is within a few minutes of the estimated sighting time. However, the ground foot print of the resolution cell is rather large (Figure 25) and there are several possible interpretations for the echo, making this a result of limited value (see Section 6).

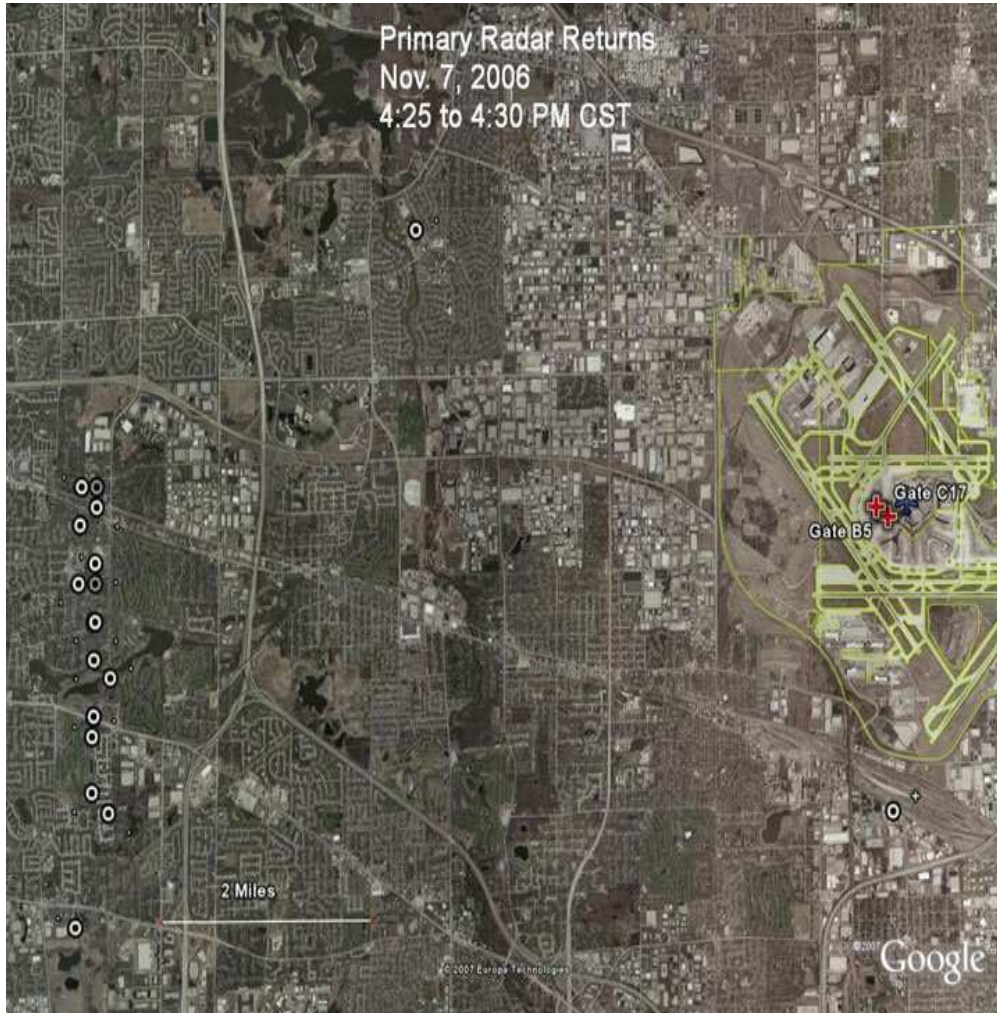
Figure 27. Primary Radar Returns Between 4:25 and 4:30 pm on November 7, 2006.

Primary (skin paint and/or "false") radar contacts in the vicinity of the airport for the time period 1625 to 1630 hrs are plotted with white circles in Figure 27. Gate B5 and C17 are shown by small red crosses at the upper center of this figure. There are a cluster of primary echoes to the west and southwest of runway 32L. The single return that is nearest gate C17 both in distance and the time of the sighting (i.e., 2230) was at 2231:18 about one mile to the west (point A); the altitude of these returns cannot be determined. (See page 83)

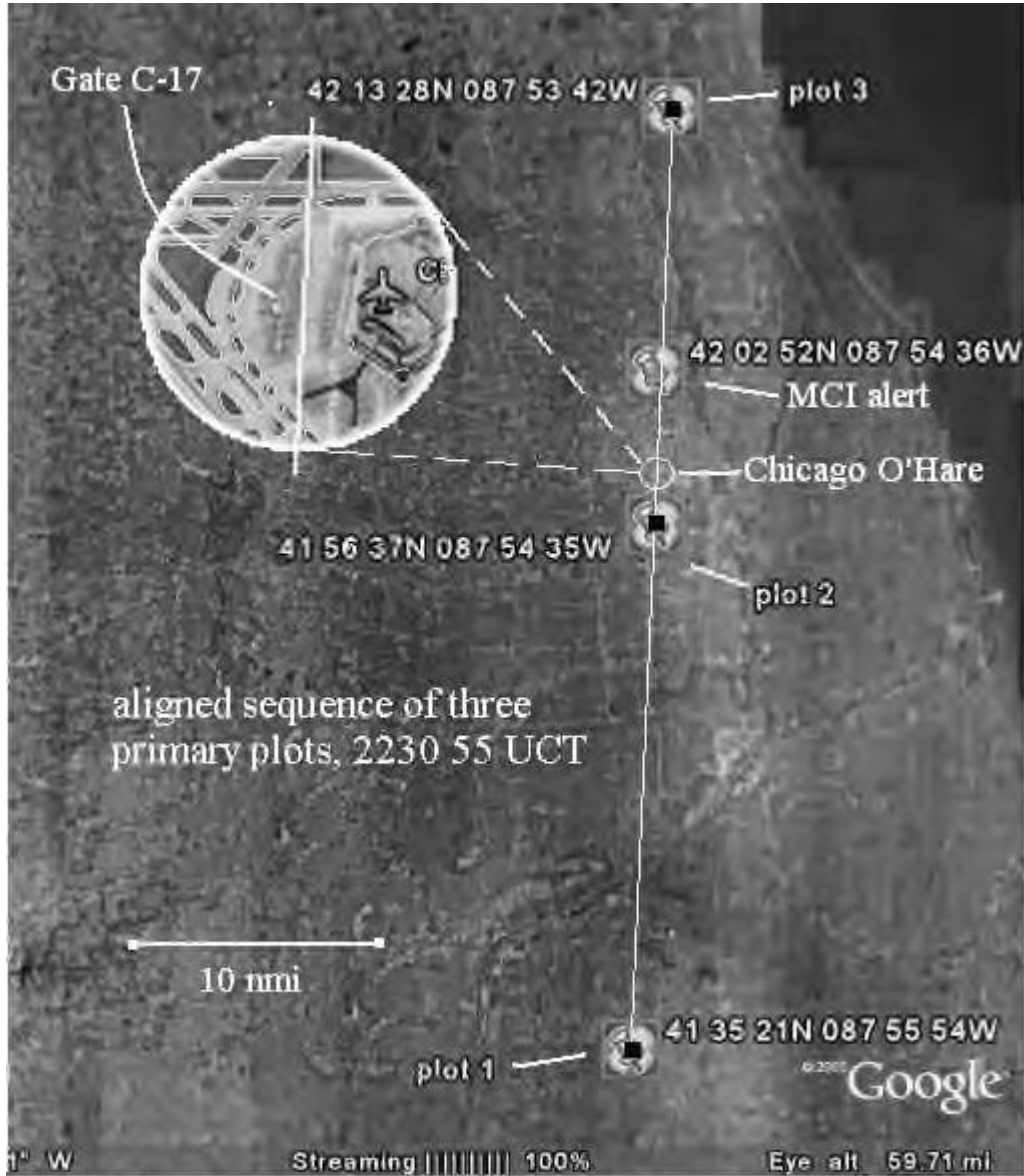
Fig. 30 Alignment of 3 Primary Radar Plots at 2230:55

The period symbol denotes "short run length primary tracks," and the capital "I" denotes an "MCI correlated track eligible for conflict alert." Reading from south to north, the coordinates define successive positions on a line that is for all practical purposes perfectly straight. A line ~ 43.8 miles long drawn between plots 1 and 3 passes through the coordinates of plot 2 within 350-400 feet. This line also passes about 200 ft to the east of the Chicago O'Hare Concourse C building. See Figure 30.
