Fortress

Fortresses of the Peninsular War 1808–14

Ian Fletcher • Illustrated by Chris Taylor

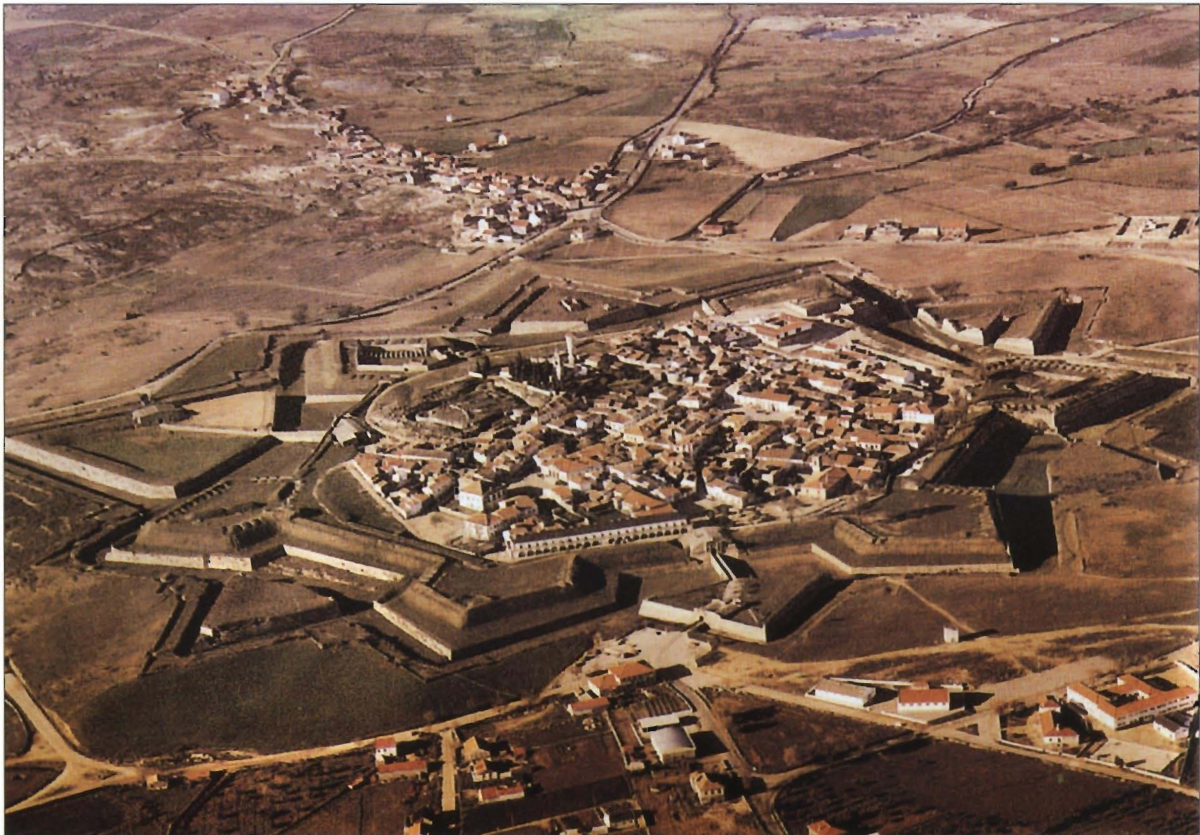
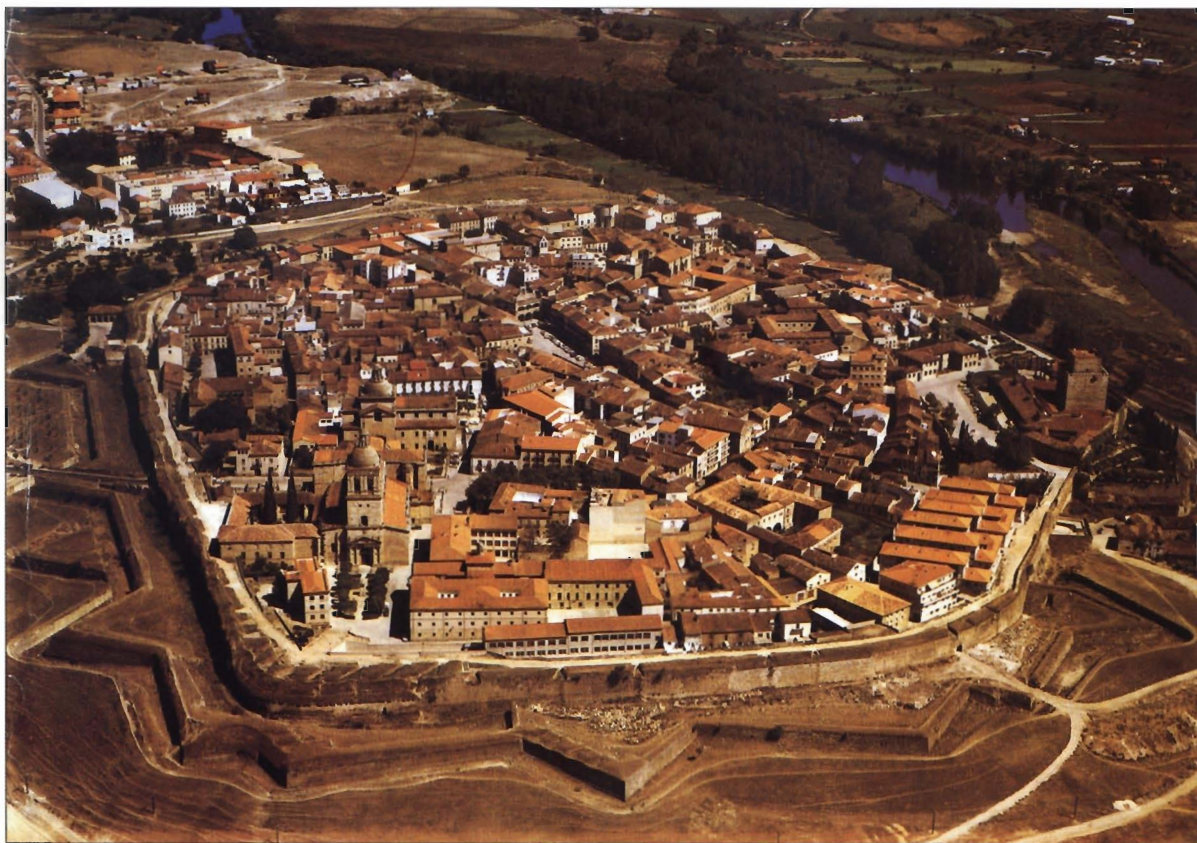
The magnificent fortress town of Almeida in Portugal. The fortress sits just across the Portuguese border and, along with Ciudad Rodrigo, guards the northern corridor between that country and Spain. It was besieged in August 1810 by the French and fell following the great explosion when a shell ignited the powder magazine. A classic Vauban-type fortress, the fortifications are a fine example of 18th-century military science.

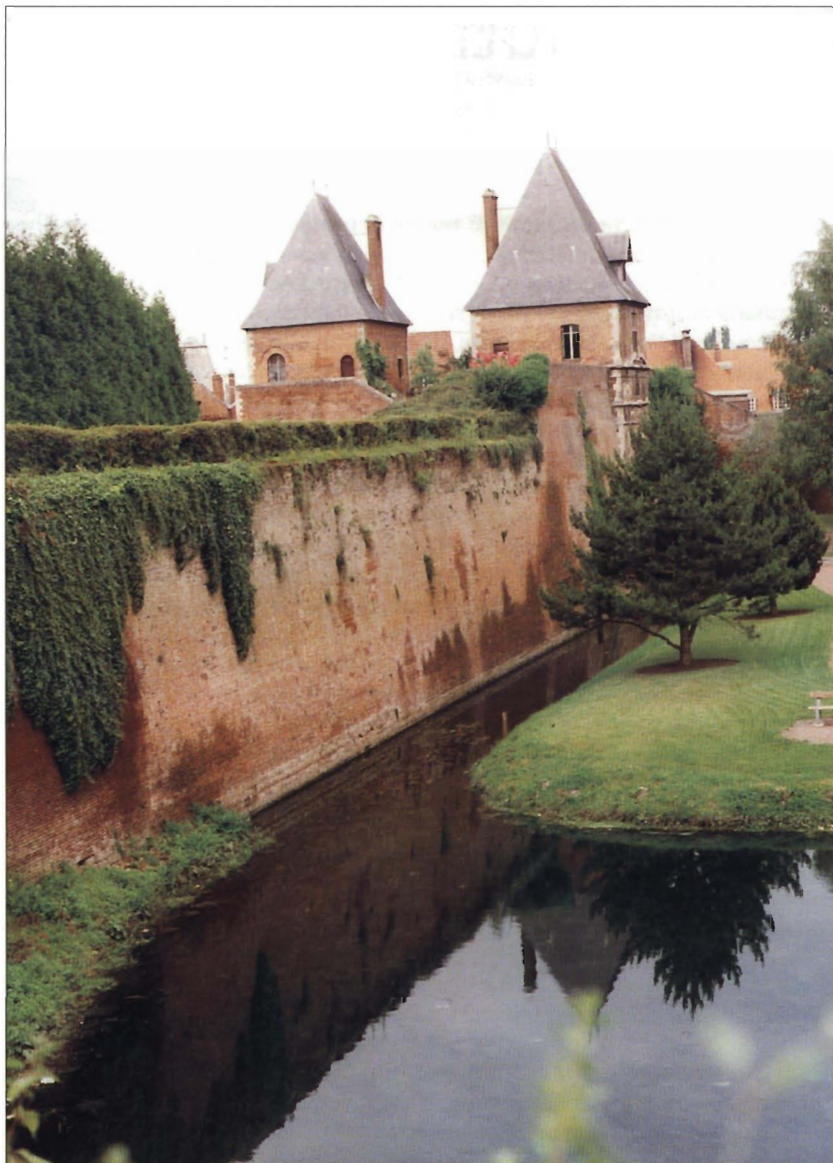
This example of a moated fortress is Peronne in France. This fortress was taken by the Foot Guards during the advance to Paris after the Battle of Waterloo. The walls benefit from having a moat, something which none of the fortresses in the Peninsula had.

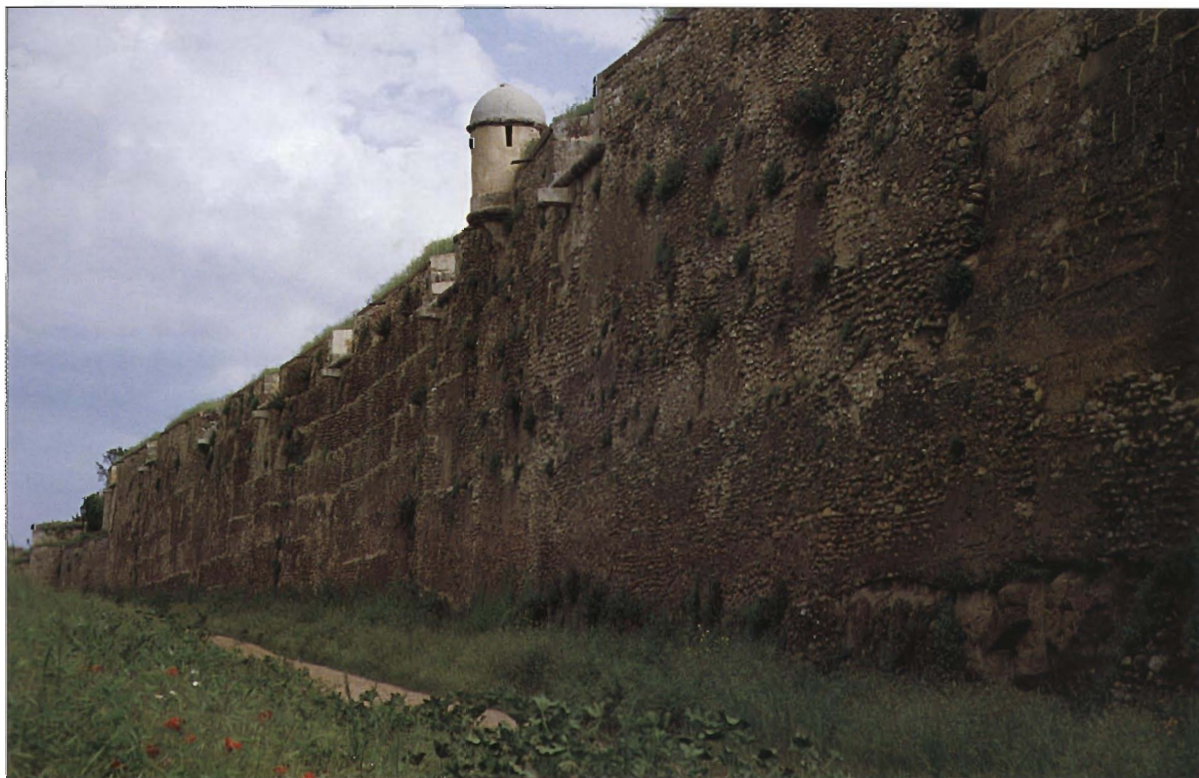
The flat, Moorish walls of Ciudad Rodrigo, as seen from within the inner ditch. Save for the introduction of embrasures for artillery these walls had remained the same for years. They provided no protection whatsoever against modern artillery. The walls were never modernised, angled or improved. Only the raising of the glacis and the building of the *faussebraie* gave the town any degree of protection during the Peninsular War.

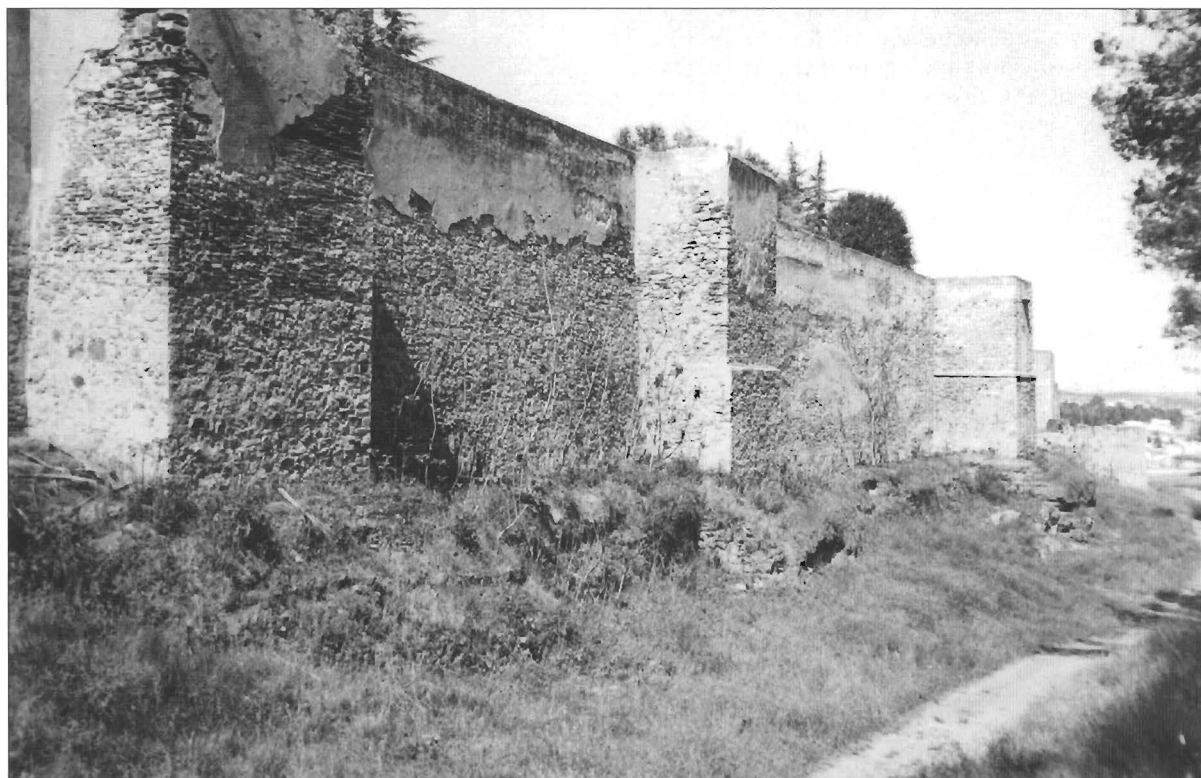
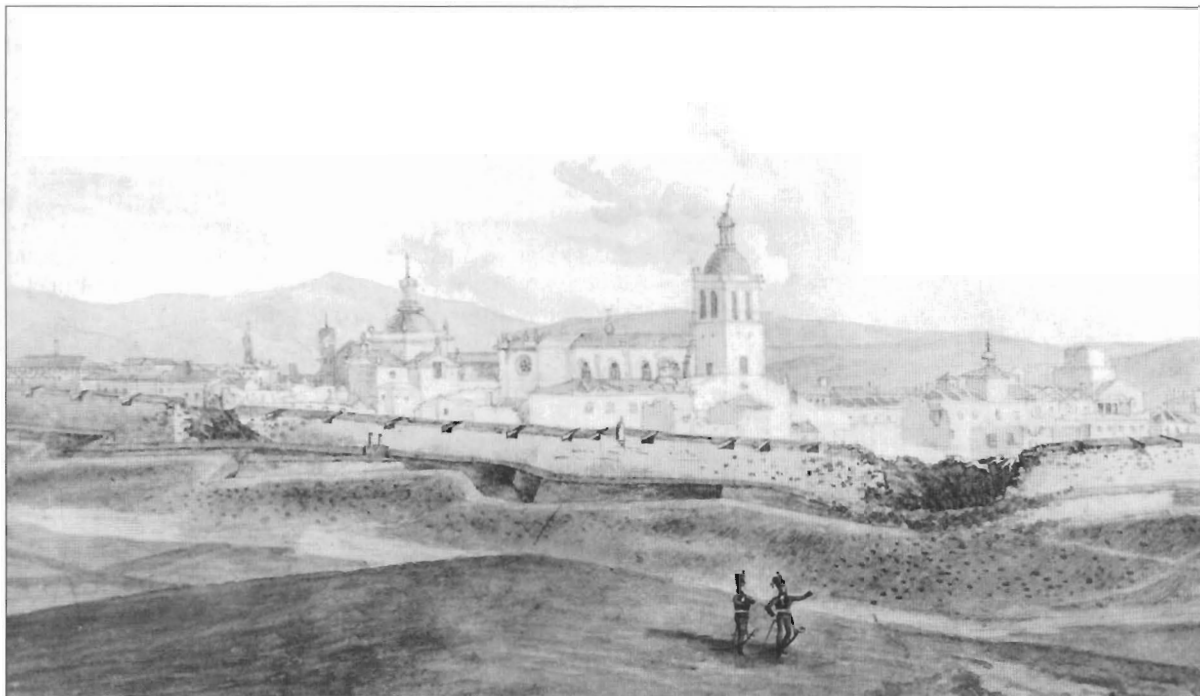
The walls of the 'castle' at Badajoz. In fact, there is no castle but a Moorish *alcazar* (or walled enclosure). These walls were taken by escalade by Picton's 3rd Division during the assault on 6 April 1812.

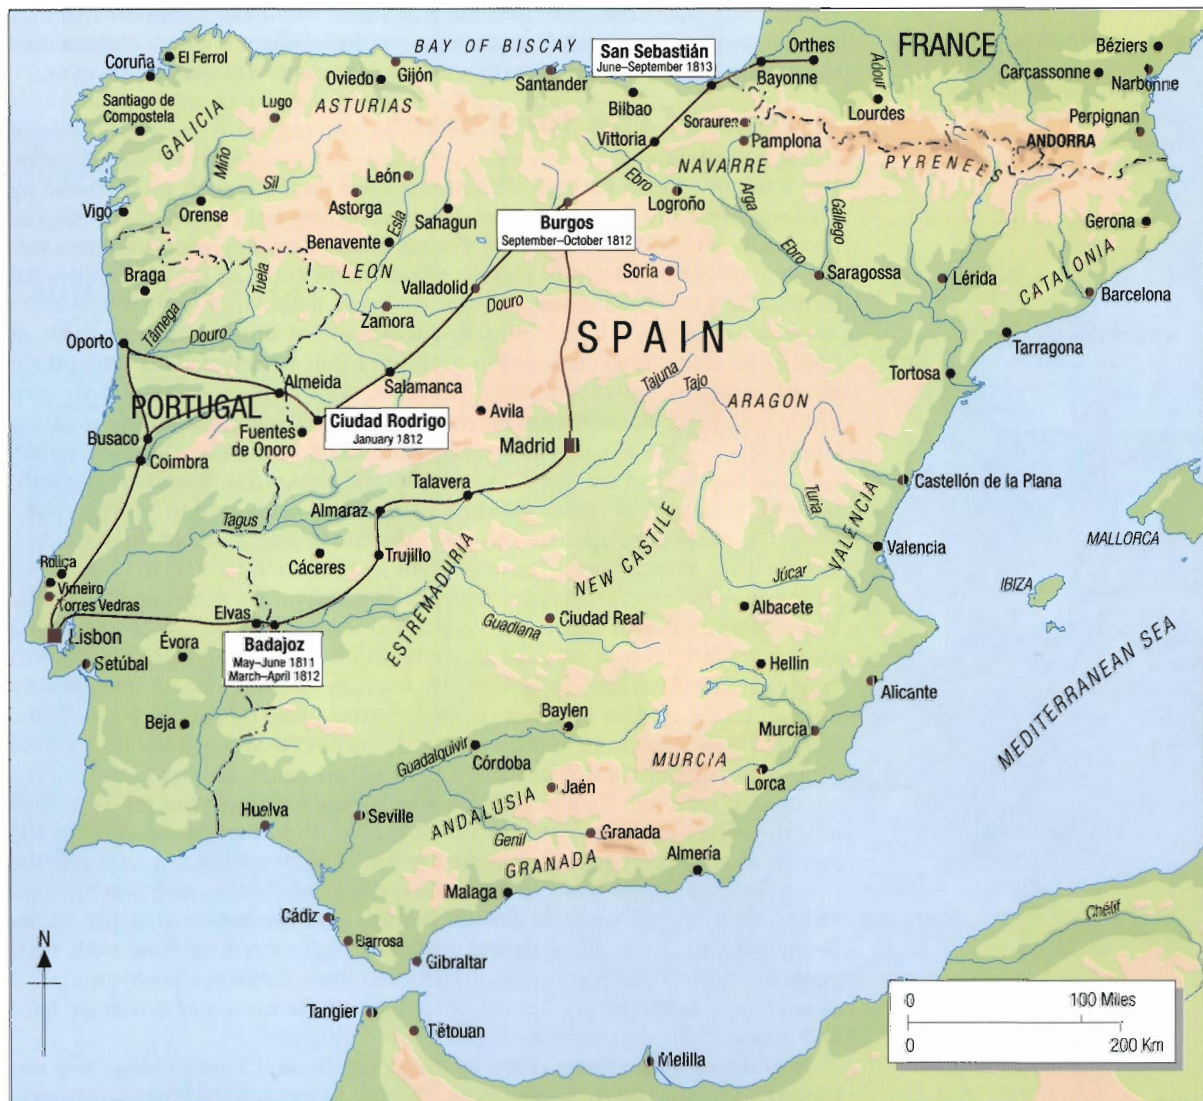
The main fortresses in the Peninsula, and the five siege operations that took place there. Also shown are the key routes between France, Spain and Portugal that these fortresses protected.

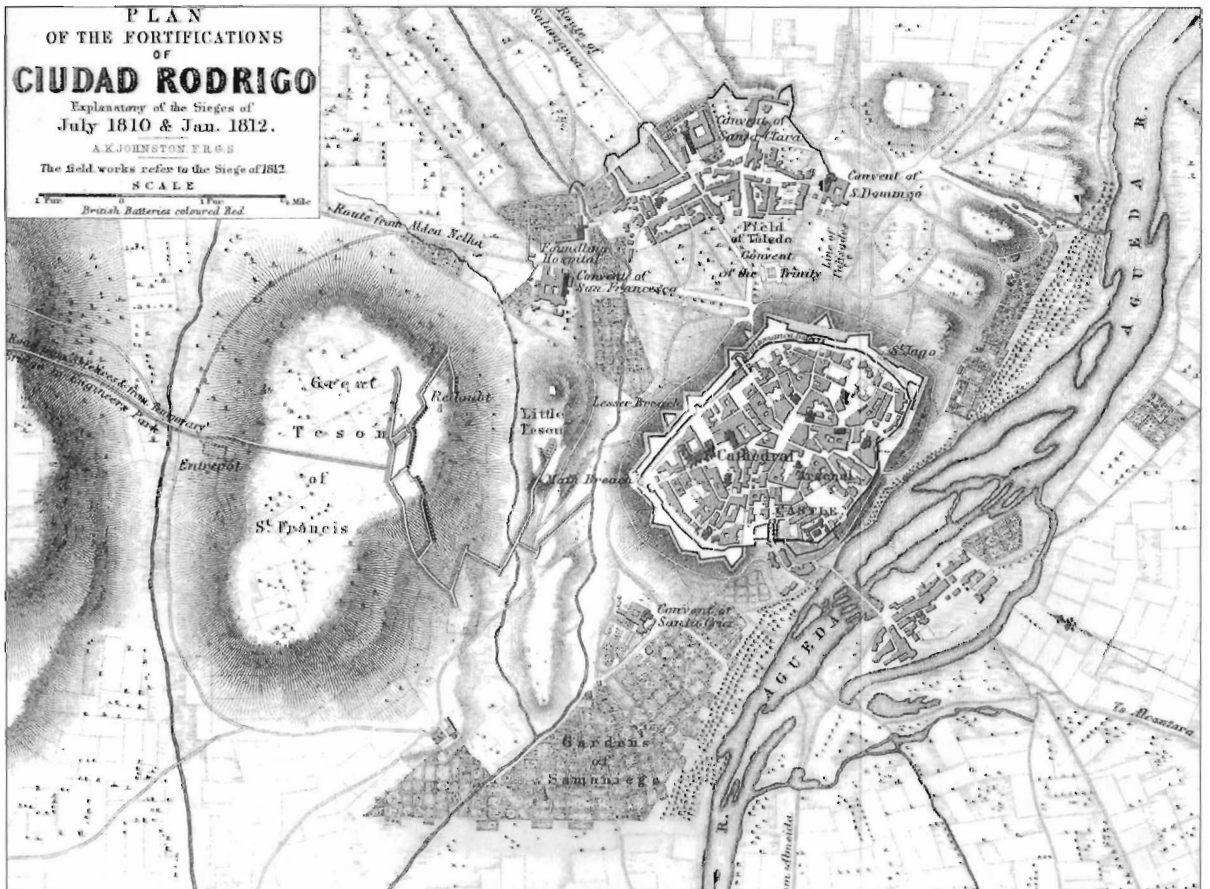
A plan of Ciudad Rodrigo, showing the siege lines of 1812. The map clearly shows how the town was protected from attack to the south by the River Agueda, and dominated to the north by the Upper Teson.

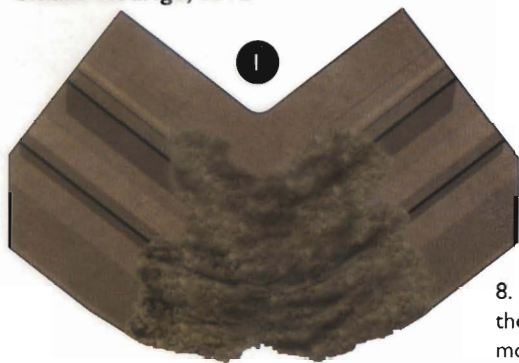
1. A plan view of the Great Breach. The Breach was stormed by the 3rd Division, many of whom were killed when the French detonated a huge mine beneath it.

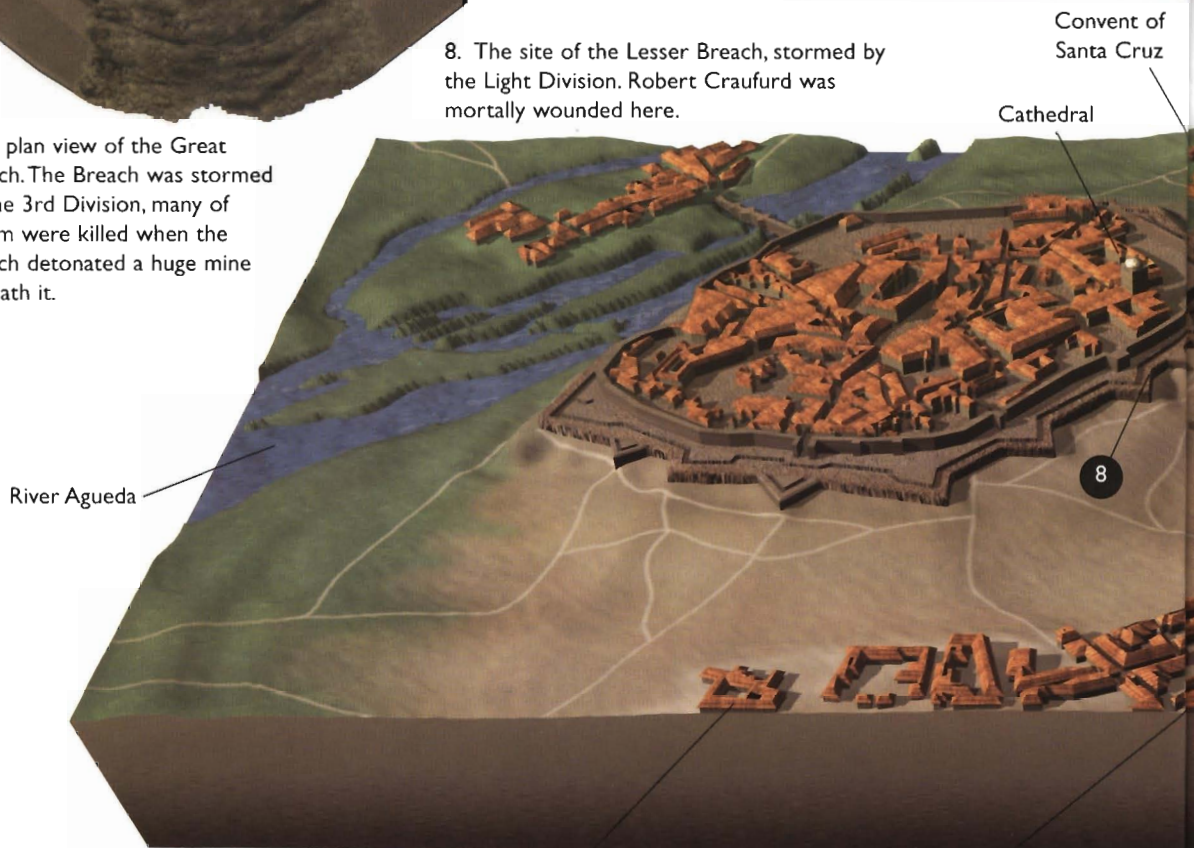
8. The site of the Lesser Breach, stormed by the Light Division. Robert Craufurd was mortally wounded here.

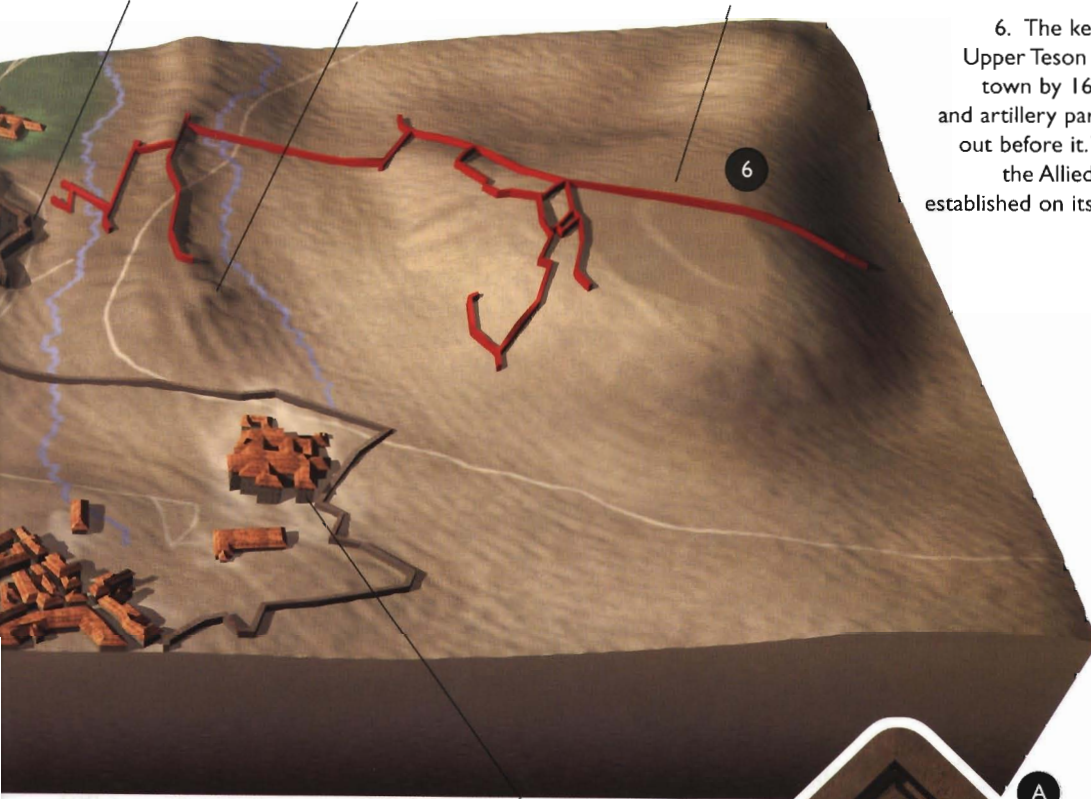
6. The key ground of the Upper Teson overlooked the town by 16ft. The engineer and artillery parapets were laid out before it. The majority of the Allied batteries were established on its forward slope.

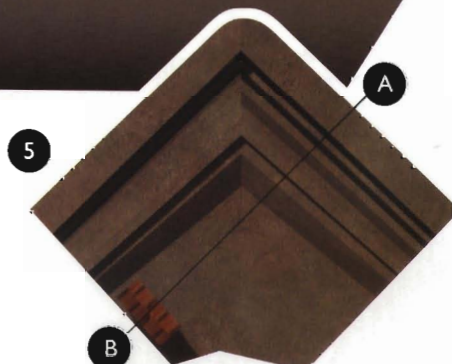
5. A plan view of the Renault redoubt, situated on the forward slope of the Upper Teson, though it did little to deny Wellington access to this feature.

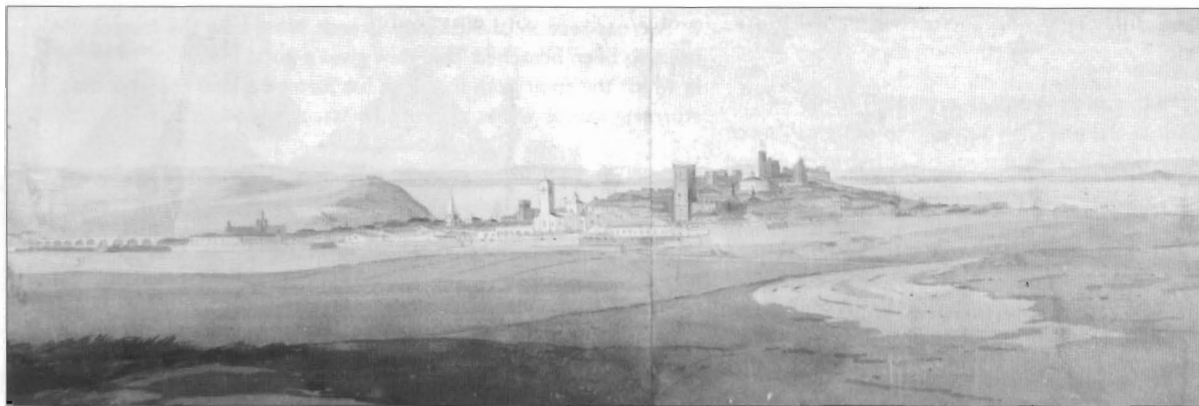
Upper Teson

A view of Badajoz, as seen from the south. The Roman bridge over the Guadiana can be seen at left, as can Fort San Cristobal, high on the hill, also to the left. This drawing was executed by Capt. C. Ellicombe, R.E. during the third siege of Badajoz.

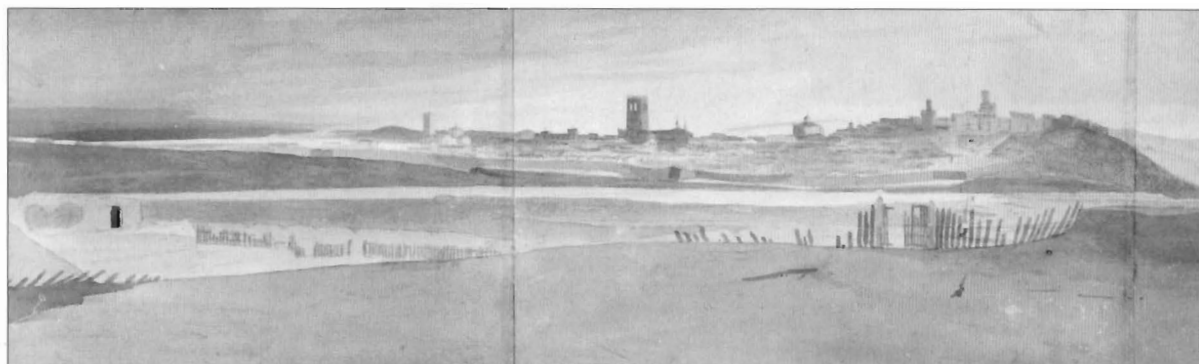
Another view of Badajoz, again drawn by Capt. Ellicombe. This drawing was done from within Fort Picurina. The inundation, or false lake, can clearly be seen, being the light coloured area running across the middle distance in front of the town walls. The castle can be seen on the hill on the right of the drawing.

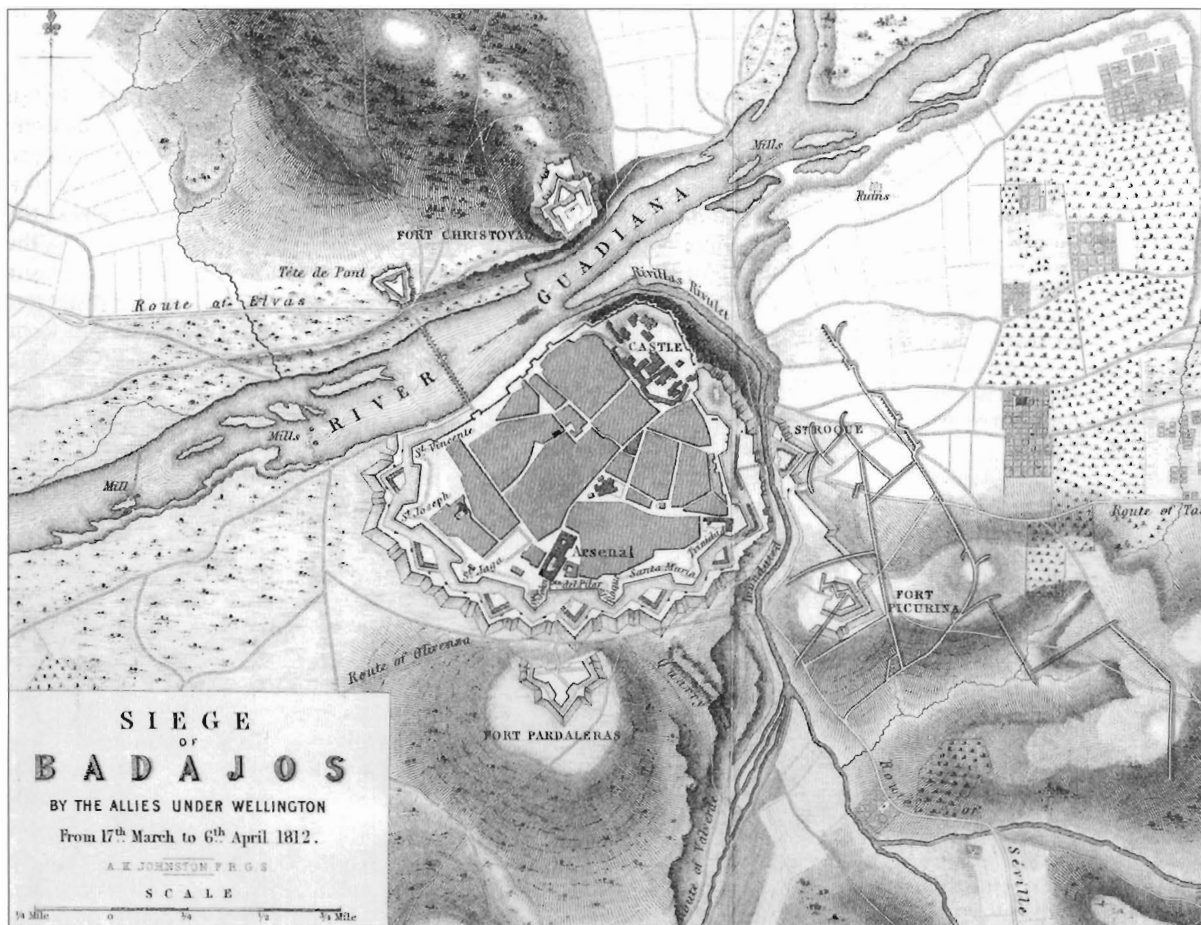
The great fortress of Badajoz, showing the lines of the siege of 1812. The large outworks of forts Pardaleras and Picurina can clearly be seen, built on the high ground to the south and south-east.

10. Fort San Roque. It was here that the French built the dam that prevented the Rivellas from flowing into the Guadiana. This in turn created the inundation (or false lake) that caused Wellington so many problems.

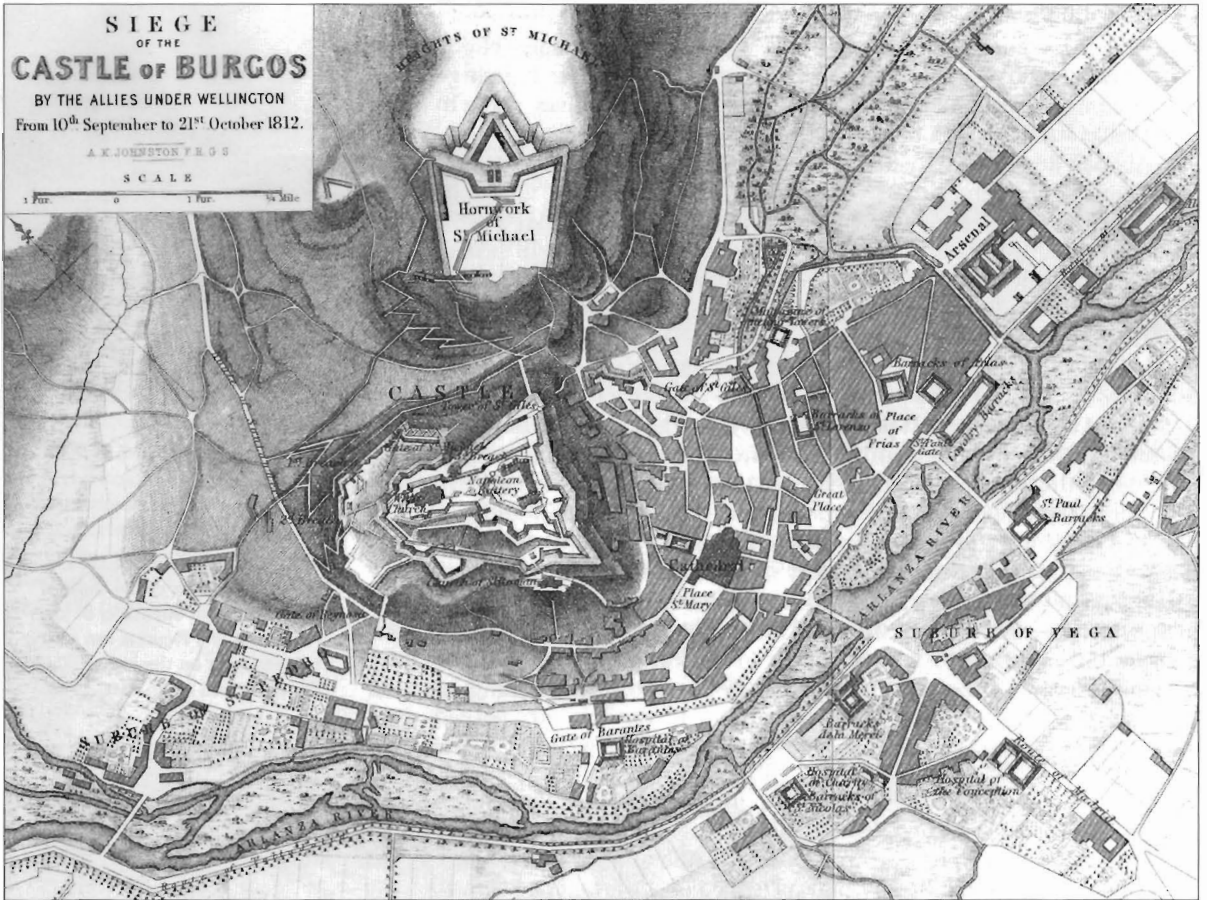
SIEGE
OF THE
CASTLE OF BURGOS
BY THE ALLIES UNDER WELLINGTON
From 10th September to 21st October 1812.
A. K. JOHNSTON F.R.G.S.
SCALE
1 Para. 0 1 Para. 1/2 Para.

A plan of Burgos, showing Wellington's siege lines of September and October 1812. As can be seen, the town itself is open and without walls. Wellington's operations were directed against the castle and the hornwork to the north. It proved to be too much for Wellington, however, and was his one great failure of the Peninsular War.

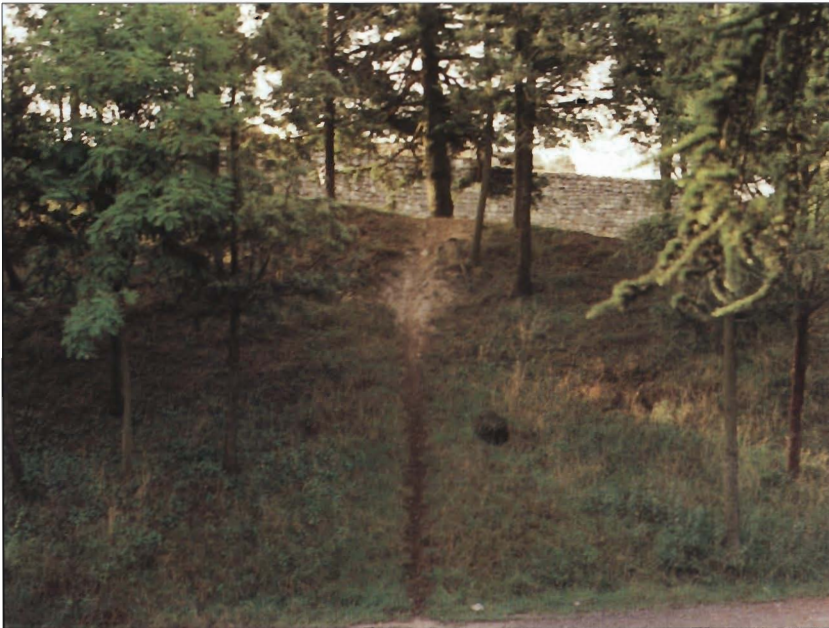
The massive bank of the third line of defences at Burgos, seen from the north. Behind the line the walls of the castle itself can just be seen.

The castle itself was not a particularly strong site, with relatively weak walls, no bastions or ravelins to protect them, and no real glacis. However, it was encircled by three defined 'lines' (earthworks). The third or upper line surrounded the castle itself along with a church, La Blanca. The line was in effect a retrenchment, but a strong and deep one, some 30ft wide. The castle keep itself had been incorporated into the third line as an interior retrenchment mounting a well protected battery named after Napoleon. The second line encompassed this third line completely. Once again it was a retrenchment with strong palisades in the ditch. The lower or outer line extended along the northern and north-west front of the castle, being connected to the second line on its east and west fronts. It was sited much lower down than the other lines with palisades protecting the flanks and re-entrants. These three lines, whilst not having any great strength, had the benefit of height and the slopes before the castle made entrenching very difficult. The down side of this was that the slopes were so steep in places that it was difficult for the defenders to depress their guns adequately to fire on their assailants.

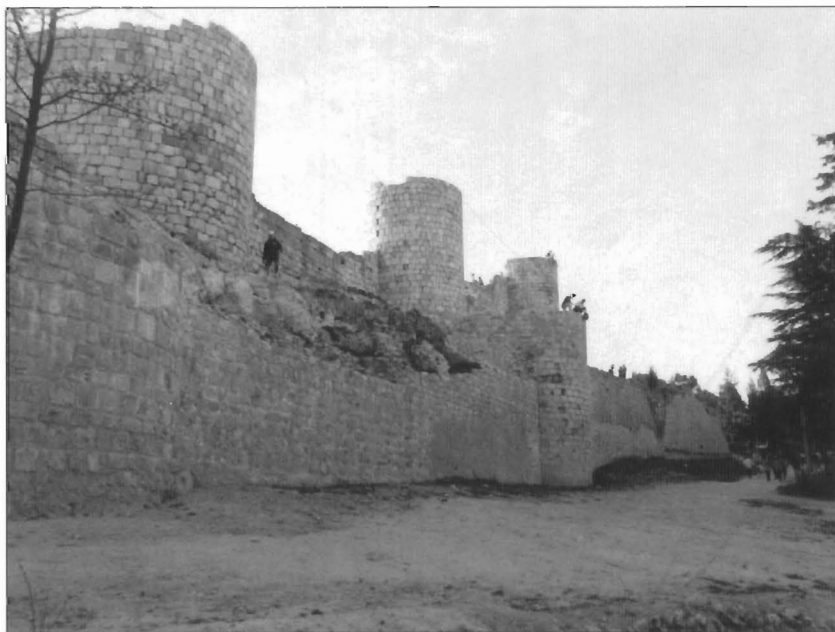
The strong walls of the eastern side of the castle of Burgos are pictured here. No attacks were made against this section of the walls.

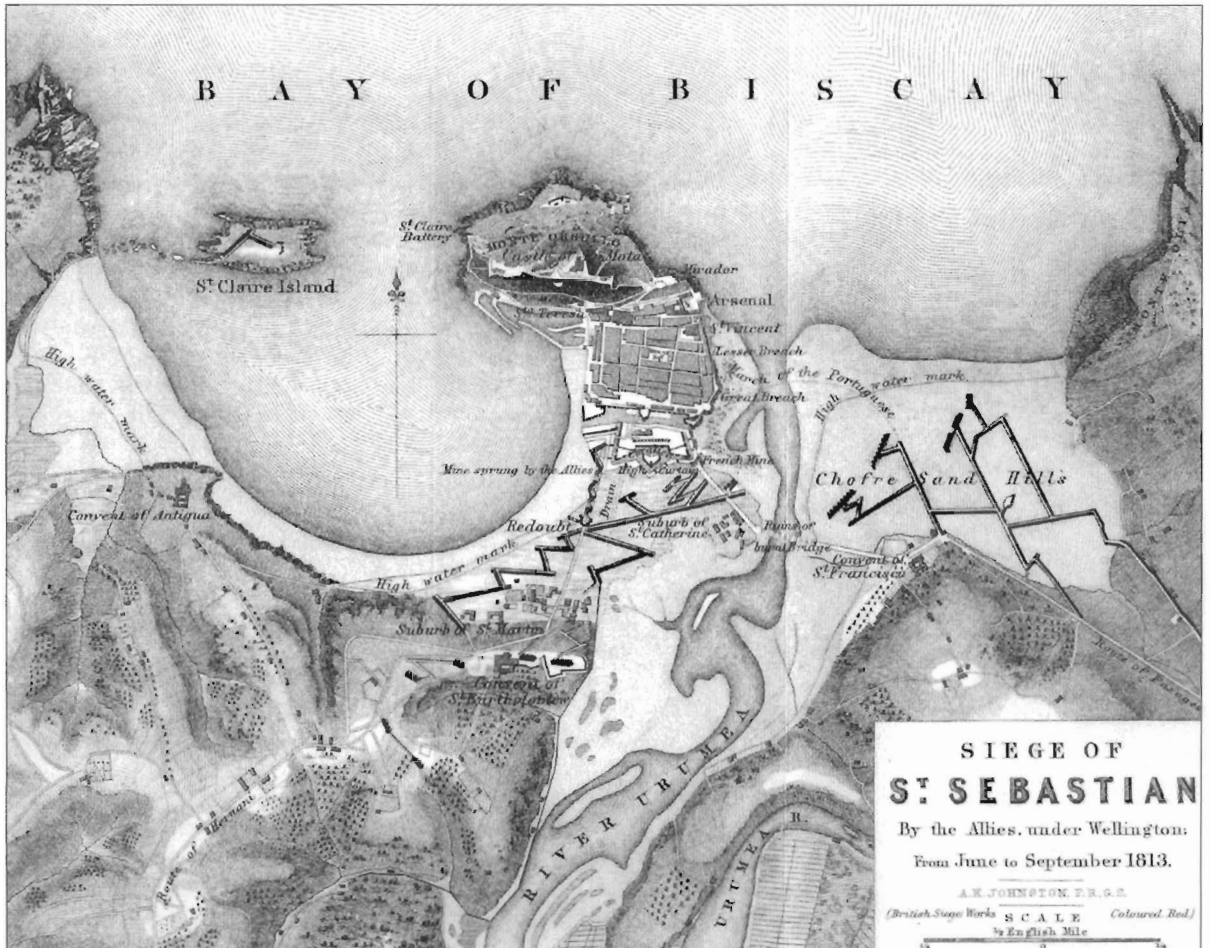
A plan of San Sebastián and the siege operations of June to September 1813.

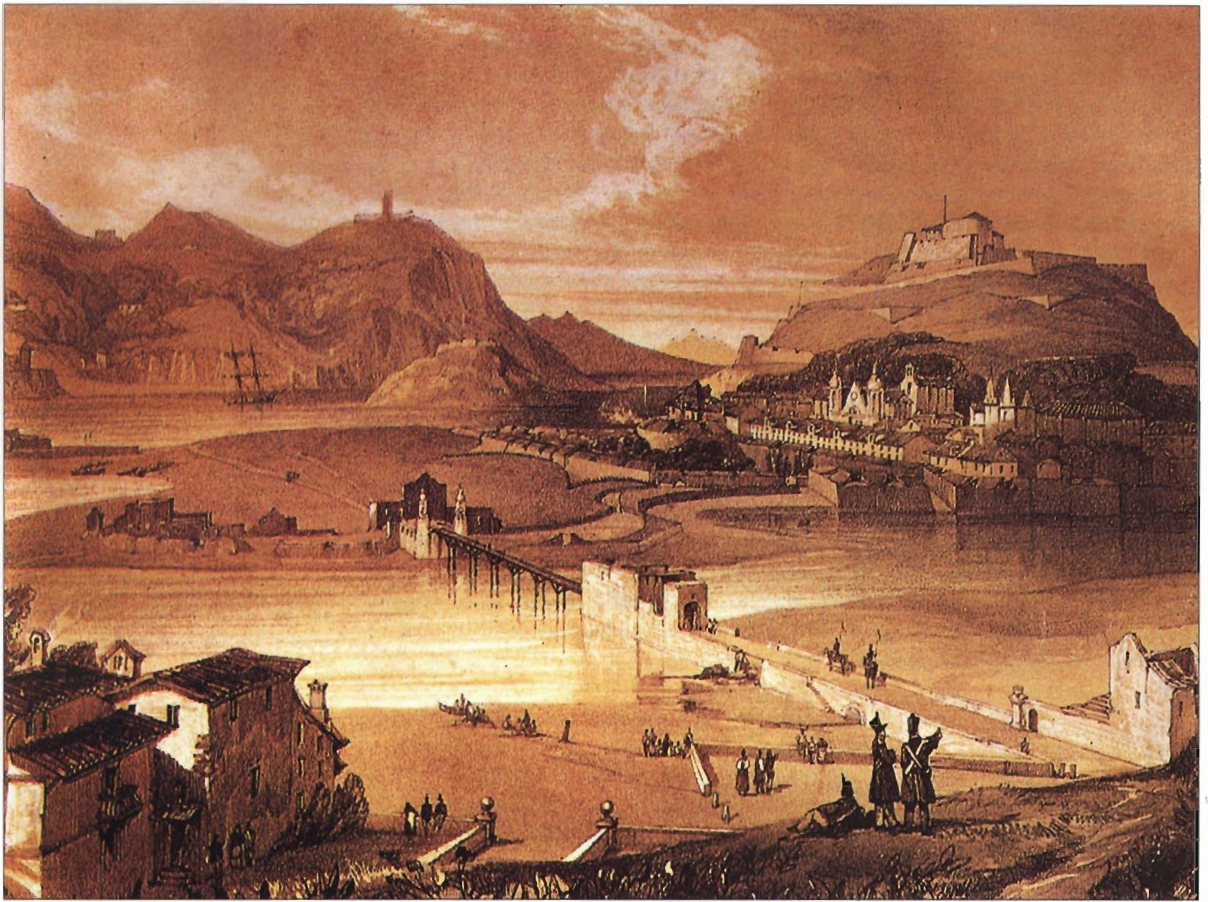
San Sebastián, as drawn by Wilkinson in 1835. The town's fortifications had not changed much in the 20 years since Wellington's men stormed the place on 31 August 1813. The castle to which Governor Rey and the survivors of his garrison retreated can clearly be seen on top of Monte Urgullo, in the background on the right.

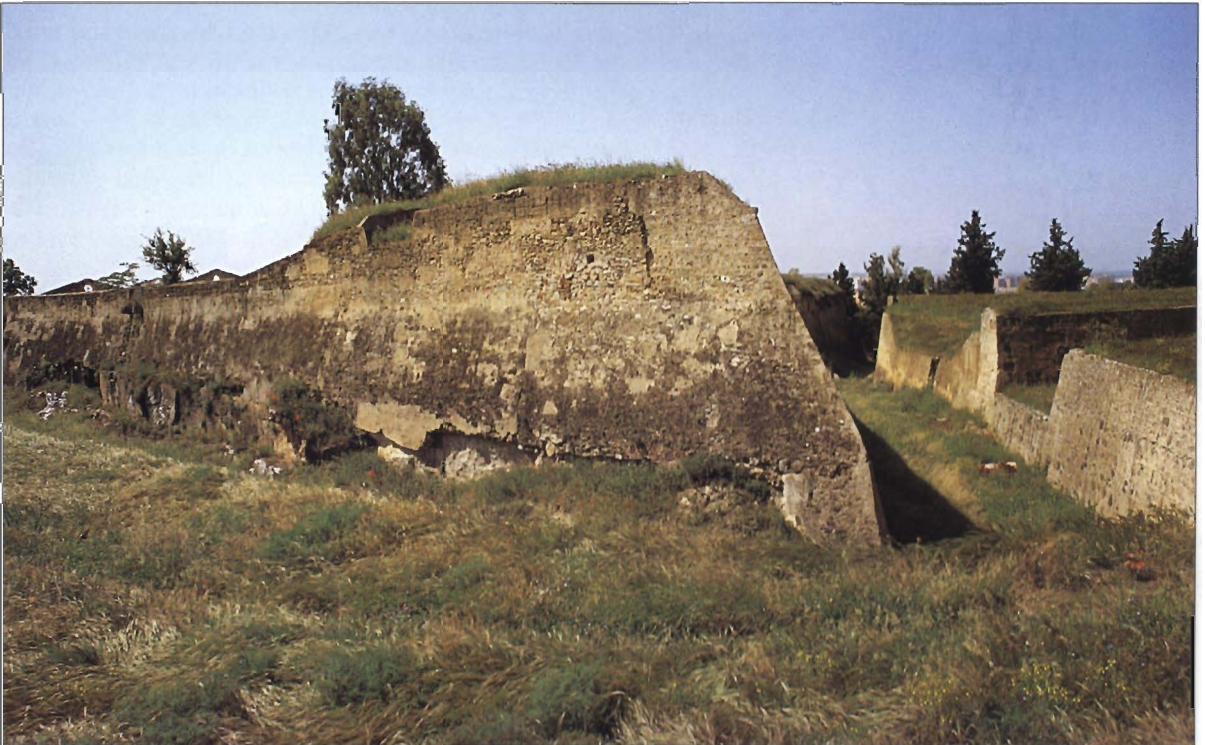
The great angled form at the northern end of Fort San Cristobal, Badajoz. It was against this flank of the fort that Wellington vainly directed his efforts in June 1811.

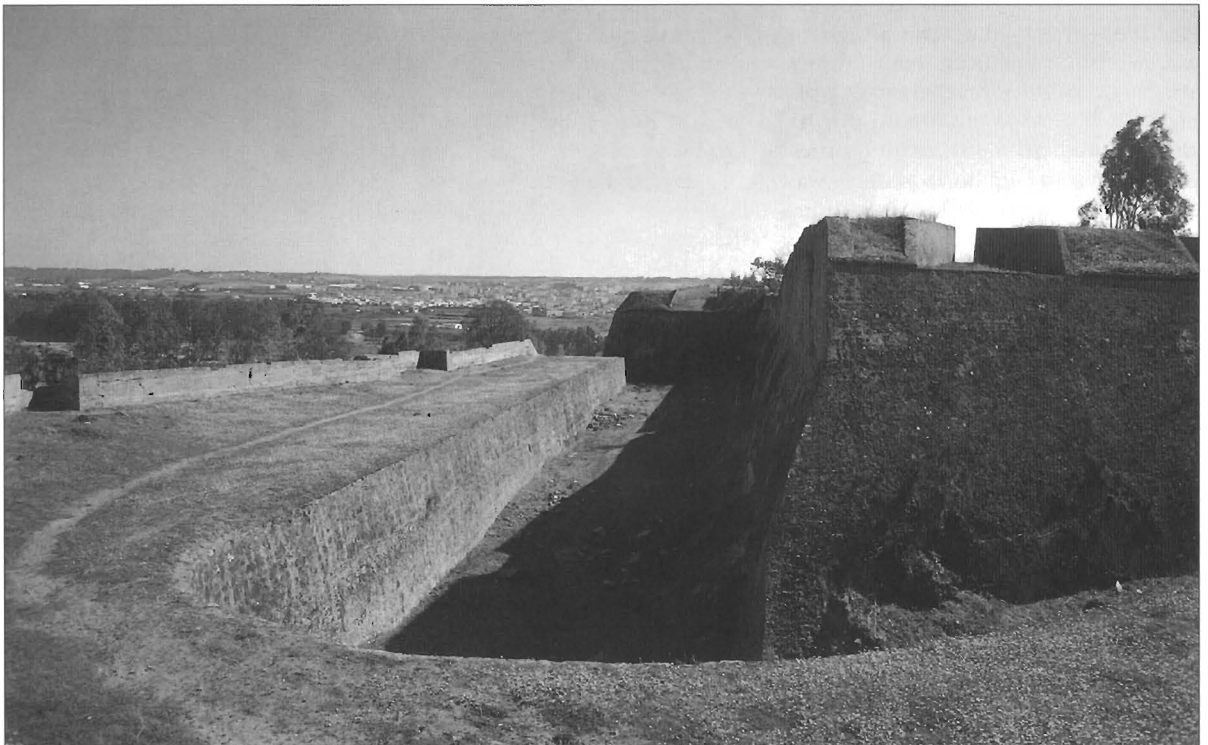
Another view of the ditch of Fort San Cristobal, Badajoz. This photo was taken from the covered way, beyond which stands a very effective glacis that almost completely covers the walls of the fort from artillery fire.

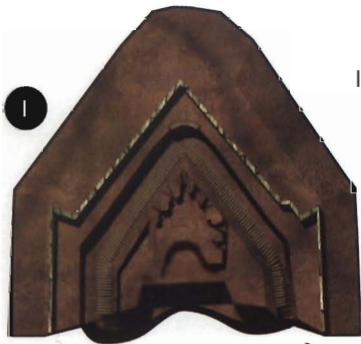
1. A plan view of Fort Picurina.

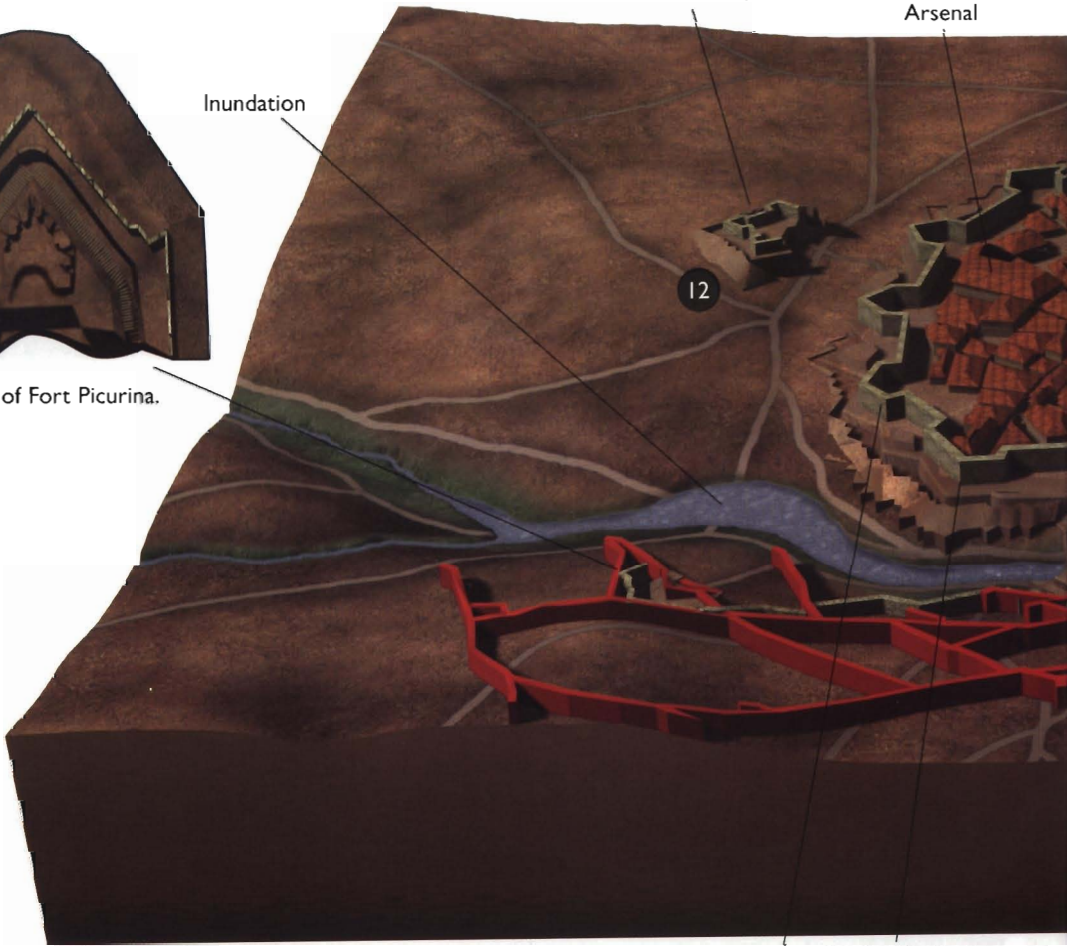
2. A cross-section of Fort Picurina's defences. Two rows of palisades protect the rear of the fort.

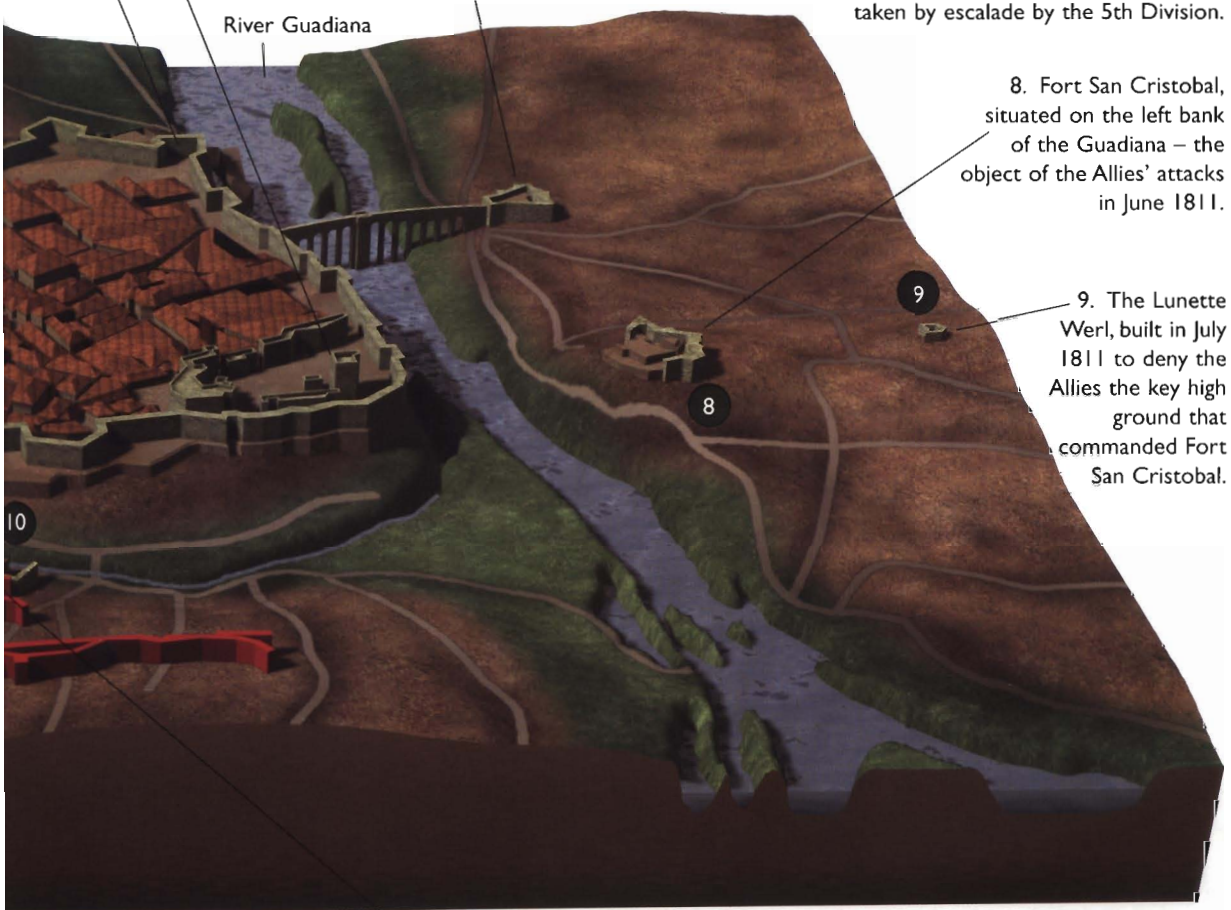
8. Fort San Cristobal, situated on the left bank of the Guadiana – the object of the Allies' attacks in June 1811.

9. The Lunette Werl, built in July 1811 to deny the Allies the key high ground that commanded Fort San Cristobal.
