Fortress

Fortresses of the Peninsular War 1808–14

Ian Fletcher • Illustrated by Chris Taylor

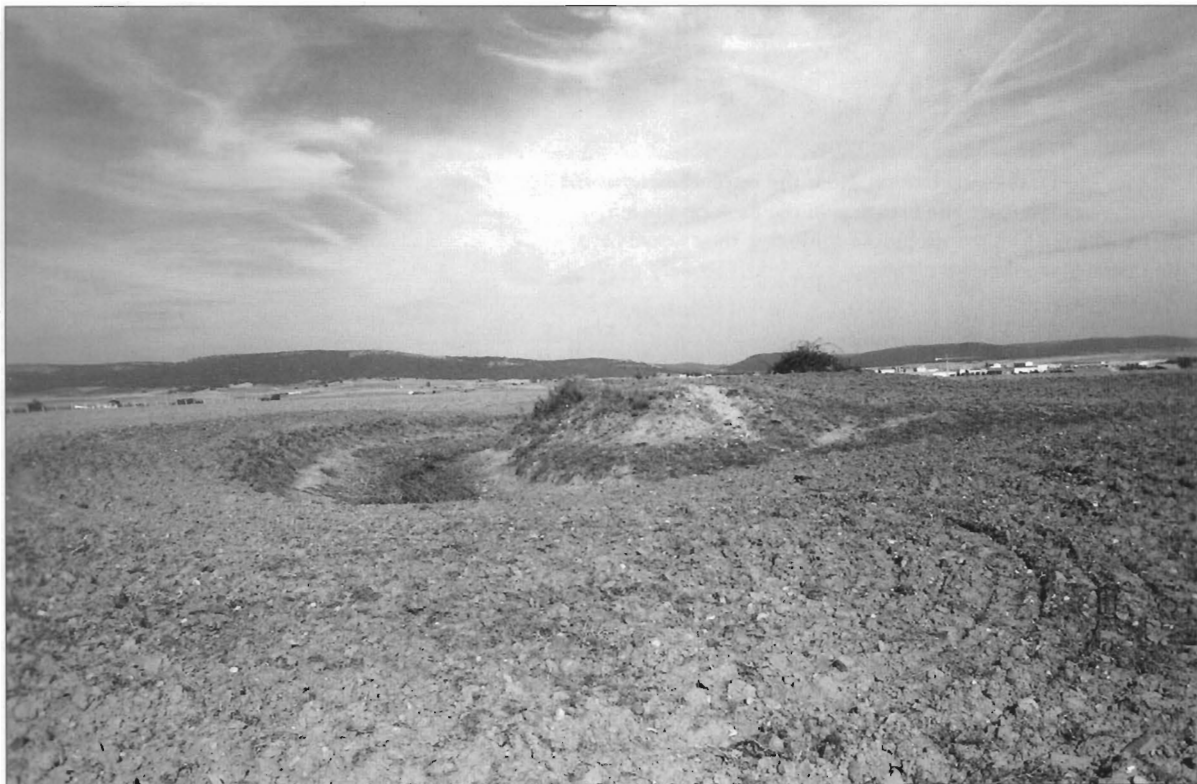
7. Another cross-sectional view of the defences of Fort Picurina. The fort commanded the high ground to the south-west of Badajoz.

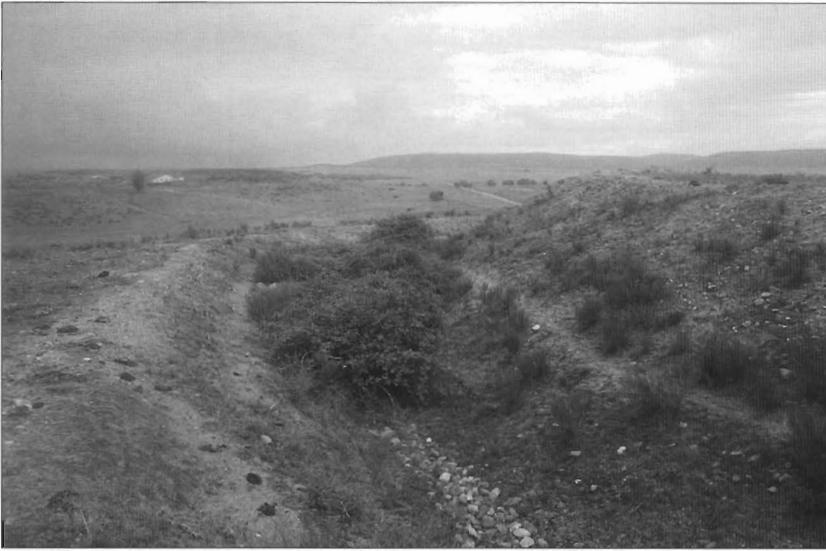
The deep ditch of the northernmost fort on the Upper Teson, at Ciudad Rodrigo. The ditch here is about 30ft deep.

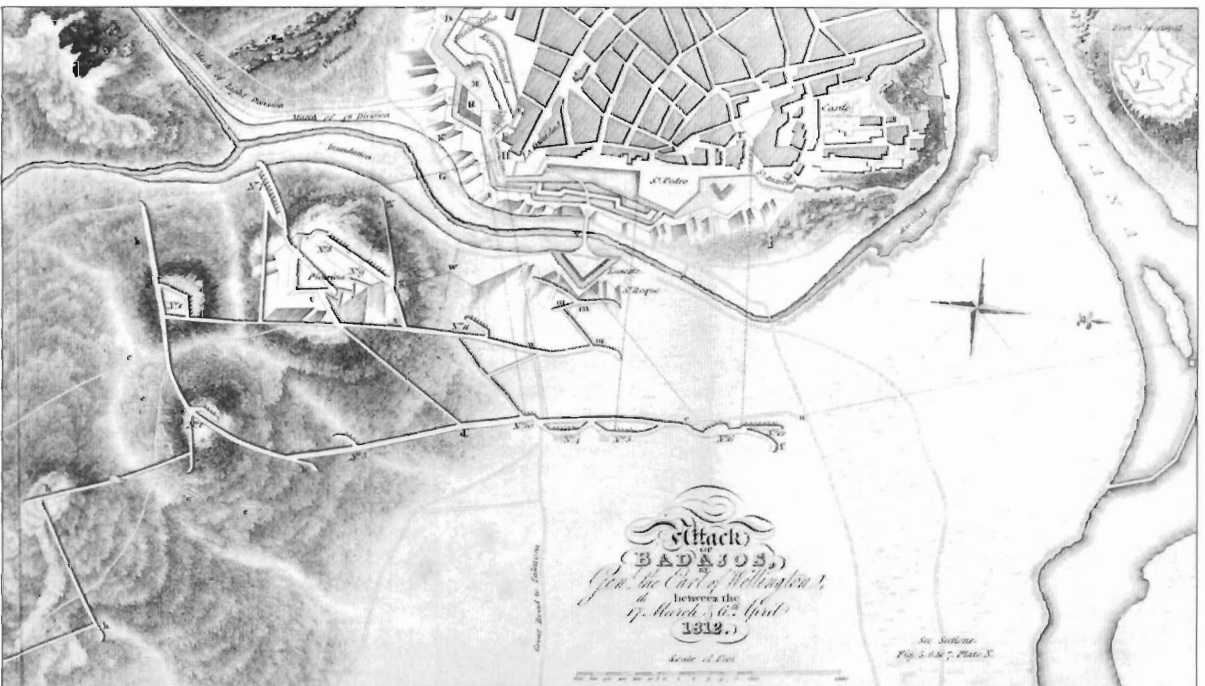
The area of the main assault of the third siege of Badajoz is shown here on this plan by Jones. The plan shows quite clearly how Fort Picurina dominated the ground here, and just how vital it was for Wellington to take the place before he could begin breaching the walls. The plan also shows the inundation, or false lake, created by the dam constructed at the Lunette San Roque (upper centre).

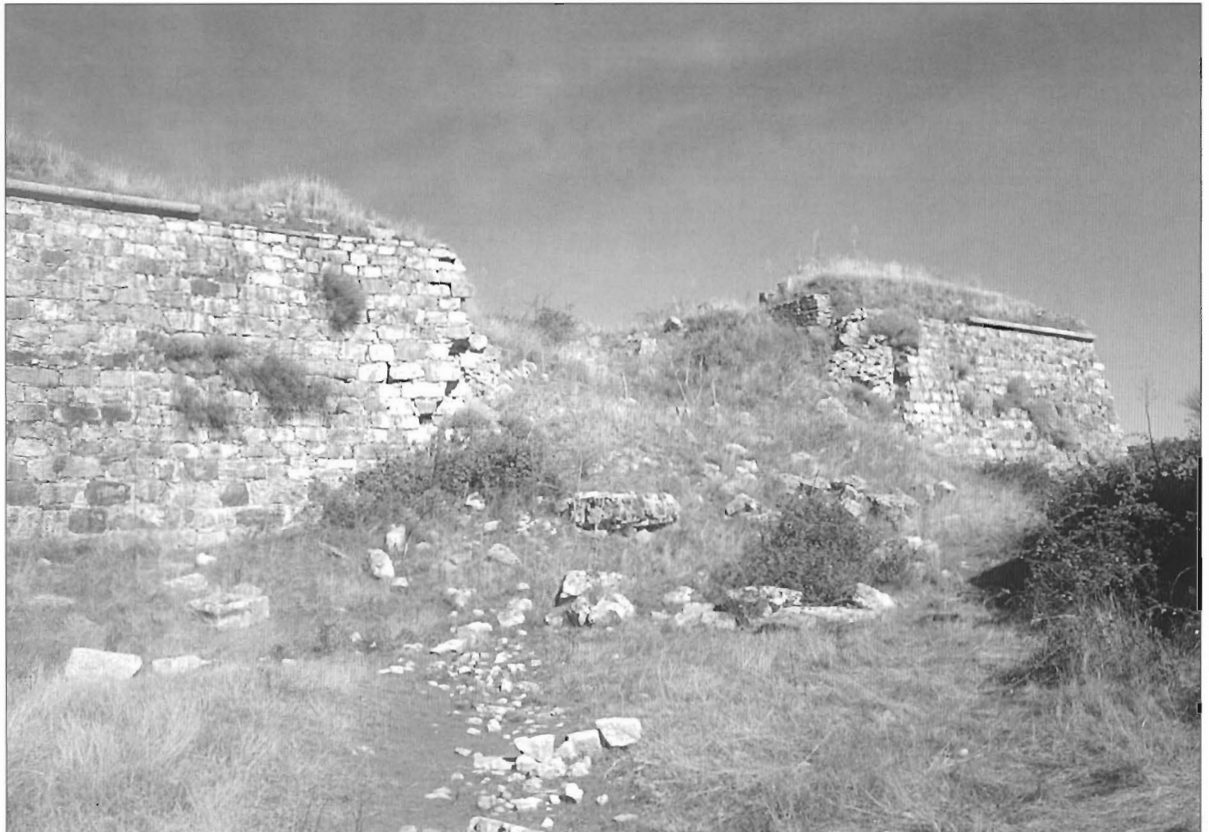
A breach in one of the bastions of Fort Conception, near Almeida. The fallen debris forms a sort of ramp, up which the stormers would attack. The defenders would try to remove as much of this as possible in order to deny them the facility. They would also block the breach with all manner of obstacles.

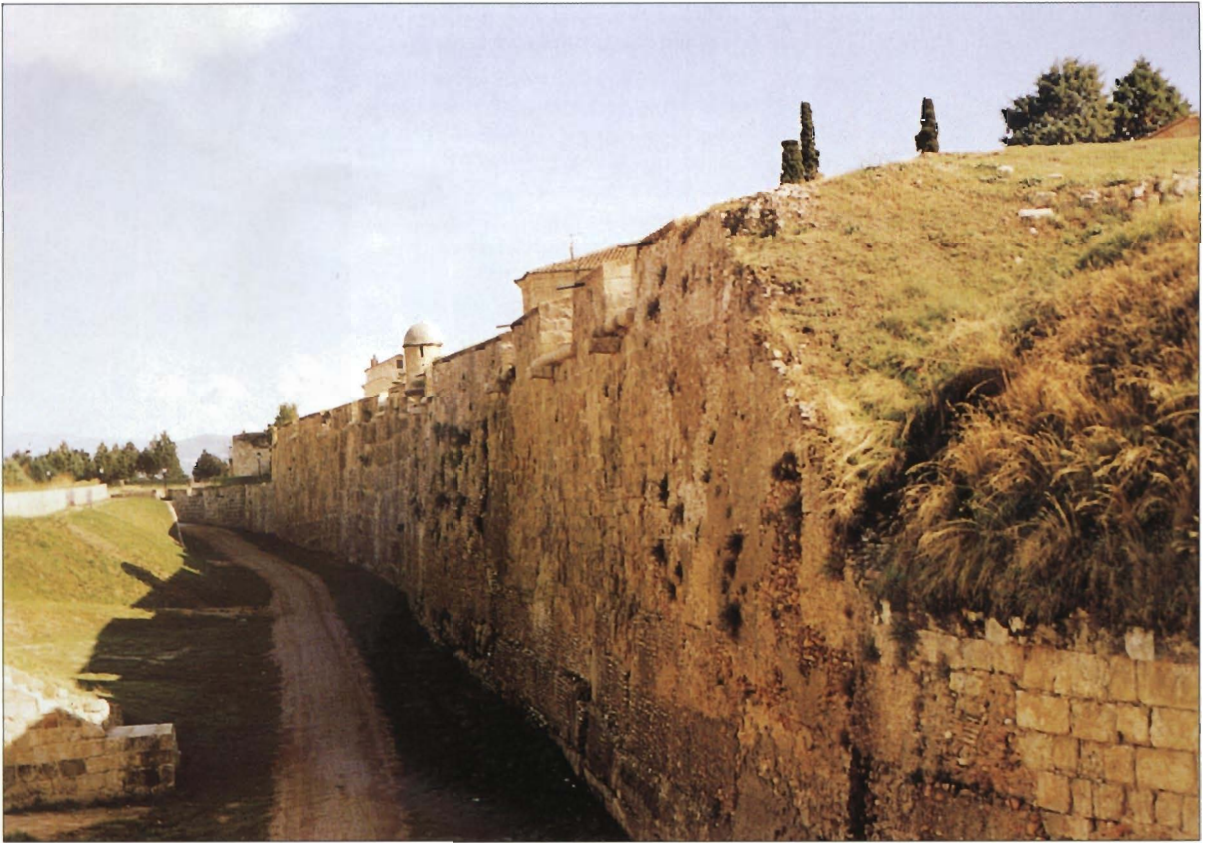
The site of the Great Breach at Ciudad Rodrigo, with the actual breach at the right-hand edge of this photo. The flat walls illustrate perfectly just how easy it was to shoot down the entire length of the ditch. However, the walls afforded little protection against artillery fire. There are no ravelins or bastions, only a *faussebraie* to protect the walls.

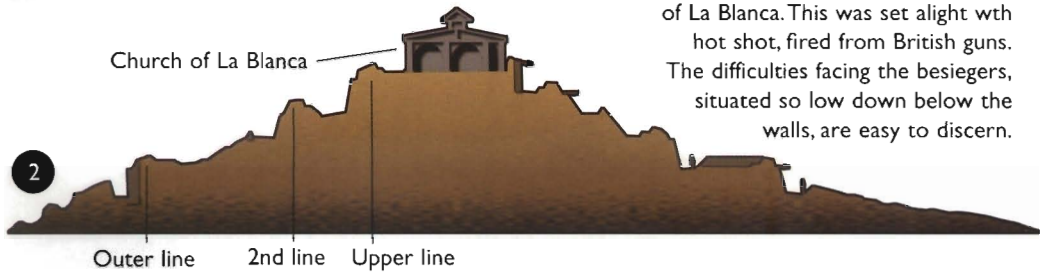
2. A cross-section through the church of La Blanca. This was set alight with hot shot, fired from British guns. The difficulties facing the besiegers, situated so low down below the walls, are easy to discern.

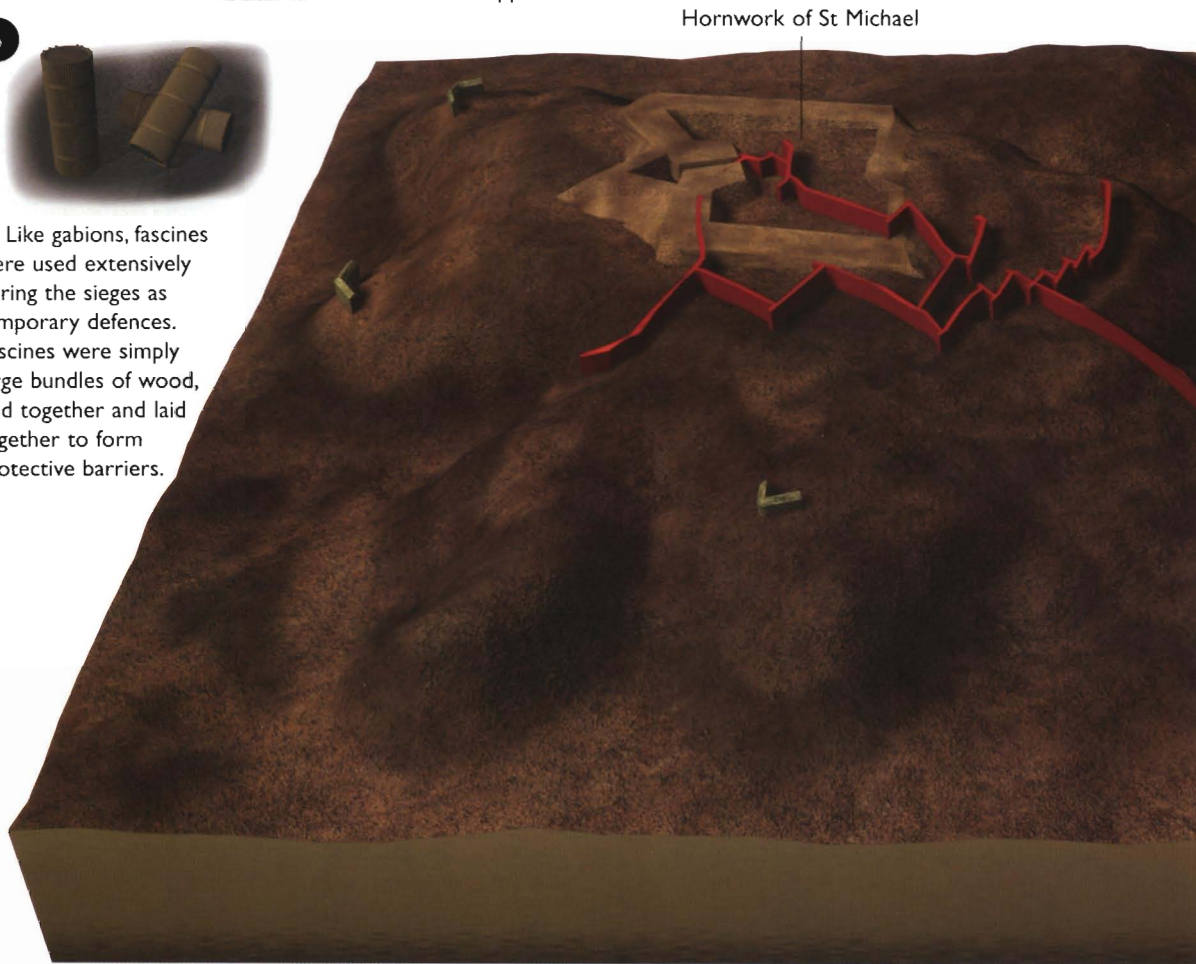
6. Like gabions, fascines were used extensively during the sieges as temporary defences. Fascines were simply large bundles of wood, tied together and laid together to form protective barriers.

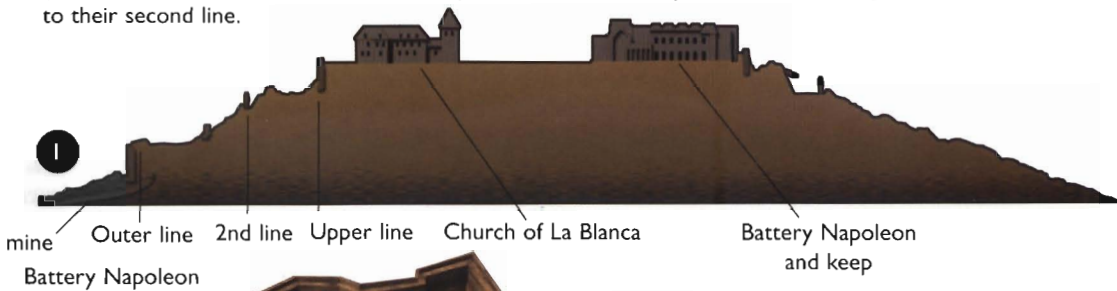
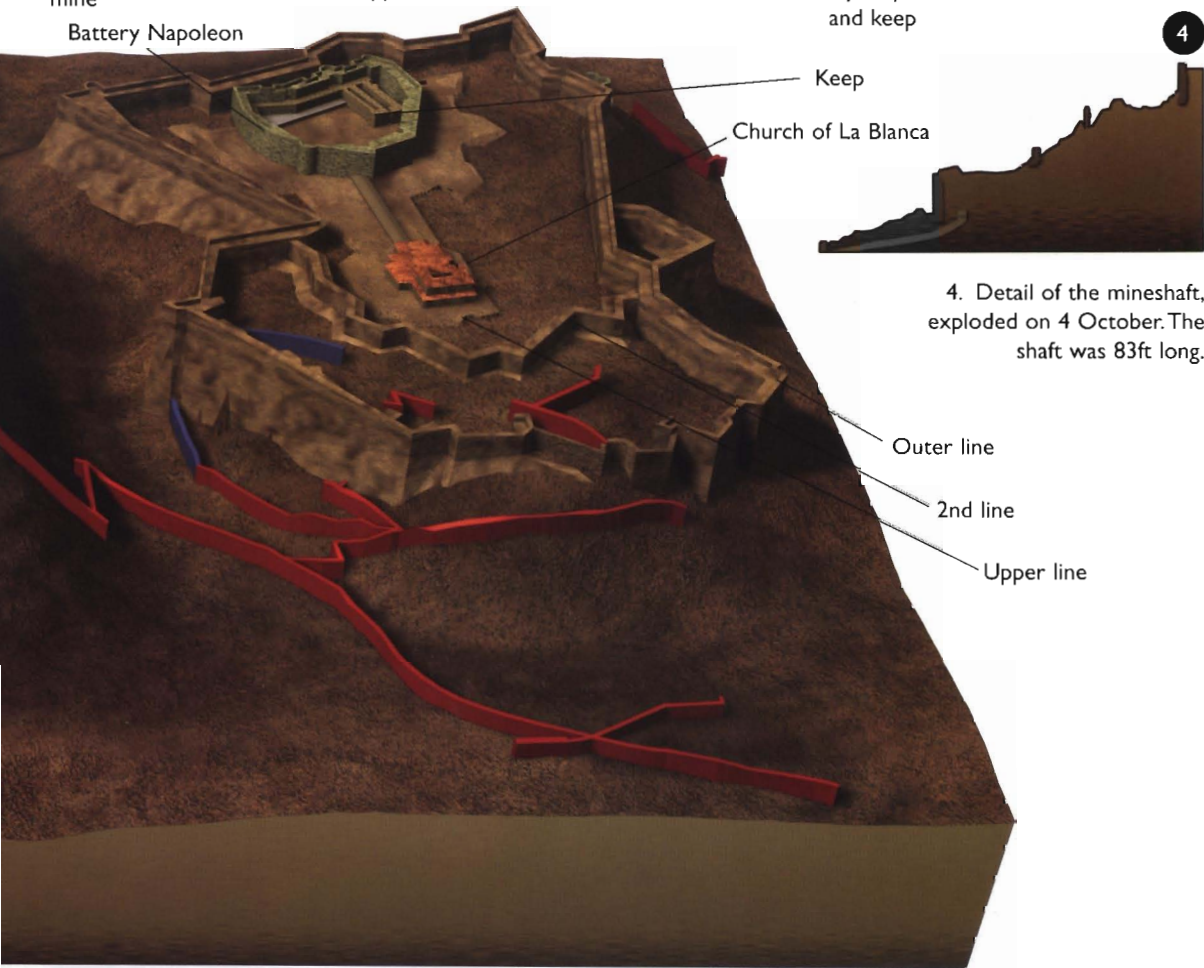
4. Detail of the mineshaft, exploded on 4 October. The shaft was 83ft long.

3. This cross-section best illustrates the problems facing Wellington's artillery. Not only were the guns too few in number, they were sited far too low to cause the walls of the castle much damage – hence the extensive mining operations.

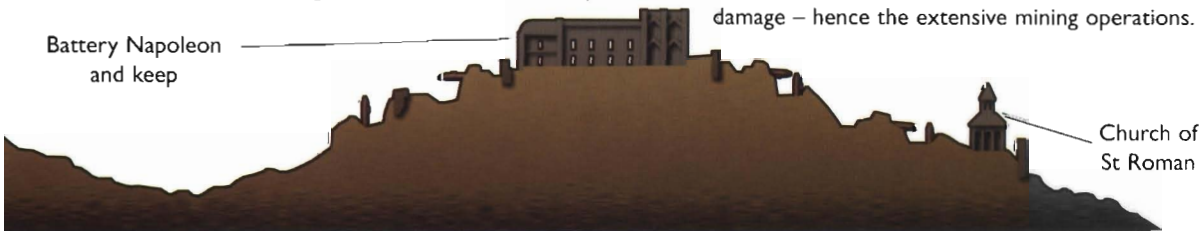
1. A cross-section through the castle of Burgos, west to east, showing the Allies' mineshaft beneath the third (or outer) line of defences. It was blown up on 4 October with great success, although the defenders retired to their second line.

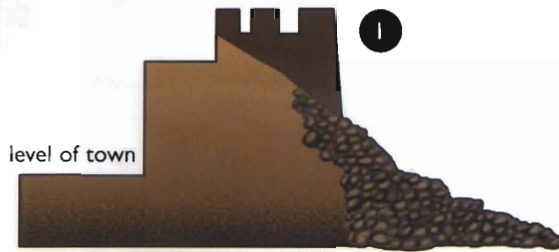
1. A section through the breach in the tower at the right-hand end of the curtain wall (see main illustration for location).

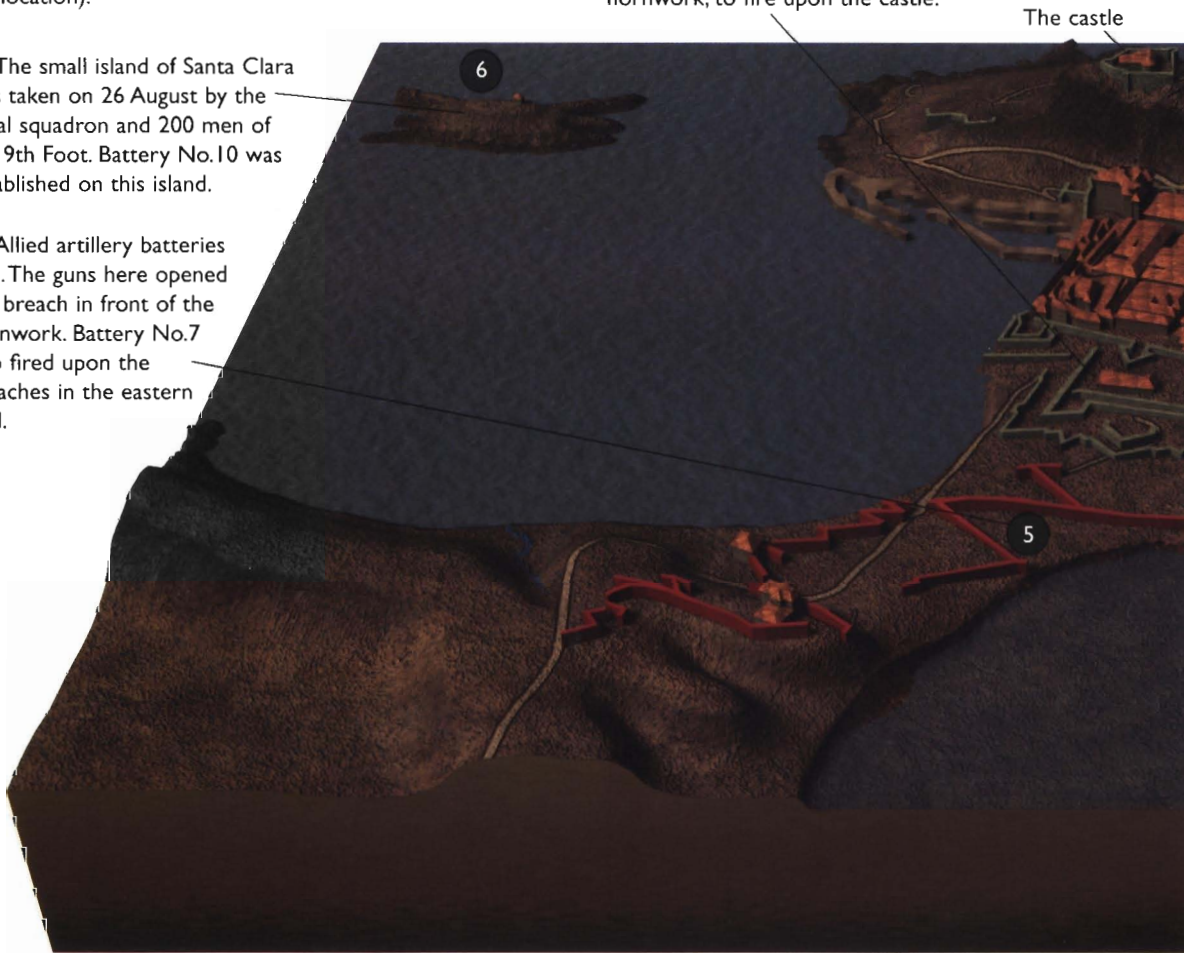
2. Cross-section through the breach in the left demi-bastion, through the curtain wall. The 35ft drop into the town caused the attackers tremendous problems on 31 August.

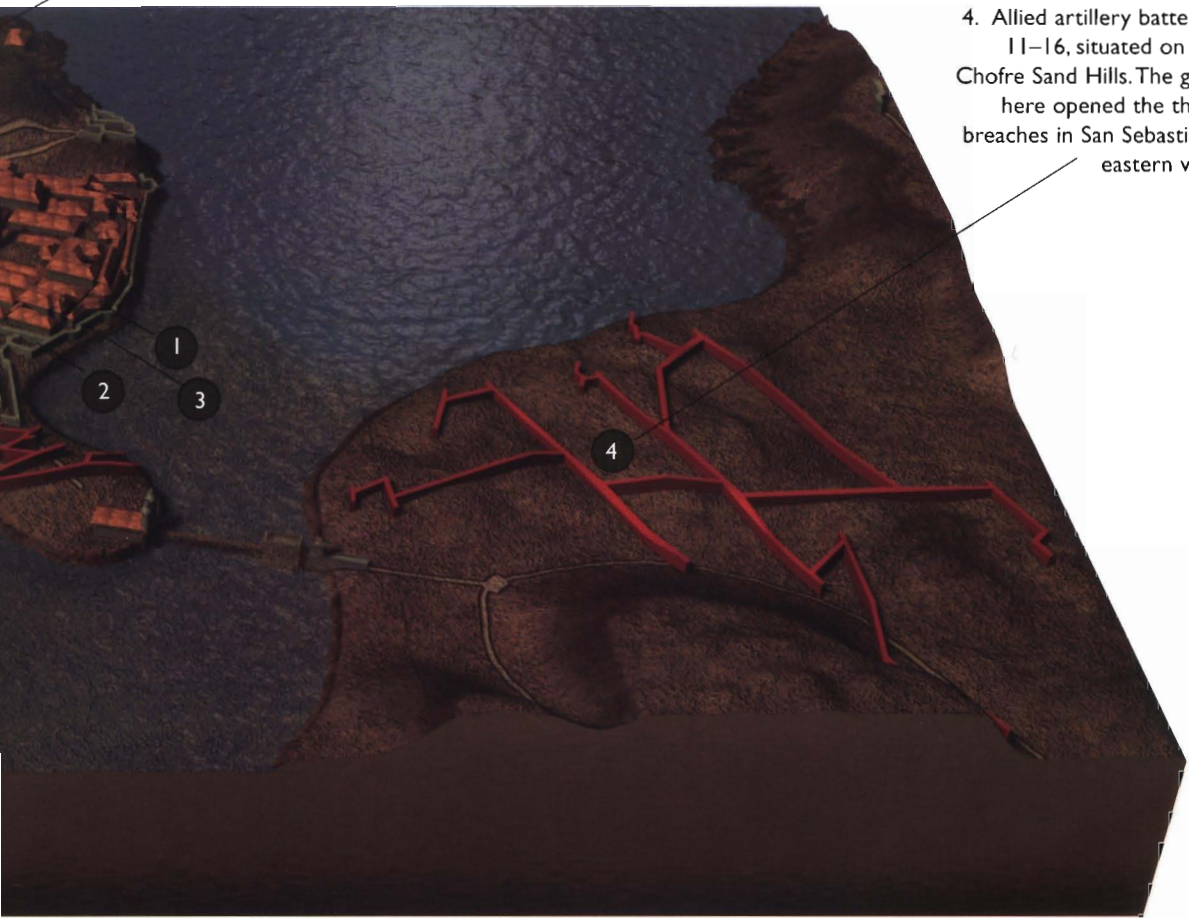
4. Allied artillery batteries 11-16, situated on the Chofre Sand Hills. The guns here opened the three breaches in San Sebastián's eastern wall.

3. Cross-section through the right-hand breach. The waters of the River Urumea lap up to the debris, making it impossible to attack the breach except at low tide. The breach is retrenched, thus giving the attackers yet another barrier to pass, even after they have carried the first breach.

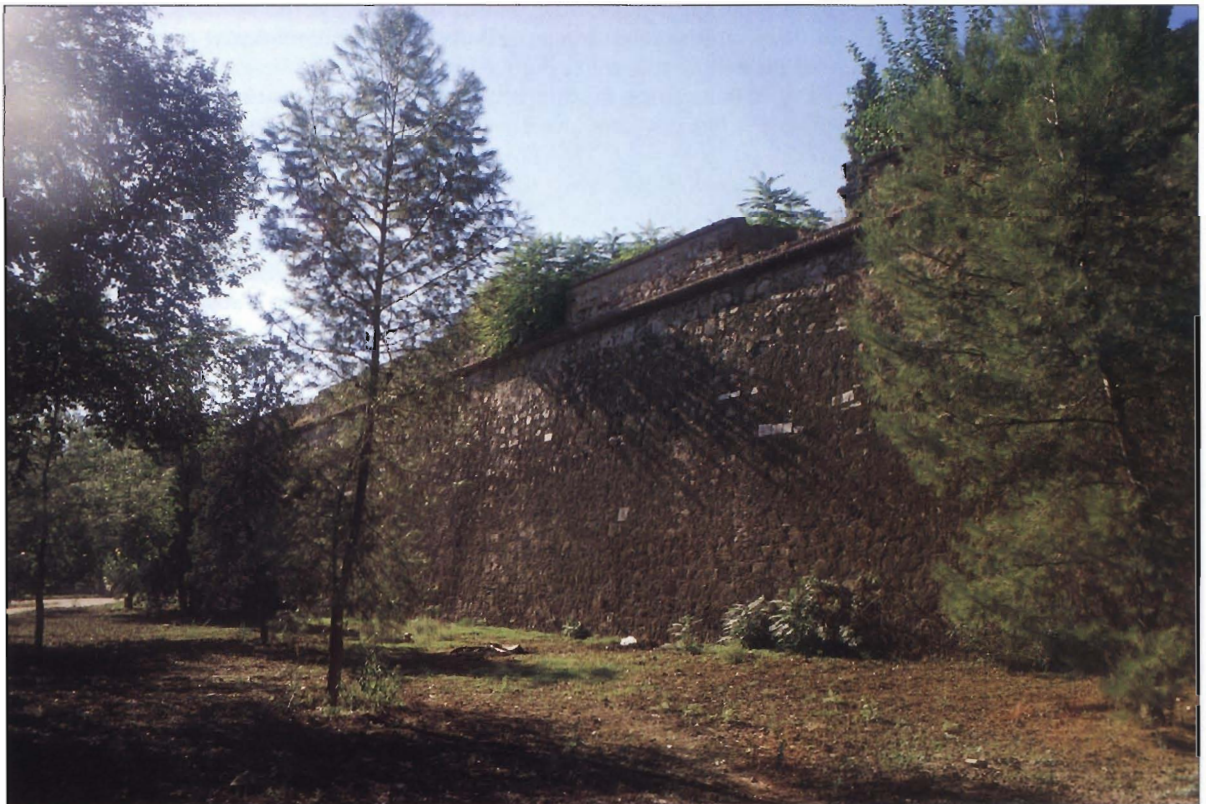
The site of the Great Breach in the Trinidad bastion, Badajoz. Until a few years ago the year 1812 was picked out with cannon balls high on the wall. They have since disappeared but it is still possible to see the holes. Many brave men are interred inside the breach.

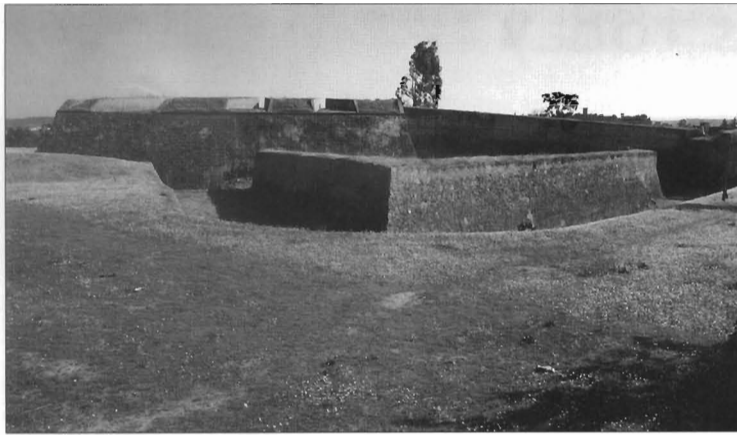
Fort San Cristobal, Badajoz, as seen from the covered way. The glacis rolls away behind the camera, effectively shielding all that is visible in this photo. It is a most effective glacis.

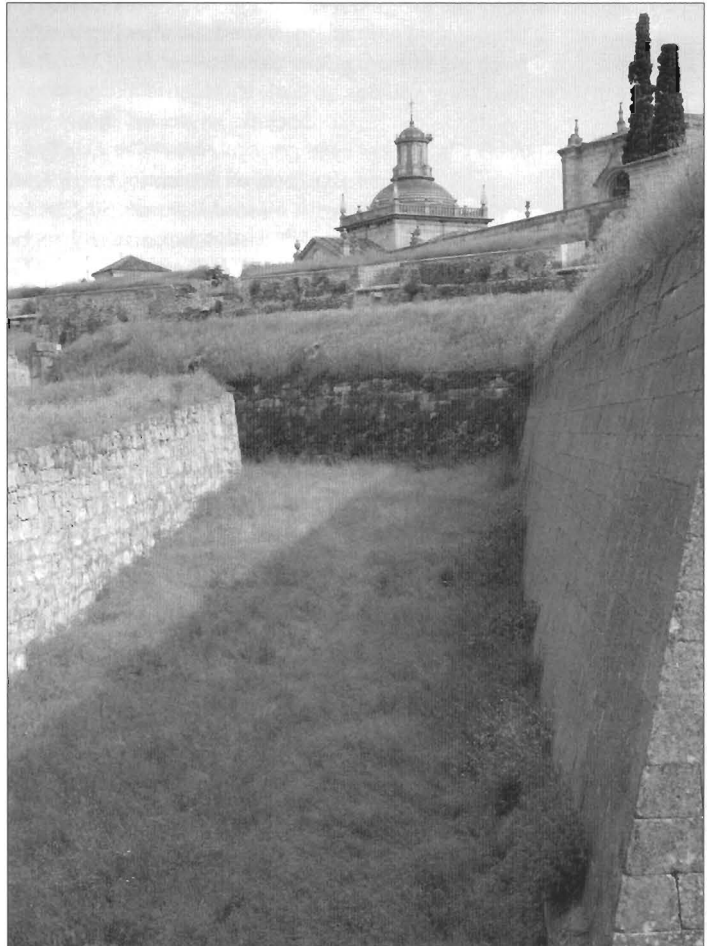
The outer ditch and faussebraie at Ciudad Rodrigo. In the left background is the site of the Lesser Breach, stormed by the Light Division. Robert 'Black Bob' Craufurd lies buried beneath it.
