# A NEW LIFE FOR THE FT-290R TRANSCEIVER !

## By F5RCT

The FT-290R is an old amateur radio workhorse which was a very popular transceiver during the 80's. It is a 2-metre multimode portable which can run with or without an external 12 V power supply unit. Still quite favoured as an exciter for transverters or linear amplifiers, it is built like the proverbial brick outhouse. Large numbers were sold and they are now commonly available for around 150€. They seem to be reliable in general and most components are discreet and can be replaced. The following article proposes a list of modifications "à la carte" to improve their performance.

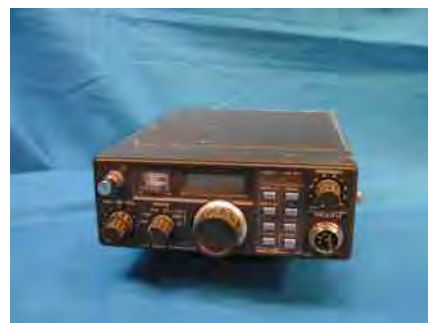
The Yaesu FT-290R is a multi-purpose, multi-mode FM / CW / USB / LSB portable 2-metre transceiver. With 13.8 VDC input, output power is 2.5 watts. Coverage is 144 to 146 MHz. FM steps are 12.5 or 25 kHz for the European version. CW/SSB steps are 100 or 1000 Hz. It has a built-in telescopic antenna. The radio operates from eight alkaline/NiCad C cells (not supplied) or from an 8.5 to 15.2 VDC power supply. It measures 6 x 2.5 x 7.9 inches (150x58x195mm) and weighs 1.3 kg.

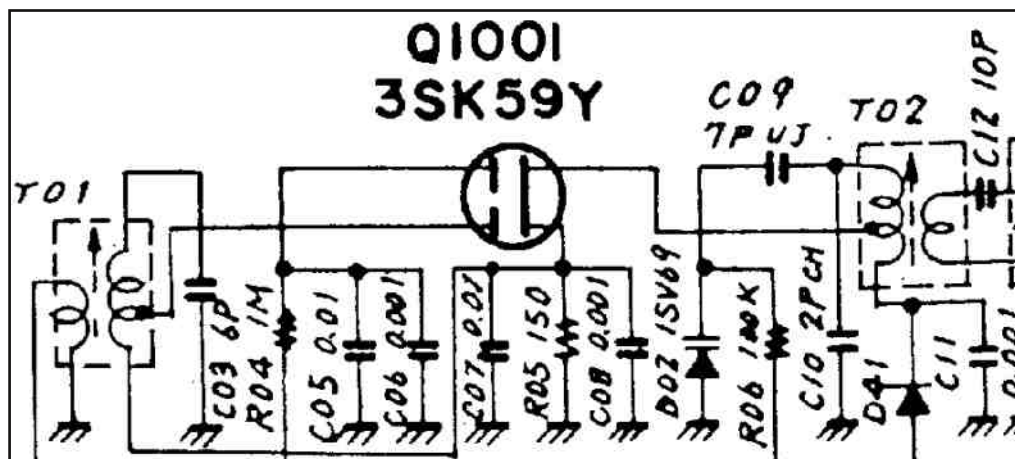
The poor sensitivity comes from different design reasons and from the input transistor:

- Antenna switching from antenna socket to receiver input has high loss. The last modification reduces the loss by 2dB.
- The input transformer T01 has loss too. Having a transformer with very thin winding wire introduces loss compared to a direct matching circuit.
- The input transistor Q1001 has a poor noise figure even if the gain is sufficient. A quick modification consists in grounding the source resistor to increase gain (+1 or 2 dB) and drain current: but there is no improvement in sensitivity (signal to noise). This will increase G2 voltage and gain. This transistor is located close to the power jack.

De-soldering of T01 is easy by using a large tip and adding a lot of solder tin to heat all leads together. Remove Q1001, C03, and C07. Clean holes with a de-soldering pump.

Replace Q1001 with a BF988 soldered on back side with reference facing the PCB. It is possible to use a BF690, BF961 or BF964 (or the SMD versions: BF998, BF994, ..)

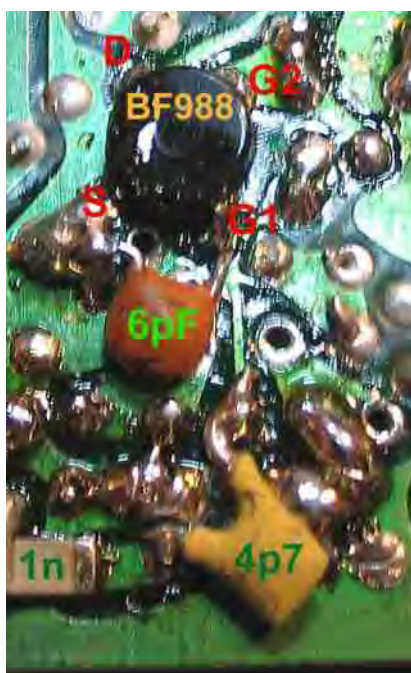
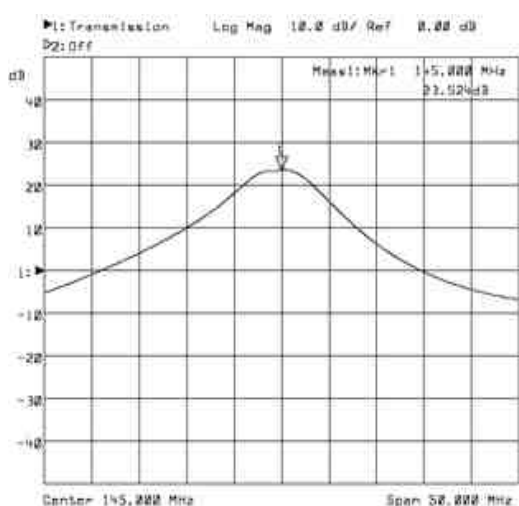
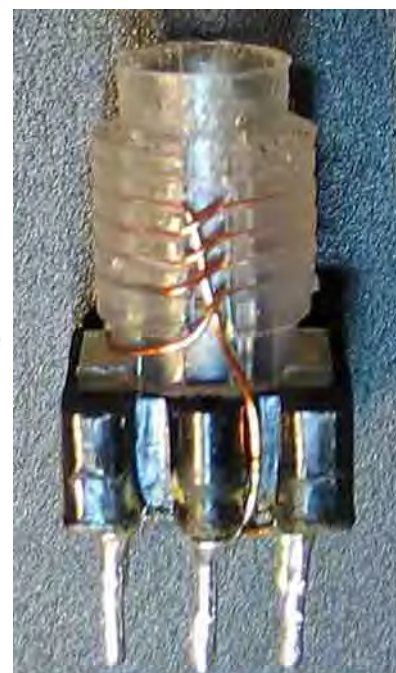
Remove carefully the shield from T01 and the ferrite cap, cut the wire and clean the coil support. Then T01 is wound with 4.5 turns of 0.25 mm enamelled wire. Start the winding at the top second slot from G1 pin connection to finish at ground connection. Place the 6pF or 5.6pF capacitor from ground S to G1. Add a 4.7 pF capacitor from G1 to input close to C101, or replace C101 with 4.7 pF and make a short jump to G1. Solder non used pins of T01 to ground.

The front end stage T01 and T02 need alignment at 145 MHz using an RF signal generator, based on maximum deviation of S-meter.

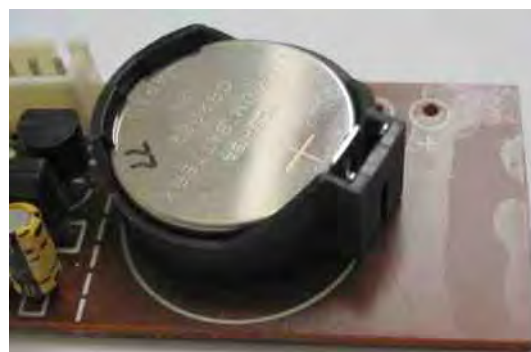
On earlier versions of FT-290R the audio gain is too high and the volume control range is too straight.

Check the voltage of the battery: If measured voltage is less then 2.8V the battery is at the end of its life.

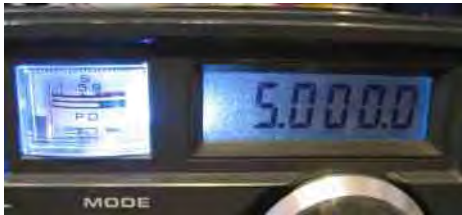
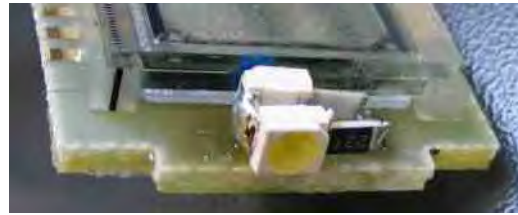
The main weak point of the FT-290 is the small incandescent backlight that has to be replaced periodically. This lamp does not handle a voltage greater than 12.5 V and blows at 14 V. It is a real pain in the neck if you do your own repairs: do the replacement once and for all.

It is possible to replace the light bulb by two white LEDs side by side in series with a 470 Ohms resistor.

This modification depends on surface mounted LEDs picked up from mobile phones. The procedure is lengthy due to the removal of the front panel and the stack of printed circuits.

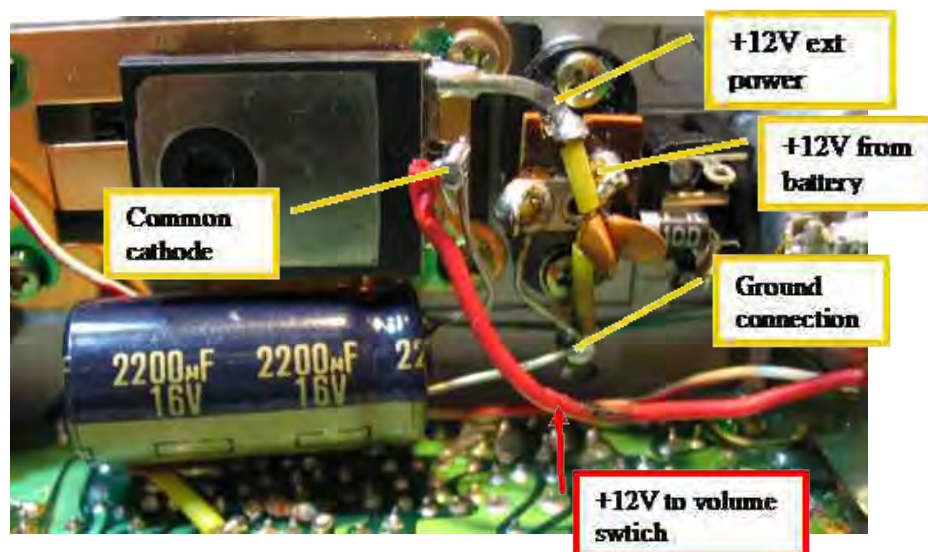
The protection against reverse polarity of supply is not sufficient: F5AEG burned the CPU board of his device. By studying the schematic diagram and the device structure we spot a diode (D01 10D1) located on the power jack and PL socket that will shortcut the supply if reverse polarity is applied. This diode is a silicon junction (0.7V) diode and is too weak for strong power. A fuse follows the switch and the diode to protect the device against inside shortcircuits.

The recommended improvement is to remove the input diode and add a Schottky series diode on +12V of the device. This change adds a voltage drop of 0.3 V max but protects the device absolutely without any trouble. The Schottky diode may be found in a computer power supply, it is the +5V rectifier diode, generally a double 30 A to 60 A 45 V diode.

Remove the parallel diode on power jack and PL socket.

Connect the two anodes of the Schottky diode together. Then solder the anode to the power jack and the cathode to the red wire and +V pole of the capacitor.

Check the capacitor and replace it if necessary with a 1000  $\mu$ F 16 V minimum. This capacitor protects the device against voltage spikes present on vehicles.

Another idea is to connect the Schottky diode in parallel to the supply after the fuse. In this case the fuse will blow if reverse polarity is applied. If you do this the anode ground connection must be connected to the frame near the fuse on the power supply board. Bear in mind that if the ground impedance is too high the protection will be not sufficient.

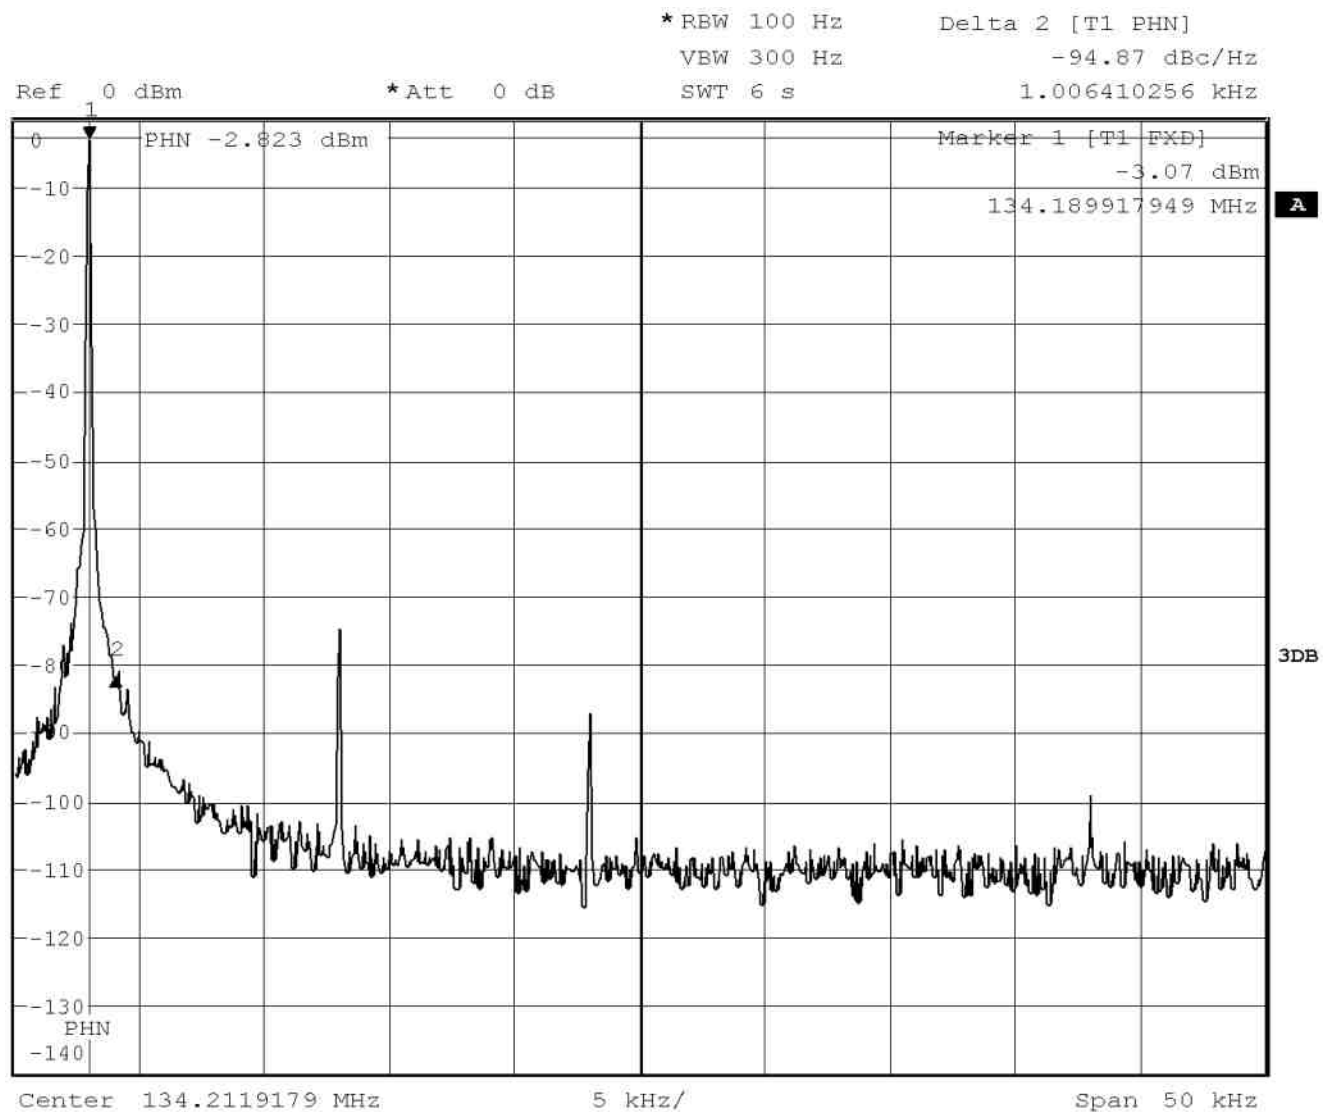
Spectrum measurement:

Spurious:

some residuals from the comparison frequency of the PLL

- 70 dBc at 10 kHz offset
- 80 dBc at 20 kHz offset
- 95 dBc at 40 kHz offset

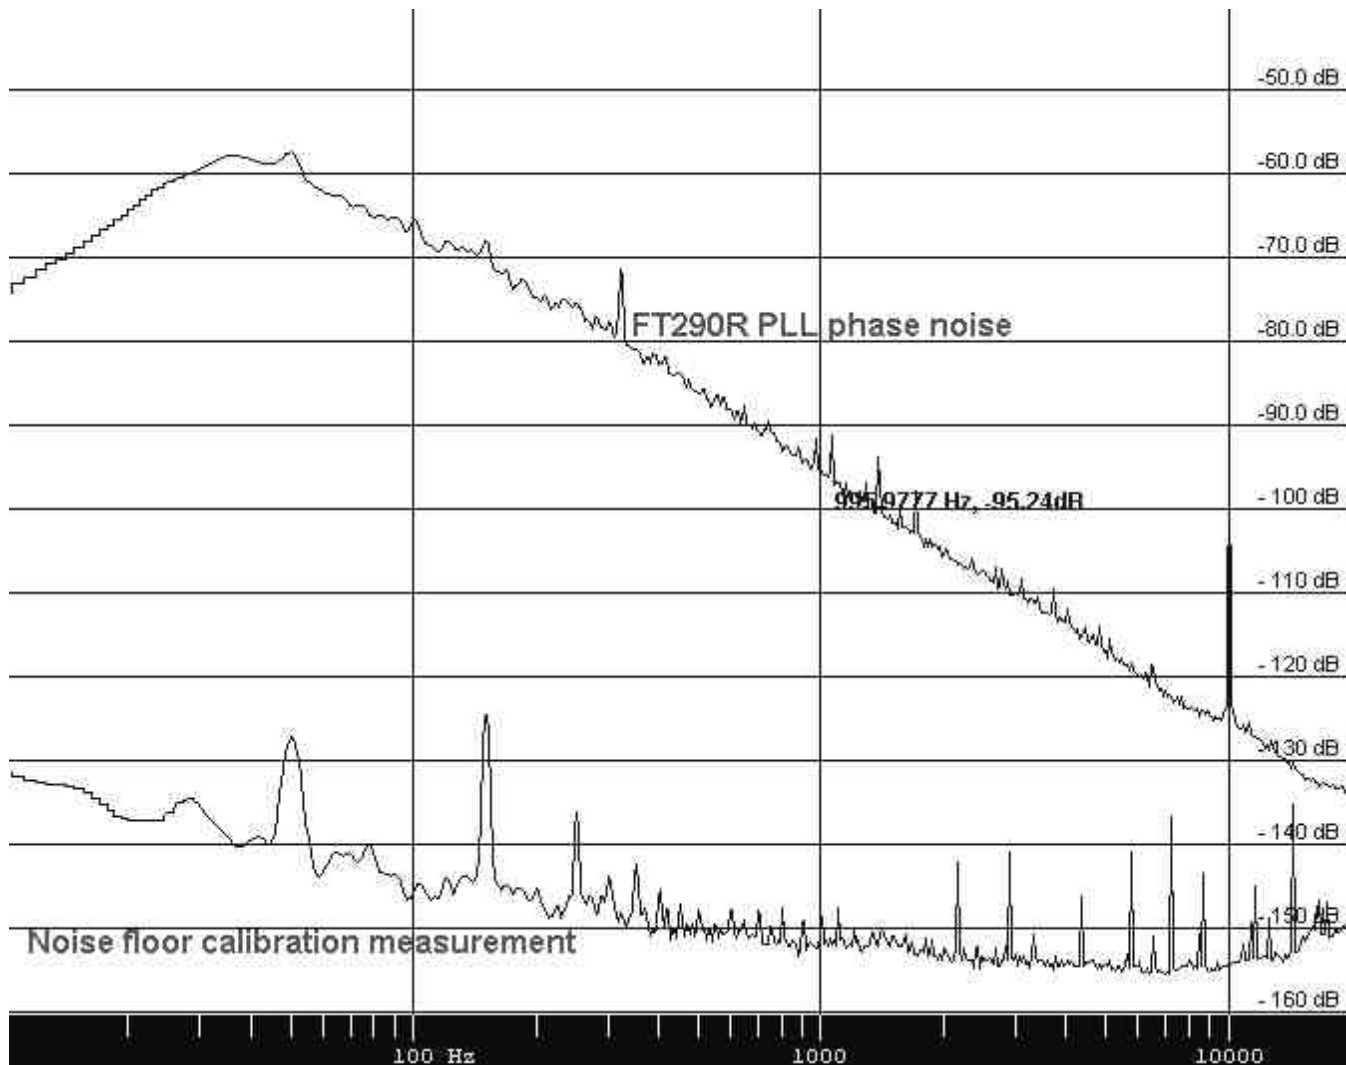
The signal at Rx mixer gate 2 was measured with an R&S FUP spectrum analyzer and phase noise system measurement.

- 95 dBc/Hz at 1 kHz offset
- 111 dBc/Hz at 3 kHz offset
- 122 dBc/Hz at 10 kHz offset

PLL phase noise measurement: -95 dBc/Hz at 1 kHz offset

- Limit the frequency range to 144-145 MHz with the jumper configuration on the CPU board. Then adjust the TC01 trimmer capacitor of the PLL's VCO (see alignment procedure) at 3.5 V for 145 MHz. The RF filters on receiving (T1001-T1004) and transmitting (T2001-T2006) section need tuning too.
- Remove the PLL shield and cut the track from pin 8 of PLL circuit to resistor R27 (1k), then add SMD 4k7 to 10k resistor. This modification decreases the noise on tuning voltage.
- On earlier versions the -6.8V voltage is provided by ICL7660 (8 pins DIL IC). Noise is generated on +5.6V, audible in FM mode. It is very easy to improve by connecting a 10 $\mu$ F capacitor between pin 8 and ground.
